## **PCB INTERIM MEASURES PLAN**

**University of  
Massachusetts**

Lederle Graduate  
Research Center

Amherst, Massachusetts

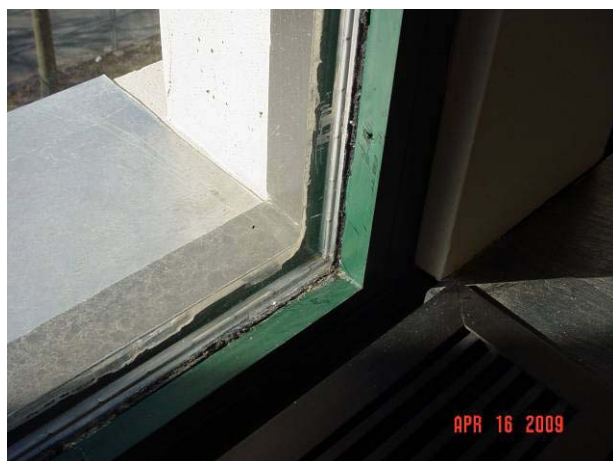
**Library Conference Room 365A**

Results of the window inspections and inventory indicated that glazing sealant similar in appearance was observed on the majority of window joints throughout the low rise, the walkway, and Tower A. The glazing sealant was black in color and had very little plasticity. Below surficial portions, the material was observed to be softer and in one location (glazing sample location LGRC-GZ-008 High Rise Location) an increase in the overall plasticity was observed. In general, the sealant appears in good condition; there are some areas (e.g., bottom frame exposed to direct sunlight) that exhibit signs of deterioration. Based on window construction drawings and field observations, the glazing sealant appears to be present on both the interior and exterior sides of the window glass and on all four sides of the window glass and the metal pane.

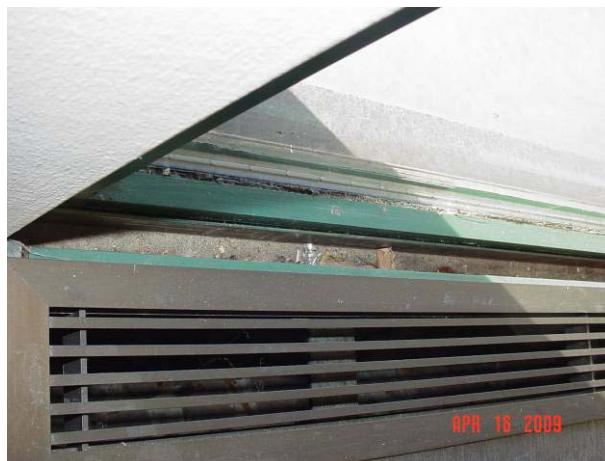
**Typical Window Joint with Glazing Sealant**

- Interior window glazing sealant on the majority of the windows at the low-rise and Tower A contain PCBs in excess of 50 ppm and up to 2% chrysotile asbestos (average PCB concentration is 9,660 ppm);
- Overall, the glazing sealant appears in good condition and is present at over 900 separate window units throughout the buildings representing approximately 20,000 linear feet. There are some areas (e.g., bottom frame exposed to direct sunlight) that exhibit signs of deterioration;
- Potential transport and exposure pathways for the PCB containing glazing sealant to potential receptors include direct contact and/or generation of dust or particulate matter that may become airborne or rest on interior surfaces; and

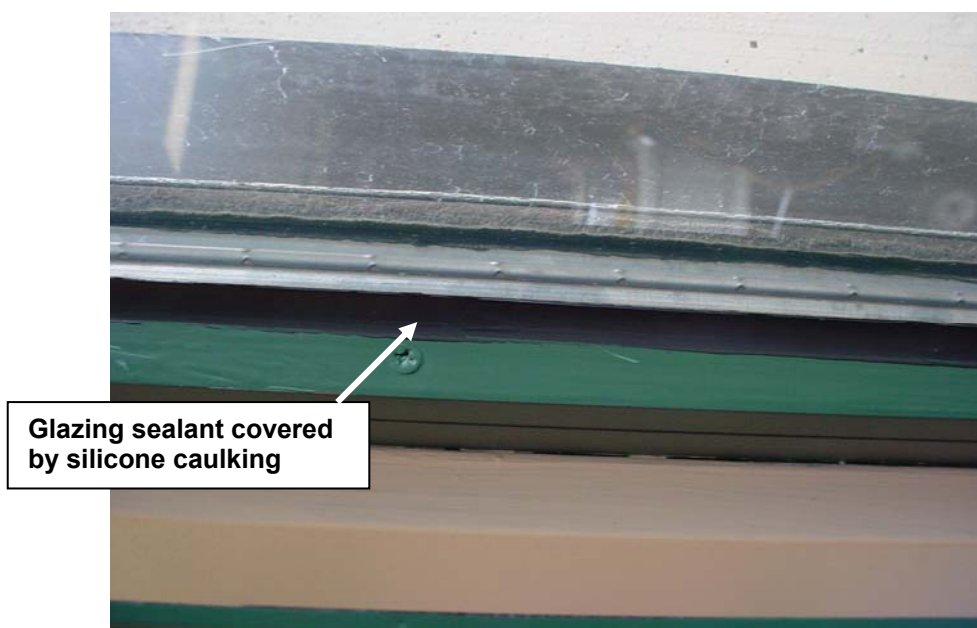
Based on the three evaluation criteria, the silicone caulk was retained for continued monitoring while the Interim Measure approval process was on-going. A photograph depicting the contained glazing sealant by the silicone caulking is presented below.

Visual inspection indicated that the encapsulant was in good physical condition with no observed cracking, peeling, or discoloration of the caulk and no observed separation from the glazing and window frames.
