Re: PCB Remediation – Sylvan Residential Complex
University of Massachusetts
Amherst, Massachusetts

**ATTACHMENT 1: PCB REMEDIATION PROJECT
STATUS UPDATE – BROWN
RESIDENCE**

This status report summarizes the PCB remediation activities conducted for the building envelope repair project and the Americans with Disabilities Act (ADA) restroom upgrade project. PCB remediation activities associated with each of these projects were substantially completed between May and August 2011. Previous communications regarding the ADA restroom upgrade project were made to your office on behalf of UMass by Environmental Compliance Services (ECS); however, as previously communicated, UMass is requesting that these two projects be “linked” into an overall Approval for PCB remediation activities at the three Sylvan Residence complex buildings. This status report is being submitted to provide additional information in support of this Approval.

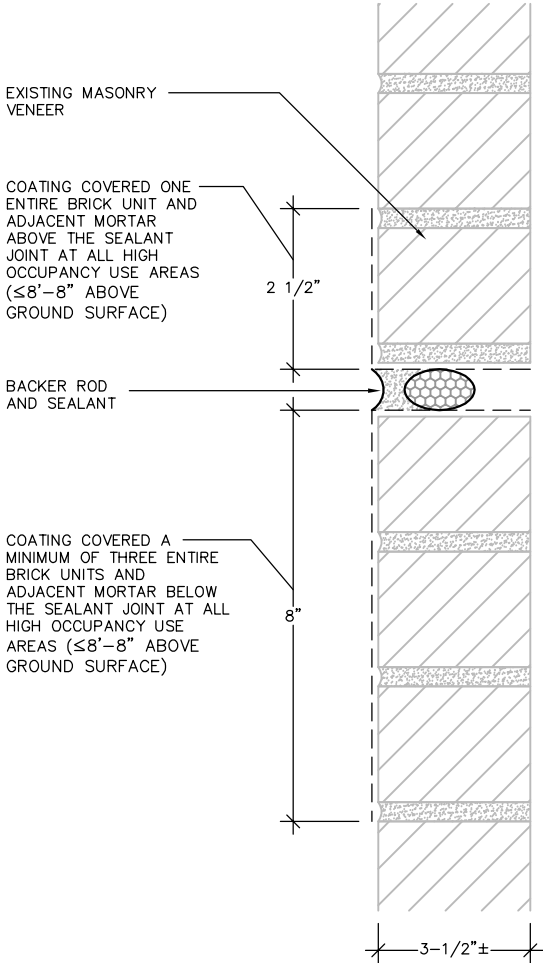
TYPICAL HORIZONTAL CONTROL JOINT

Above Horizontal Control Joints		
Distance Above the Joint (inches)	Sample ID	Total PCBs (ppm)
0.5 to 1.0	MR-VBB-112	0.48
	MR-VBB-120	1.4
	MR-VBB-133	< 0.095
	MR-VBB-143	160*
	MR-VBB-224	280*
	MR-VBB-241	< 0.10
	MR-VBB-242	0.46
	MR-VBB-244	0.21
	MR-VBB-261	< 0.10
	MR-VBB-263	0.21
	MR-VBB-136	2.8
	MR-VBB-205	3.4

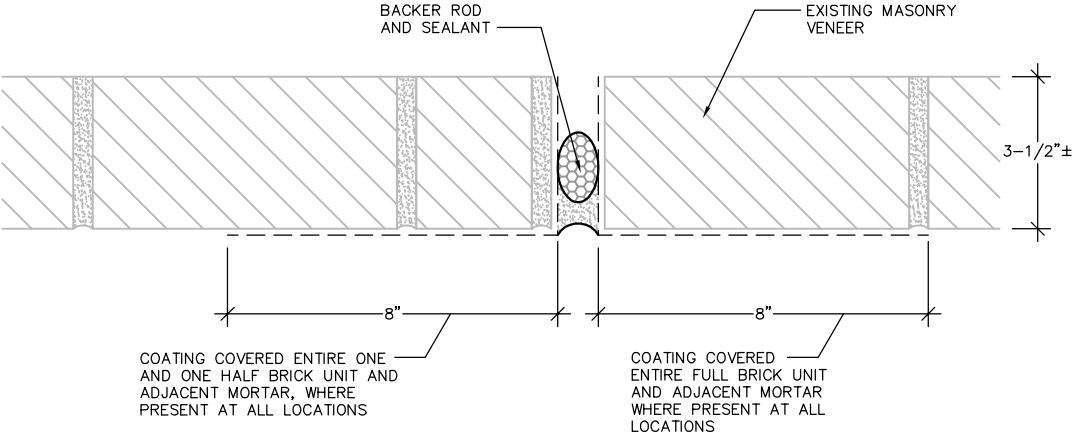
TYPICAL VERTICAL CONTROL JOINT (PLAN)

Vertical Control Joints		
Distance From Joint (inches)	Sample ID	Total PCBs (ppm)
8	MR-VBB-114	3.1
	MR-VBB-134	0.11
	MR-VBB-203	0.38
	MR-VBB-113	0.11
	MR-VBB-115	0.12

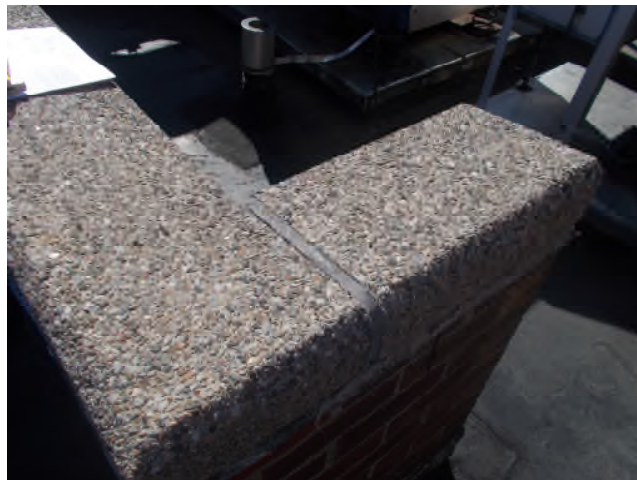
Rooftop Enclosure Wall

Brick enclosure walls are located on the roof top area surrounding the four air handling units. Each of the four enclosures consists of a 3 ½ foot high brick wall with a masonry cap (see photo at right). A total of 64 caulked joints each less than one foot in length, oriented perpendicular to the brick, are present between the pre-cast concrete cap blocks. Additionally, a caulked joint is present between the masonry cap and the RTU walls.

The existing building envelope and roof repair project scope includes the complete removal of the RTU enclosures in support of the roof replacement activities.
