February 20, 2014

Re: PCB Remediation Completion Report – Sylvan Residential Complex  
University of Massachusetts  
Amherst, Massachusetts

**Brown Residence**

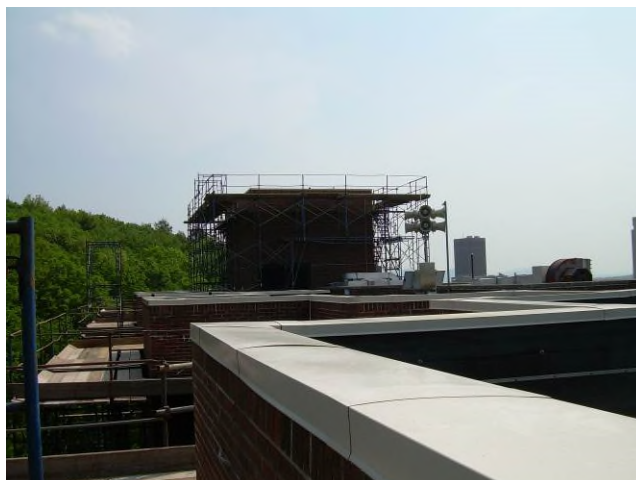
**Scaffolding on Roof Area Prior to Remediation**

Removal of the  $\geq 50$  ppm PCB containing caulking and building materials was conducted within polyethylene containment structures constructed: 1) on the lift boom for vertical and horizontal control joints, 2) on the roof area for penthouse wall control joints, and 3) on the scaffolding for the parapet wall removal. Water misting was the primary means of dust control throughout the project. HEPA filtration was also utilized for additional dust controls during the removal of the horizontal and vertical control joints on the boom lift. Polyethylene sheeting was placed on the ground surfaces below work areas.

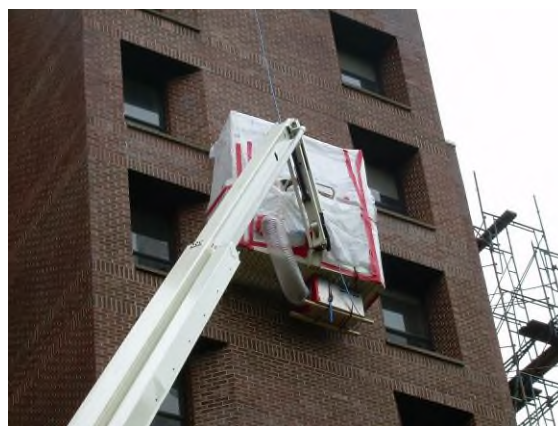
**Polyethylene Containment on Boom Lift**

Following the establishment of site controls as described above, caulking and loose or damaged building materials associated with the horizontal and vertical control joints (including those damaged during verification sampling) were removed for off-site disposal as  $\geq 50$  ppm PCB waste. Following removal, the joints were inspected and additional removal was conducted as necessary prior to application of the encapsulant described below.

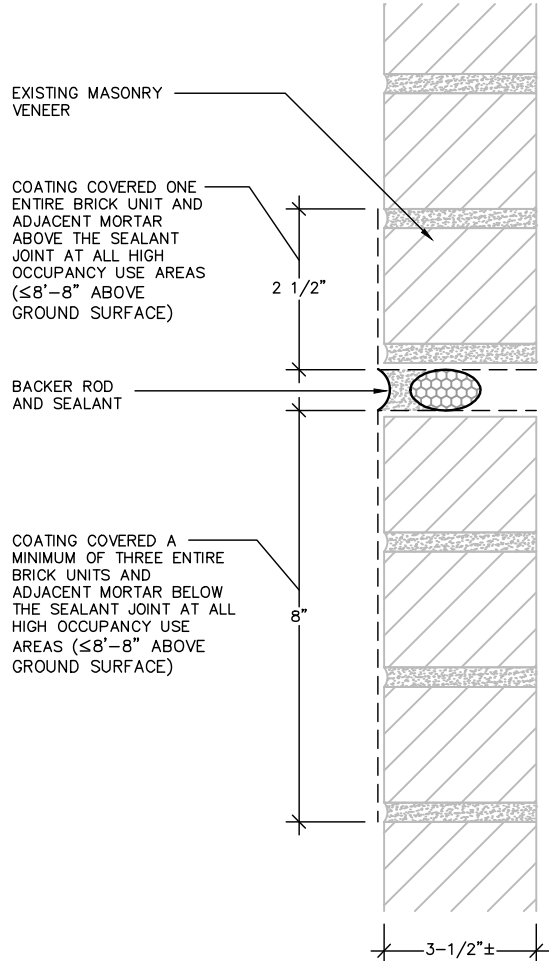
TYPICAL HORIZONTAL CONTROL JOINT

UPPER FLOOR LOCATIONS  
(> 8' 8" ABOVE GROUND SURFACE)  
(LOW OCCUPANCY USE)

Analytical Testing Results		
Above Horizontal Control Joints		
Distance Above Joint (inches)	Sample ID	Total PCBs (ppm)
1 - 1 1/2	BR-CBB-010	0.85
1 1/2 - 2 1/2	BR-VBB-010	<0.91
1 1/2 - 2 1/2	BR-VBB-015	1.4
1 1/2 - 2 1/2	BR-VBB-019	0.35
1 1/2 - 2 1/2	BR-VBB-023	2.4
1 1/2 - 2 1/2	BR-VBB-055	<0.1
1 1/2 - 2 1/2	BR-VBB-057	0.53
1 1/2 - 2 1/2	BR-VBB-061	0.12
1 1/2 - 2 1/2	BR-VBB-064	0.49
1 1/2 - 2 1/2	BR-VBB-067	1.1
1 1/2 - 2 1/2	BR-VBB-069	0.43
1 1/2 - 2 1/2	BR-VBB-071	0.37
1 1/2 - 2 1/2	BR-VBB-109	0.34
1 1/2 - 2 1/2	BR-VBB-112	0.18
1 1/2 - 2 1/2	BR-VBB-114	0.77
1 1/2 - 2 1/2	BR-VBB-117	0.11
1 1/2 - 2 1/2	BR-VBB-121	3.7
1 1/2 - 2 1/2	BR-VBB-123	0.57
1 1/2 - 2 1/2	BR-VBB-125	1.5
1 1/2 - 2 1/2	BR-VBB-128	1.1
1 1/2 - 2 1/2	BR-VBB-130	0.43
Linear Footage: 3,972 l.f.		
1/8 - 1/2	BR-CBB-009	17*

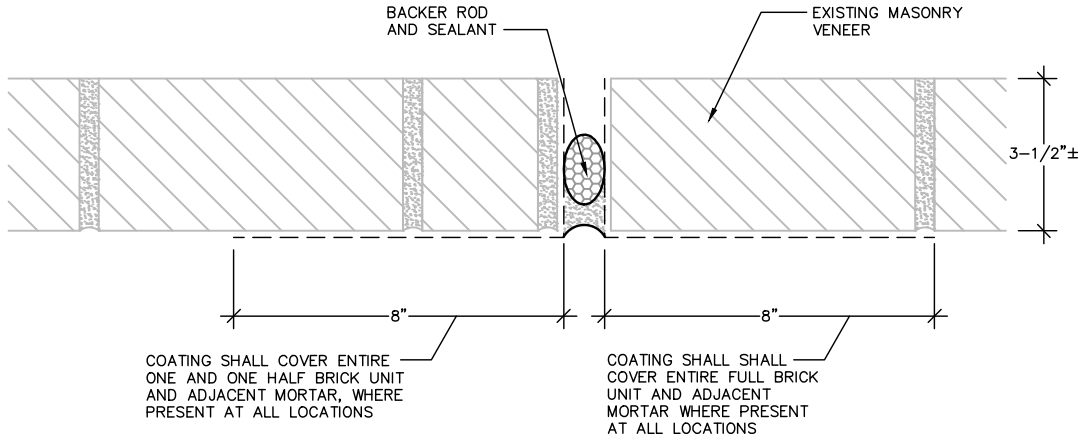
TYPICAL VERTICAL CONTROL JOINT (PLAN)

FIRST FLOOR LOCATIONS  
(≤ 8' 8" ABOVE GROUND SURFACE)  
(HIGH OCCUPANCY USE)

Analytical Testing Results		
Vertical Control Joints		
Distance From Joint (inches)	Sample ID	Total PCBs (ppm)
1 1/2 - 2	BR-CBB-016	1.1
1 1/2 - 2	BR-CBB-026	13
1 1/2 - 2	BR-CBB-030	0.92
2 1/2 - 3 1/2	BR-VBB-013	0.21
2 1/2 - 3 1/2	BR-VBB-014	0.31
2 1/2 - 3 1/2	BR-VBB-074	1.1
2 1/2 - 3 1/2	BR-VBB-077	0.23
2 1/2 - 3 1/2	BR-VBB-078	0.34
2 1/2 - 3 1/2	BR-VBB-083	0.94
4 - 5	BR-CBB-015	0.19
4 - 5	BR-CBB-027	0.30
4 - 5	BR-CBB-031	0.28
Linear Footage: 278 l.f.		
1/8 - 1/2	BR-CBB-017	21*
1/8 - 1/2	BR-CBB-025	46*
1/8 - 1/2	BR-CBB-029	5400*
