December 29, 2014

Re: Long-Term Monitoring and Maintenance Implementation – 2014 Monitoring Results  
University of Massachusetts, Amherst, Massachusetts

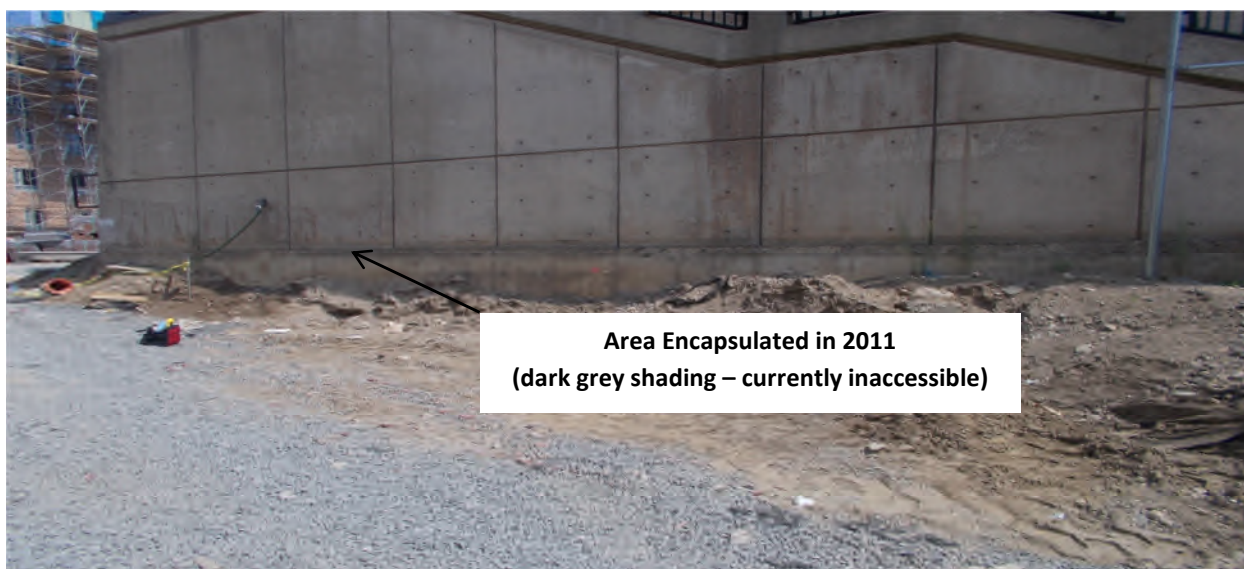
**Concrete Wall to North of Main Stairway**

On October 10, 2013 accessible coatings applied to concrete materials were inspected for signs of deterioration or damage. The majority of the concrete façade identified as containing residual PCBs  $> 1$  ppm to the north and south of the stair landing was not accessible for inspection due to the installation of new retaining walls and planting beds as described above and as shown in the photo below.

The remaining exposed encapsulated concrete façade was limited to a total of approximately 3.5 square feet of concrete at the northern and southern ends of the stair landing (i.e., seven feet of former joint to a distance of six inches above the former joints). The epoxy coating on the southern façade area was observed to be in good condition while there was limited flaking and peeling observed on the clear acrylic coating on the northern façade area. Analytical results from the two wipe samples collected (1 from each area) indicated that PCBs were non-detect ( $< 0.20 \mu\text{g}/100\text{cm}^2$ ).

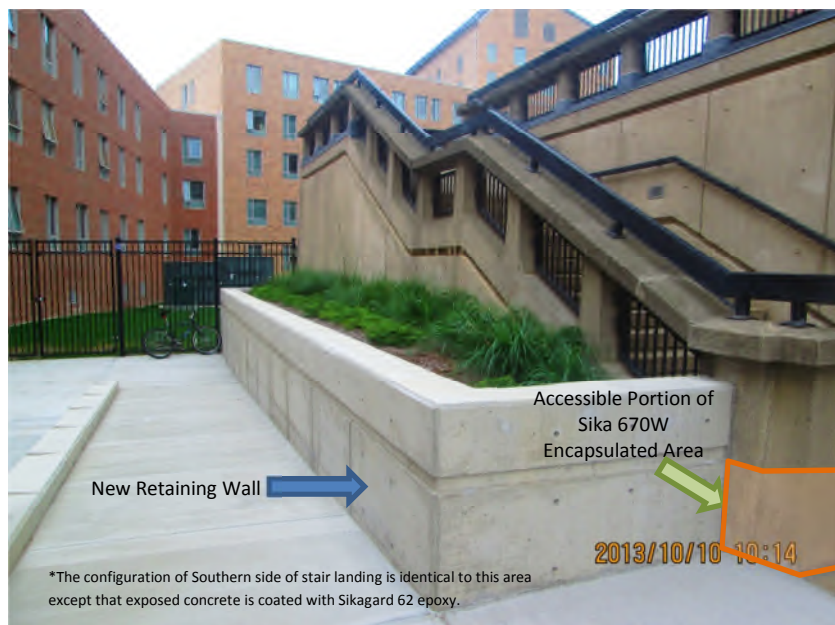
**Northern Side of Stair Landing**

On July 22, 2014, accessible coatings applied to concrete materials were inspected for signs of deterioration or damage. The remaining exposed concrete areas remained the same as in the 2013 monitoring event and the two sampling areas remained the same. A summary of the results of the visual inspections and wipe sampling is as follows:

- Southern Façade Area - Sikagard 62 liquid epoxy coating was observed to be in good condition with no signs of damage or wear. Results of the verification wipe sample collected from the epoxy coated surfaces indicated that PCBs were non-detect (LTM-TH-VWC-270 at  $< 0.20 \mu\text{g}/100\text{cm}^2$ ) consistent with previous sampling events; and
- Northern Façade Area - Sikagard 670W clear coat encapsulant was found to be flaking and peeling in select sections of the concrete as observed following the application of the coatings in Fall 2012; a verification wipe sample was collected from the flaking area and analytical results indicated that PCBs were non-detect (LTM-TH-VWC-271 at  $< 0.20 \mu\text{g}/100\text{cm}^2$ ) consistent with previous sampling events.

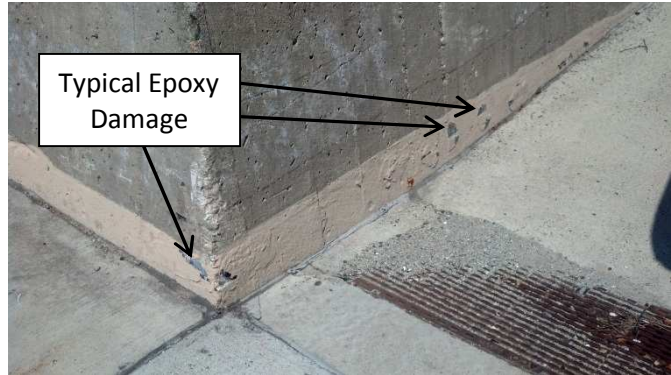
- Sikagard 62 Liquid Epoxy: The visual inspection conducted found no evidence of significant peeling, breakage, or brittleness of the coating. However, some damage was observed at a few isolated exterior locations including areas not previously observed during the 2012 or 2013 monitoring. Locations of these areas are depicted on Figure 3-1 and an example of one of the damaged areas is shown in the adjacent photo.
