Re: Long-Term Monitoring and Maintenance Implementation – 2019 Monitoring Results  
University of Massachusetts, Amherst, Massachusetts

**Attachment 1 – Tobin Hall  
Long-Term Maintenance and Monitoring Program  
In-Place Management of PCB Impacted Materials  
UMass Amherst**

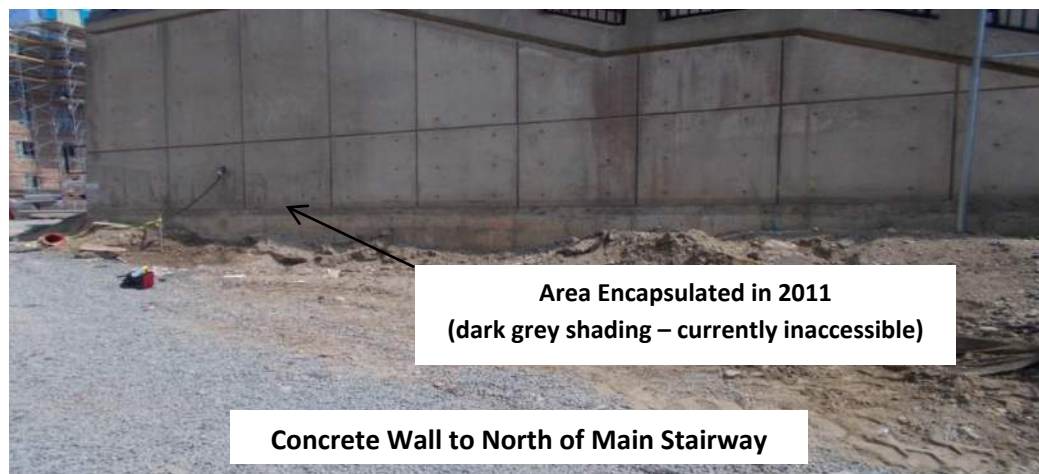
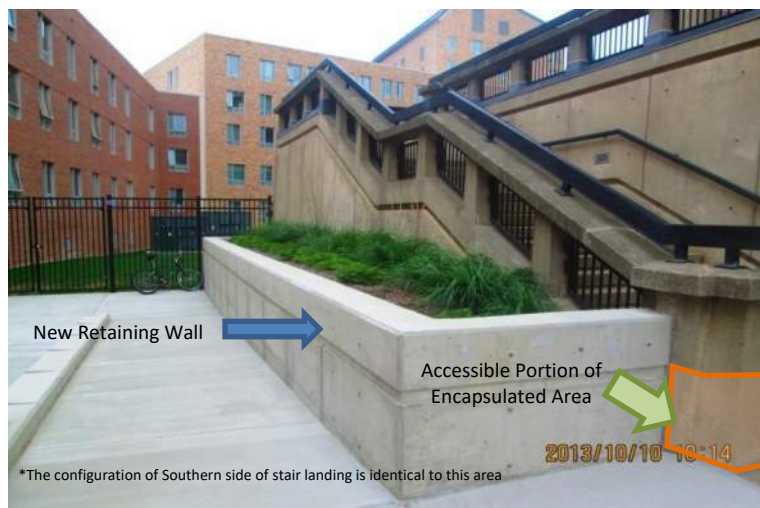
**Northern Side of Stair Landing**

Results of visual inspections indicated that the epoxy coatings on accessible portions of the retaining walls were in good physical condition. One wipe sample was collected from each of the two encapsulated areas and submitted for PCB analysis. Analytical results reported PCBs as non-detect ( $< 0.20 \mu\text{g}/100\text{cm}^2$ ) in both samples. The locations of the samples are depicted on Figure 1-1.

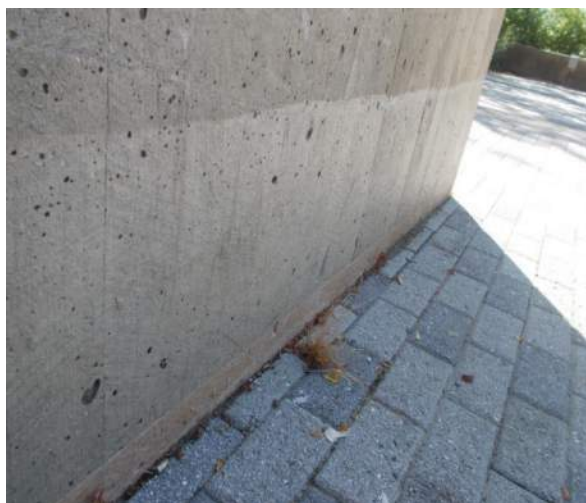
**Typical Retaining Wall Application**

- Sikagard 62 Liquid Epoxy: The visual inspections found no evidence of significant peeling, breakage, or brittleness of the coating. Overall, areas of flaking and peeling were observed in isolation locations and remained generally consistent between inspections with some additional areas observed periodically. In 2017, UMass re-applied epoxy to surfaces observed to have been damaged during previous monitoring. Visual inspections conducted during the 2017 monitoring event confirmed the application of the epoxy coatings to the previously reported damaged areas and one additional small area was observed to be damaged in the Berkshire Plaza (< 1 square foot).

- Sikagard 62 Epoxy: The coatings were observed to be in good physical condition. One additional isolated area of damage was observed on a retaining wall in the Berkshire Plaza.
- Sikagard 670W Acrylic: Visual inspection of the clear acrylic coating indicated that the coating remains in good condition over much of the encapsulated surfaces however, some new areas of observed flaking and peeling were observed within the Berkshire Plaza. The observed flaking and peeling were consistent with other areas described above.
- Concrete Ceiling of Pedestrian Tunnel: Visual inspection of the paint and caulking within the joint indicated the materials remain in good condition.
- The locations of the encapsulated surfaces and areas of observed damage or flaking and peeling are presented on Figure 2-1.

Based on these results, the liquid coatings applied to concrete surfaces within the Southwest Concourse continue to be effective in encapsulating residual PCBs in masonry. Minor damage to the epoxy coating was observed in Berkshire Plaza. Repairs to the epoxy will continue to be made as part of routine maintenance activities within the concourse.

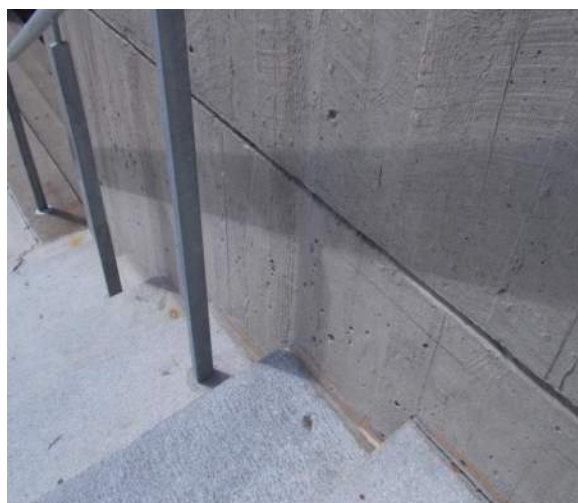
**Typical Stair Application  
(shadow from railing visible as dark area)**

- Sikagard 670W: Visual inspection of the clear acrylic coating indicated that the coating remains in good condition over the majority of the encapsulated surfaces. Some areas of flaking and peeling were observed but in general they were limited to isolated areas typically 4 to 6 inches in size (some areas were observed up to 1 foot in size). The areas of flaking and peeling remained relatively consistent between sampling events indicating that the issues may have been present at the time of application and not indicative of long-term wear of the coatings.

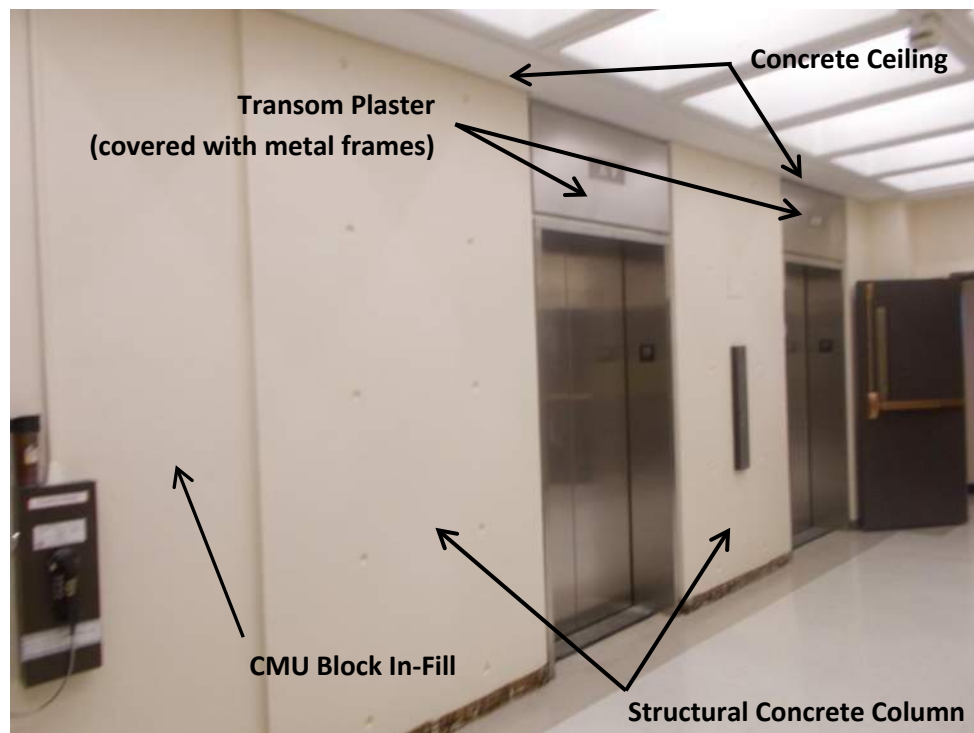
Visual inspections of encapsulated surfaces were conducted during the annual monitoring event on July 29, 2019. Coatings were observed to be in good physical condition with no signs of wear or damage. Results of verification wipe samples were consistent with previous events and indicated that PCBs were either non-detect (6 samples at < 0.20 ug/100cm<sup>2</sup>) or present at concentrations < 1 µg/100 cm<sup>2</sup> (1 sample with a reported concentration of 0.30 ug/100cm<sup>2</sup>).

Based on the 2019 monitoring activities, no corrective actions are proposed at this time.

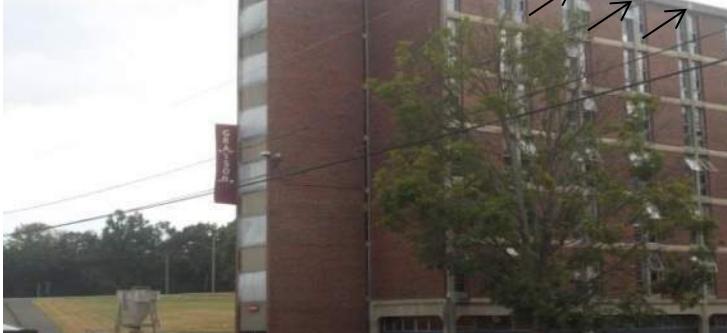
- Locations of Typical Parapet Masonry Joints
- Elevator Hall CMU Block Walls (2012 and 2013): PCBs are being managed in place at > 1 ppm at the 6<sup>th</sup> floor elevator lobby of both Field and Grayson Houses following the removal of caulked joints around Type D windows (see Figure 4-1).

- Exterior Parapet Masonry Joints – Coated concrete surfaces surrounding the exterior parapet masonry joints were inspected for damage. The visual inspection found no evidence of deterioration of the coating with the exception of the single joint identified at the roofline of Field House in 2013. In July 2018, the additional epoxy coatings were applied to this joint where damage had been noted during previous inspections.

- **Field and Grayson Houses:**
  - Exterior Parapet Masonry Joints – Coated concrete surfaces surrounding the exterior parapet masonry joints were inspected for damage. The visual inspection found no evidence of deterioration of the coating.

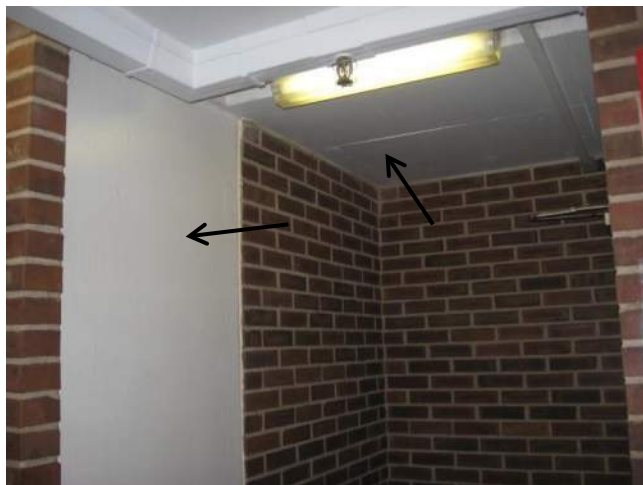
Typical Interior Encapsulated Surfaces  
(Concrete Walls and Ceiling)

*Visual Inspection:* Results of the visual inspections indicated that the encapsulating barriers (caulking within exterior control joints and liquid coatings applied over interior and exterior areas with residual PCBs) were in good physical condition with no damage or evidence of deterioration observed.

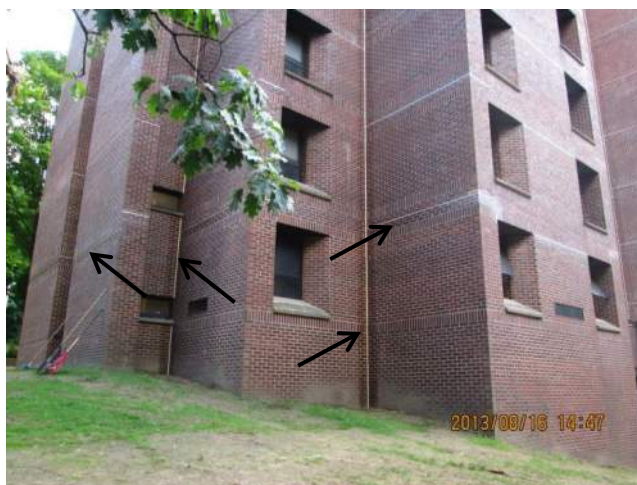
Typical Vertical and Horizontal Control Joints  
(New Caulking and Clear Coating Visible)

- Exterior Expansion Joint Caulking: Visual inspection of the caulking within the horizontal and vertical controls joints indicated that the caulking was in good physical condition with no damaged or missing sections observed.
- Exterior Brick Surfaces: Visual inspection of the Sikagard 670W clear acrylic coating applied along the exterior horizontal and vertical controls joints indicated that the coating remains in good condition over the majority of encapsulated surfaces with isolated areas of flaking and peeling consistent with observations of similar coating applications at other areas on the campus.
- Interior Concrete Columns/Walls/Ceilings: Visual inspection indicated that coatings installed to masonry materials were in good condition. No deterioration was observed.

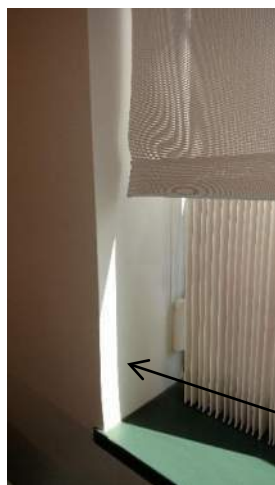
**Typical Area of In-Place Management**

Results of visual inspections conducted on an annual basis through 2018 reported no damage, deterioration, or disturbance of the replacement window frames and gypsum wall board materials.
