# PCB INTERIM MEASURES PLAN

University of  
Massachusetts

Lederle Graduate  
Research Center

May 2012

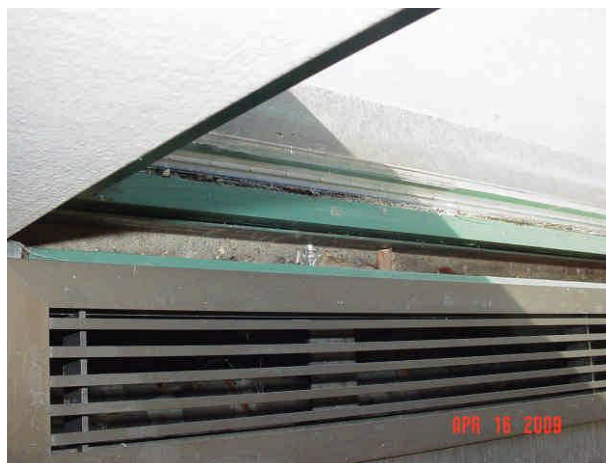
**Typical Window Joint with Glazing Sealant**

Results of the window inspections and inventory indicated that glazing sealant similar in appearance was observed on the majority of window joints throughout the low rise, the walkway, and Tower A. The glazing sealant was black in color and had very little plasticity. Below surficial portions, the material was observed to be softer and in one location (glazing sample location LGRC-GZ-008 High Rise Location) an increase in the overall plasticity was observed. In general, the sealant appears in good condition; there are some areas (e.g., bottom frame exposed to direct sunlight) that exhibit signs of deterioration. Based on window construction drawings and field observations, the glazing sealant appears to be present on both the interior and exterior sides of the window glass and on all four sides of the window glass and the metal pane.

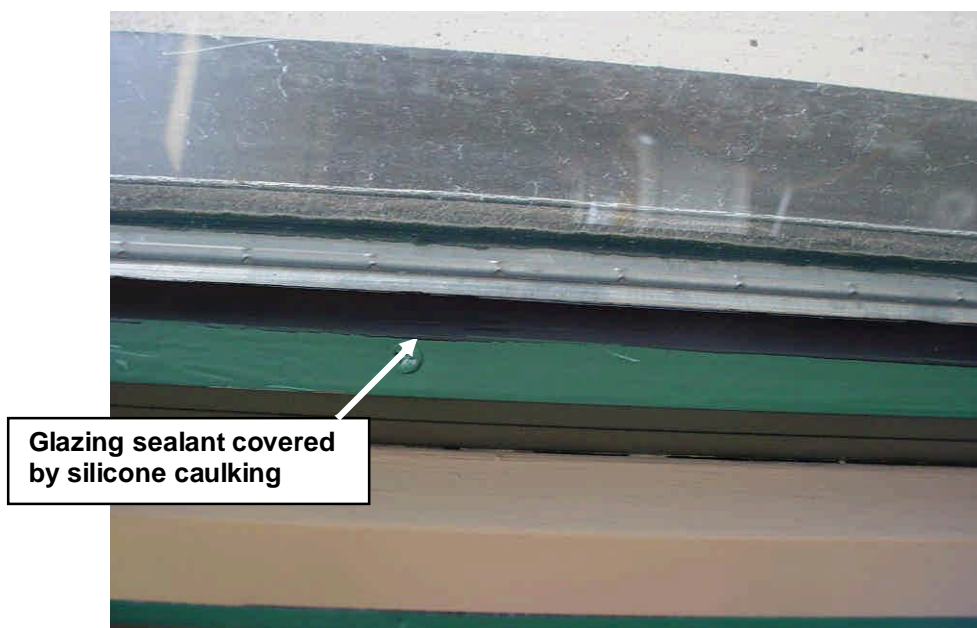
Based on the three evaluation criteria, the silicone sealant was retained for continued monitoring while the Interim Measure approval process was on-going. A photograph depicting the contained glazing sealant by the silicone sealant is presented below.
