**PCB
MONITORING AND
MAINTENANCE
IMPLEMENTATION
PLAN**

**University of
Massachusetts**

Southwest Residential
Area

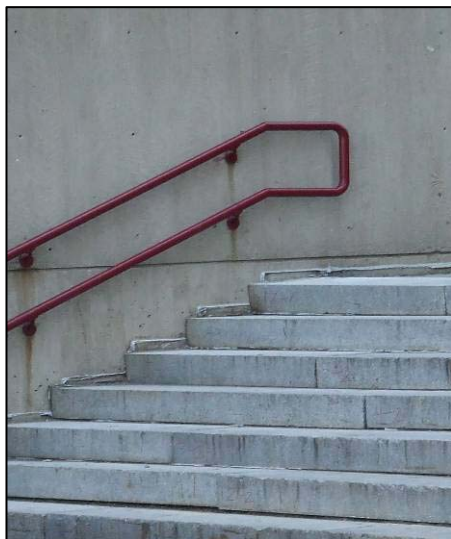
Photo 1 (Top Left): Caulking joints between stairs and walls.

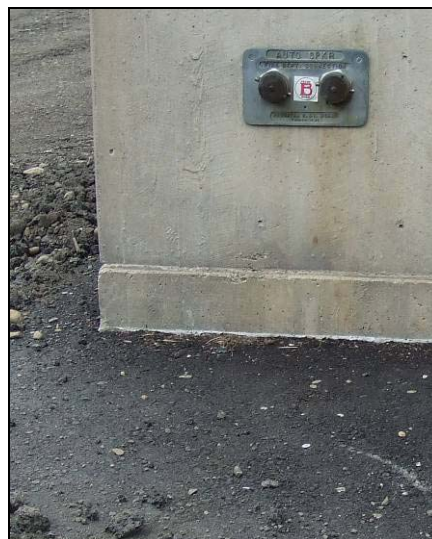
Photo 2 (Top Right): Caulking joints between paved ground surfaces and walls.

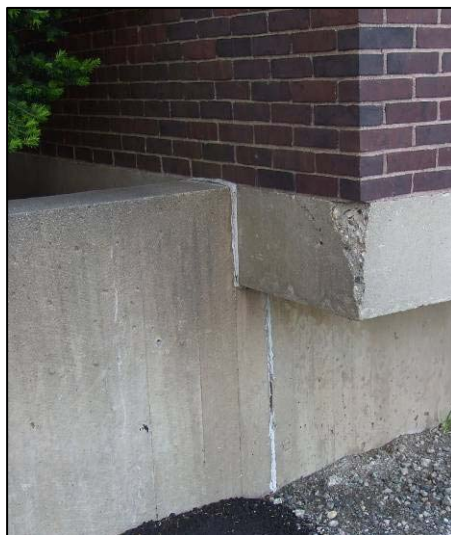
Photo 3 (Bottom Left): Caulking joints between a building wall and the end of a retaining wall.

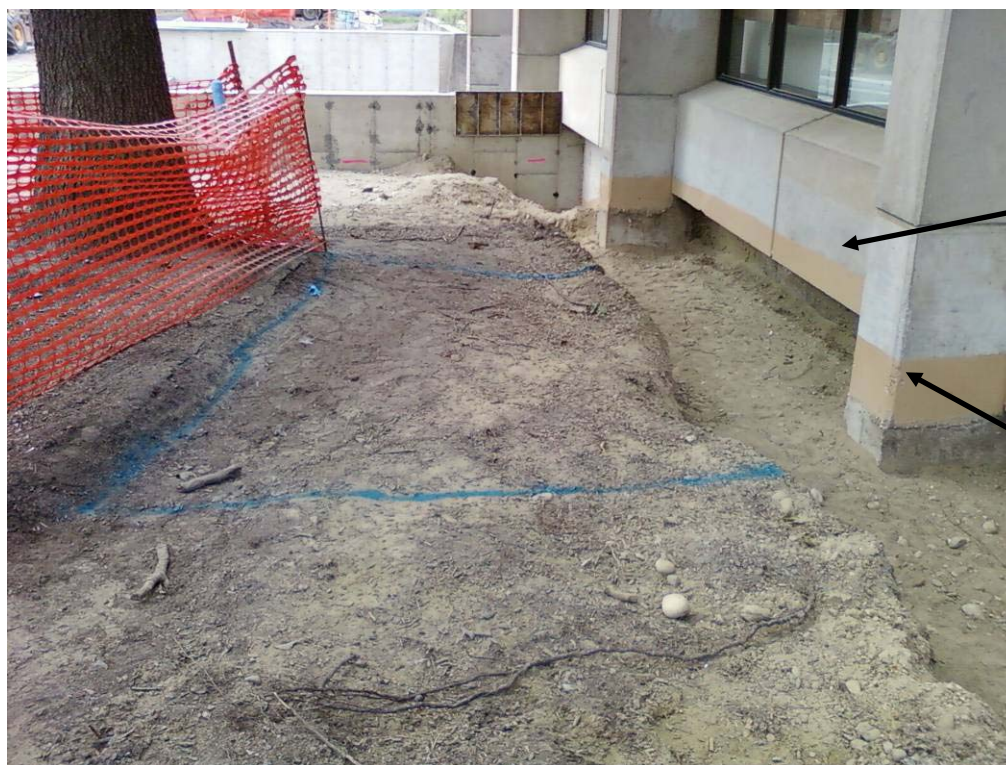
Sika 670 W
clear coating
above the
finished grade
line

Sika 62 tan
epoxy below
the finished
grade line; to
be covered by
soils and/or
concrete

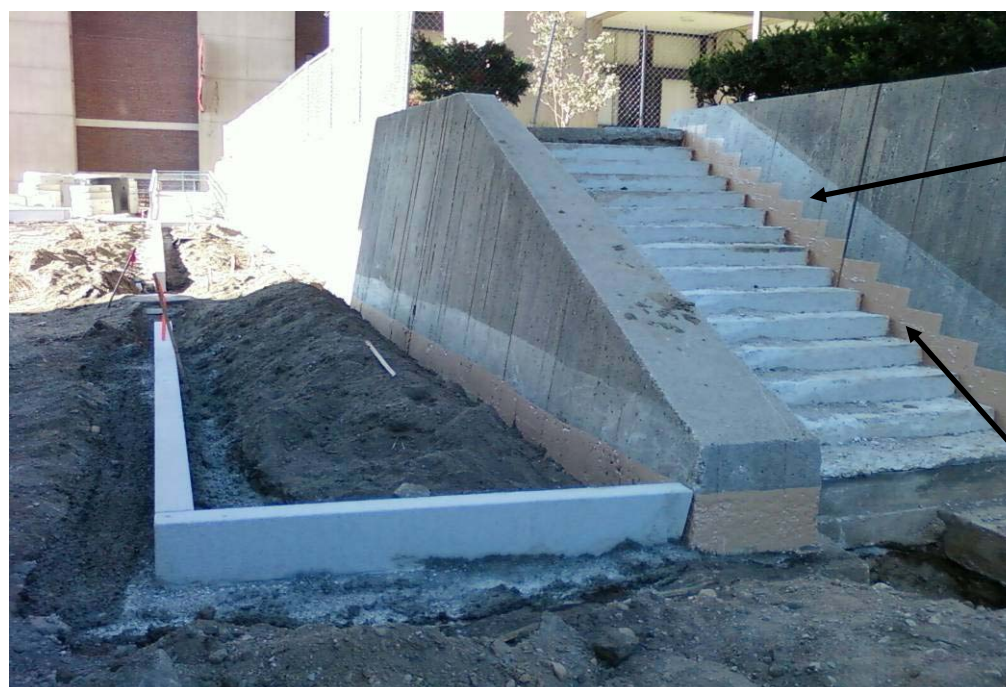
Sika 670 W
clear coating
above the
finished grade
line

Sika 62 tan
epoxy below
the finished
grade line; to
be covered by
granite stairs

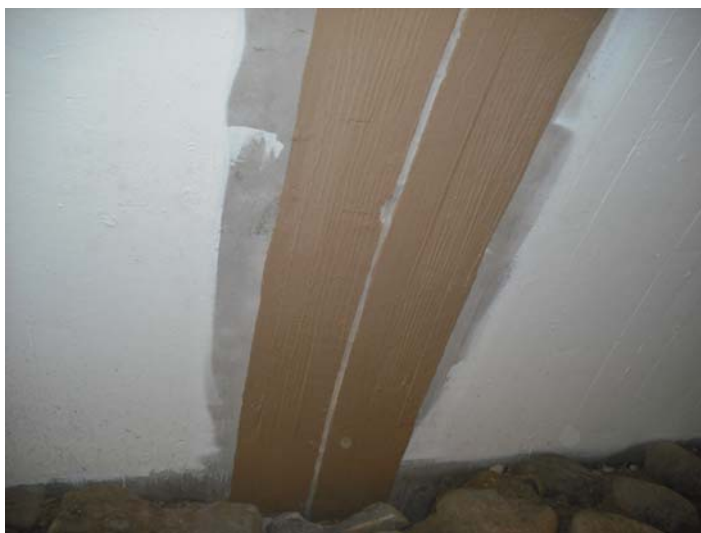
The concrete in former direct contact with the caulking (inside the return of the joint with PCBs at 309 ppm) was encapsulated with two coats of the Sikagard 62 epoxy coating, followed by new caulking. The Sikagard 62 epoxy was also applied to the concrete located within 12 inches of the joint in two coats of contrasting color followed by an elastomeric acrylic coating (white color). The remaining portions of the ceiling were coated with the white elastomeric acrylic coating. A photo of the encapsulated area is shown to the right.
