Re: PCB Interim Measures Completion Report and MMIP
Lederle Graduate Research Center
University of Massachusetts – Amherst

PCB Interim Measures Completion Report

Lederle Graduate
Research Center

University of
Massachusetts

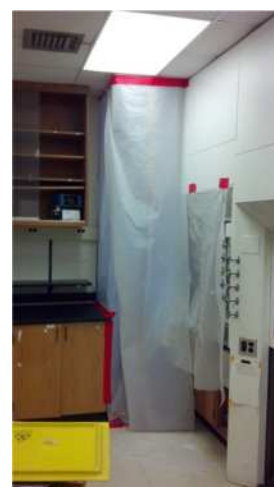
Typical Polyethylene Controls

- All movable objects were removed from the work area by occupants;
- All non-movable objects were covered with 6-mil fire retardant polyethylene sheeting;
- Polyethylene containments were erected at the window openings; and

- Access to the work areas was limited to authorized personnel through the posting of signs on the doors to the spaces and at the perimeter of the work areas.

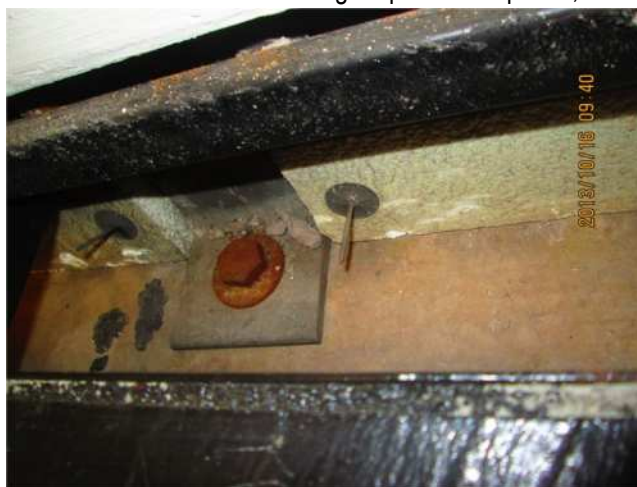
Typical Heating Duct at Base of Windows

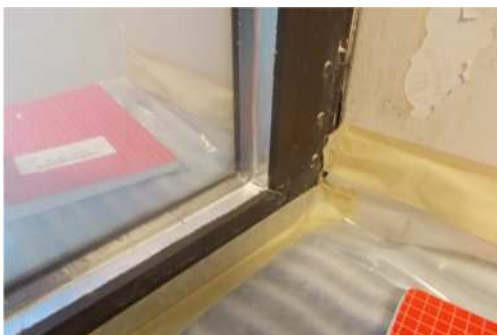
Typical Window Following Aluminum Foil Tape Application

Following completion of the cleaning, a layer of aluminum foil tape was applied over the glazing sealants. Based on lessons learned during the NIH renovation project, for the 2013 encapsulation activities, the application was modified to include the installation of a wider strip of aluminum tape to cover more of the glass and metal frame adjacent to the glazing sealants. In addition, aluminum corner pieces were pre-fabricated and installed at the corners of the window frames to create better transition points for the barrier at the window corners.

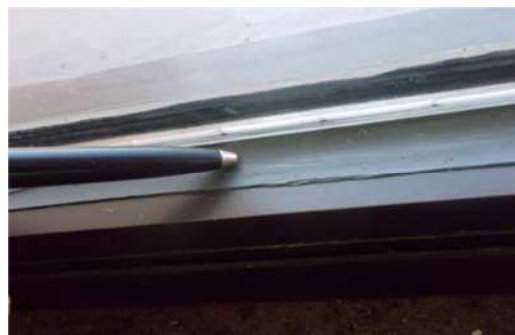
Typical Window Following Caulking Application

black Dow 795 silicone caulking was

installed over the foil tape to complete the two-barrier encapsulation of the glazing sealant.

Upon completion of caulking installation, visual inspection was conducted to confirm that no aluminum foil tape was visible.

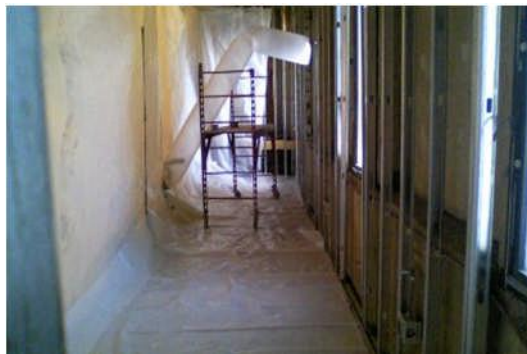
Polyethylene Containment

- The work was conducted within polyethylene containments established on each floor for the asbestos removal aspects of the project;
- HEPA filtration was established within each containment to establish negative pressure controls;
- Access to the active work areas was limited to authorized personnel only; and
- At the conclusion of each work day or following completion of work within an area, the work area, tools, and equipment were decontaminated by HEPA vacuuming and wet wiping using diesel fuel and cloth rags.

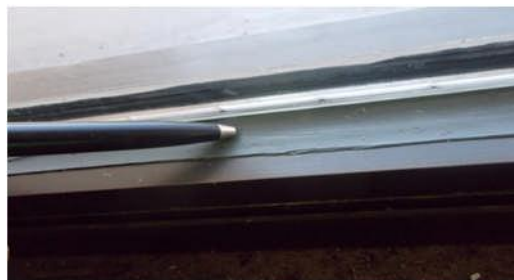
Final Caulking Application

Following completion of the window cleaning, a strip of aluminum foil tape (Carolina Tape Product # 957) was applied to the glazing sealants around the full perimeter of each window. A bead of black Dow 795 silicone caulking was then applied over the foil tape. Visual confirmation that all glazing sealants were covered by the tape and caulking was made by Woodard & Curran personnel.
