Window Removal Completion Report

Lederle Graduate
Research Center

Low-Rise Building

December 2014

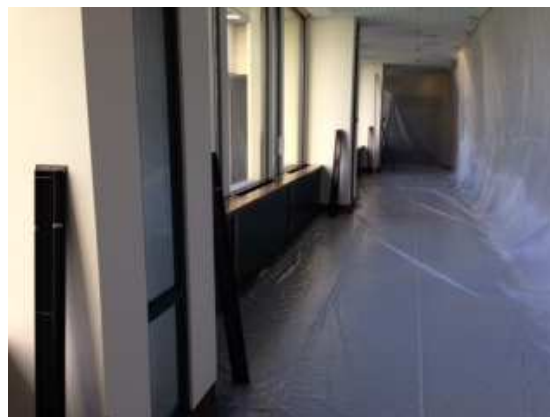
- All movable objects were removed from the work area by occupants;
- All non-movable objects were covered with 6-mil fire retardant polyethylene sheeting;
- Polyethylene containments, negative pressure controls, and HEPA filtration were established prior to work starting in each area; and
- Access to the work areas was limited to authorized personnel through the posting of signs on the doors to the spaces and at the perimeter of the work areas.

Typical Polyethylene Controls

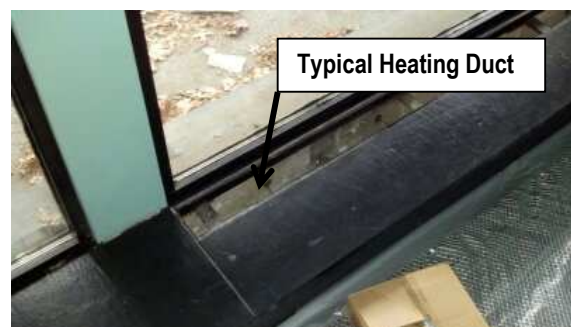
Following completion of the cleaning, visual inspections were conducted to confirm the areas were clear of dirt and debris and verification wipe samples were collected from the decontaminated window sills by Woodard & Curran personnel. Window sill decontamination wipe samples were collected using hexane-saturated gauze wipes in accordance with the standard wipe test method under 40 CFR 761.123. Wipe samples were submitted to Con-Test Analytical Laboratories under the standard chain of custody procedures. Samples were extracted via method 3540C (Soxhlet extraction) and analyzed via EPA method 8082.

Typical Window Sill Following Cleaning

Verification wipe samples were collected at a frequency of 5% of locations (or 1 per 20 windows) as described in the IMP for a total of 37 post-cleaning verification wipe samples. Analytical results indicated that PCBs were either non-

detect (25 samples at $< 0.20 \mu\text{g}/100\text{cm}^2$) or below the cleanup level of $10 \mu\text{g}/100\text{cm}^2$ (12 samples with a maximum concentration of $0.91 \mu\text{g}/100\text{cm}^2$).

Based on the results of the visual inspection and verification wipe sampling, no additional decontamination of the horizontal sills or heating ducts within the project work areas was warranted (or conducted).

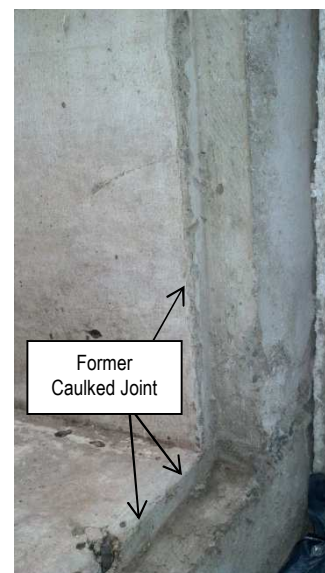
Analytical results indicated that PCBs were present at concentrations > 25 ppm in all the samples, with total PCBs reported at concentrations ranging from 250 to 11,000 ppm. Based on these results, exterior concrete formerly in direct contact with exterior window caulking at all 50 Type L windows was assumed to contain PCBs > 25 ppm and no additional bulk samples were collected.

**Typical Type L Window
Opening Following
Caulking Removal**

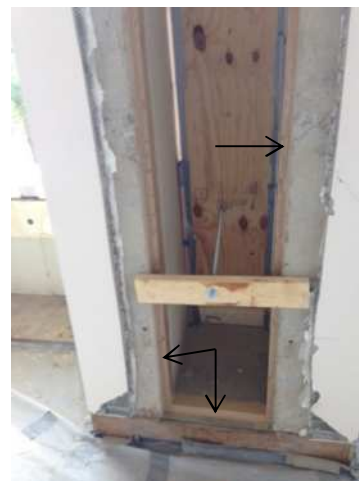
For the first set of five windows (located on the northwest corner of the second floor), DevCon 5-minute epoxy was applied as the encapsulant. During the initial application, it was noted that the application of the product over a two inch wide strip of concrete was inefficient due to the application delivery of the product. Following application of the first coat, and visual inspection to confirm a smooth uniform appearance across the application area, a post-encapsulation wipe sample was collected. Analytical results indicated that PCBs were present at a concentration of $7.3 \mu\text{g}/100\text{cm}^2$. Based on these results, a second coat of DevCon 5-minute epoxy was applied to the five locations and two additional wipe samples were collected. Analytical results from these wipes indicated that PCBs were present at concentrations of 0.28 and $1.4 \mu\text{g}/100\text{cm}^2$. Prior to receipt of the analytical results, the replacement frames and caulking were installed to maintain the project schedule. Although results from one sample were $> 1 \mu\text{g}/100\text{cm}^2$, the replacement frames and caulking serve as a secondary physical barrier to the surfaces.

Areas of Epoxy Application

Based on the difficulty of application and the results of the initial wipe sampling, the project team elected to apply two coats of Sikagard 62 liquid epoxy to concrete at the remaining locations. Following application, visual inspections were conducted to confirm the epoxy had been applied to achieve a smooth uniform coat across the application area and post-encapsulation wipe samples were collected from the encapsulated surfaces.

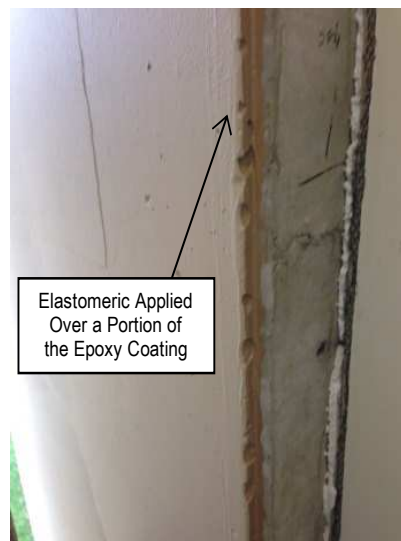
Following the epoxy application and subsequent inspection and sampling, two coats of Sikagard 550w elastomeric coating were applied to exterior concrete surfaces along the inner face of the concrete structures. To prevent gaps in coverage, the elastomeric coating was applied to a portion of the epoxy coatings and outward, away from the window opening to the previously existing elastomeric coating (typically to a distance of approximately three to five feet from the former joint).

Elastomeric Applied
Over a Portion of
the Epoxy Coating

Typical Elastomeric Coating
Application

Following application, visual inspections were conducted to confirm the coating had been applied in a smooth uniform layer and wipe samples were collected from the painted surface just beyond the epoxy coated surface. Verification samples were collected at a frequency of one sample every five windows corresponding to the epoxy wipe sample locations. Based on the sampling frequency and the phased approach for activities a total of 12 wipe samples were collected from elastomeric coated surfaces. Analytical results indicated that PCBs were either non-detect (8 samples at $< 0.20 \mu\text{g}/100\text{cm}^2$) or $< 1 \mu\text{g}/100\text{cm}^2$ (4 samples with a maximum concentration of $0.56 \mu\text{g}/100\text{cm}^2$).
