Re: Long-Term Monitoring and Maintenance Implementation – 2015 Monitoring Results
University of Massachusetts, Amherst, Massachusetts

**Attachment 1 – Tobin Hall
Long-Term Maintenance and Monitoring Program
In-Place Management of PCB Impacted Materials
UMass Amherst**

**Attachment 2 – Southwest Concourse Area
Long-Term Maintenance and Monitoring Program
In-Place Management of PCB Impacted Materials
UMass Amherst**

**Attachment 3 – Dubois Library
Long-Term Maintenance and Monitoring Program
In-Place Management of PCB Impacted Materials
UMass Amherst**

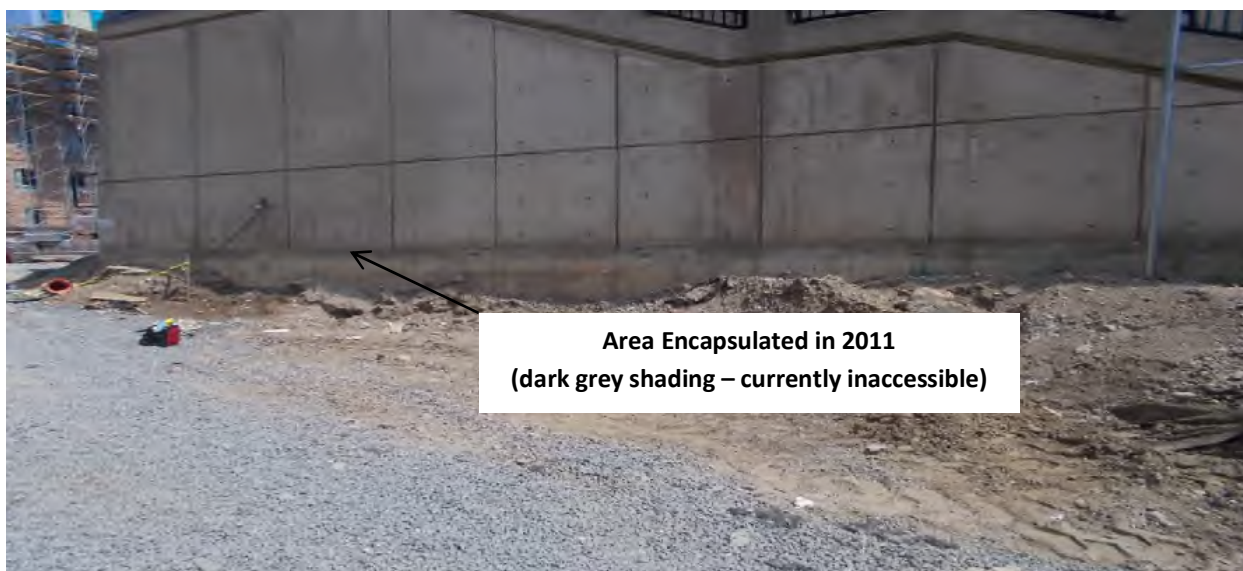
Concrete Wall to North of Main Stairway

Baseline Verification Data Summary: Two initial baseline wipe samples were collected in August 2011 from the building wall encapsulated with Sikagard 670W clear acrylic coating as part of the decking removal project. Analytical results reported PCBs as non-detect (< 0.20 µg/100 cm²) in both samples. One baseline wipe sample was collected from the epoxy coated concrete surfaces as part of the stair landing removal project in 2012. Analytical results reported PCBs as non-detect (< 0.20 µg/100 cm²).

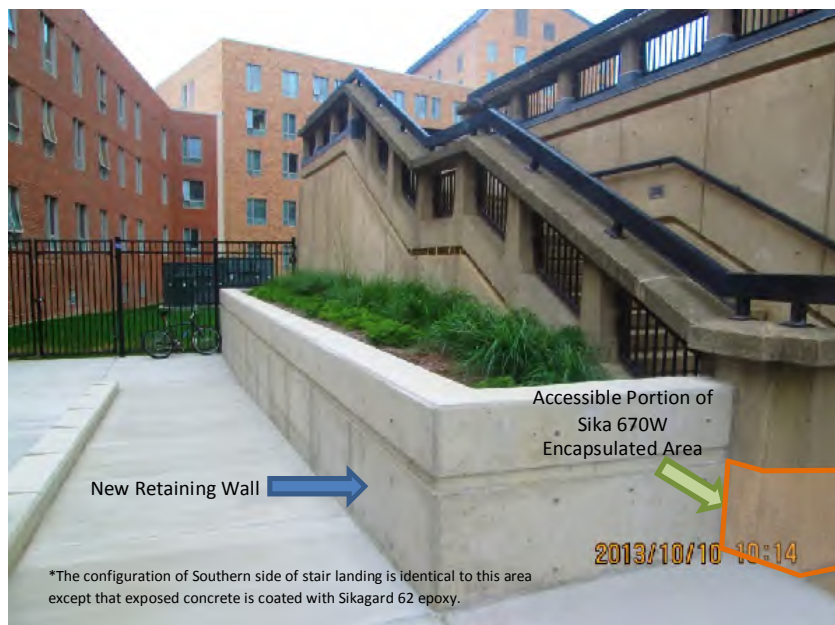
Northern Side of Stair Landing

On October 10, 2013 accessible coatings applied to concrete materials were inspected for signs of deterioration or damage. The majority of the concrete façade identified as containing residual PCBs > 1 ppm to the north and south of the stair landing was not accessible for inspection due to the installation of new retaining walls and planting beds as described above and as shown in the photo below.

The remaining exposed encapsulated concrete façade was limited to a total of approximately 3.5 square feet of concrete at the northern and southern ends of the stair landing (i.e., seven feet of former joint to a distance of six inches above the former joints). The epoxy coating on the southern façade area was observed to be in good condition while there was limited flaking and peeling observed on the clear acrylic coating on the northern façade area. Analytical results from the two wipe samples collected (1 from each area) indicated that PCBs were non-detect ($< 0.20 \mu\text{g}/100\text{cm}^2$).

Based on the observed flaking and peeling of the clear acrylic coating on the northern column, the coating will be replaced with two coats of Sikagard 62 liquid epoxy coating to match the southern concrete column.

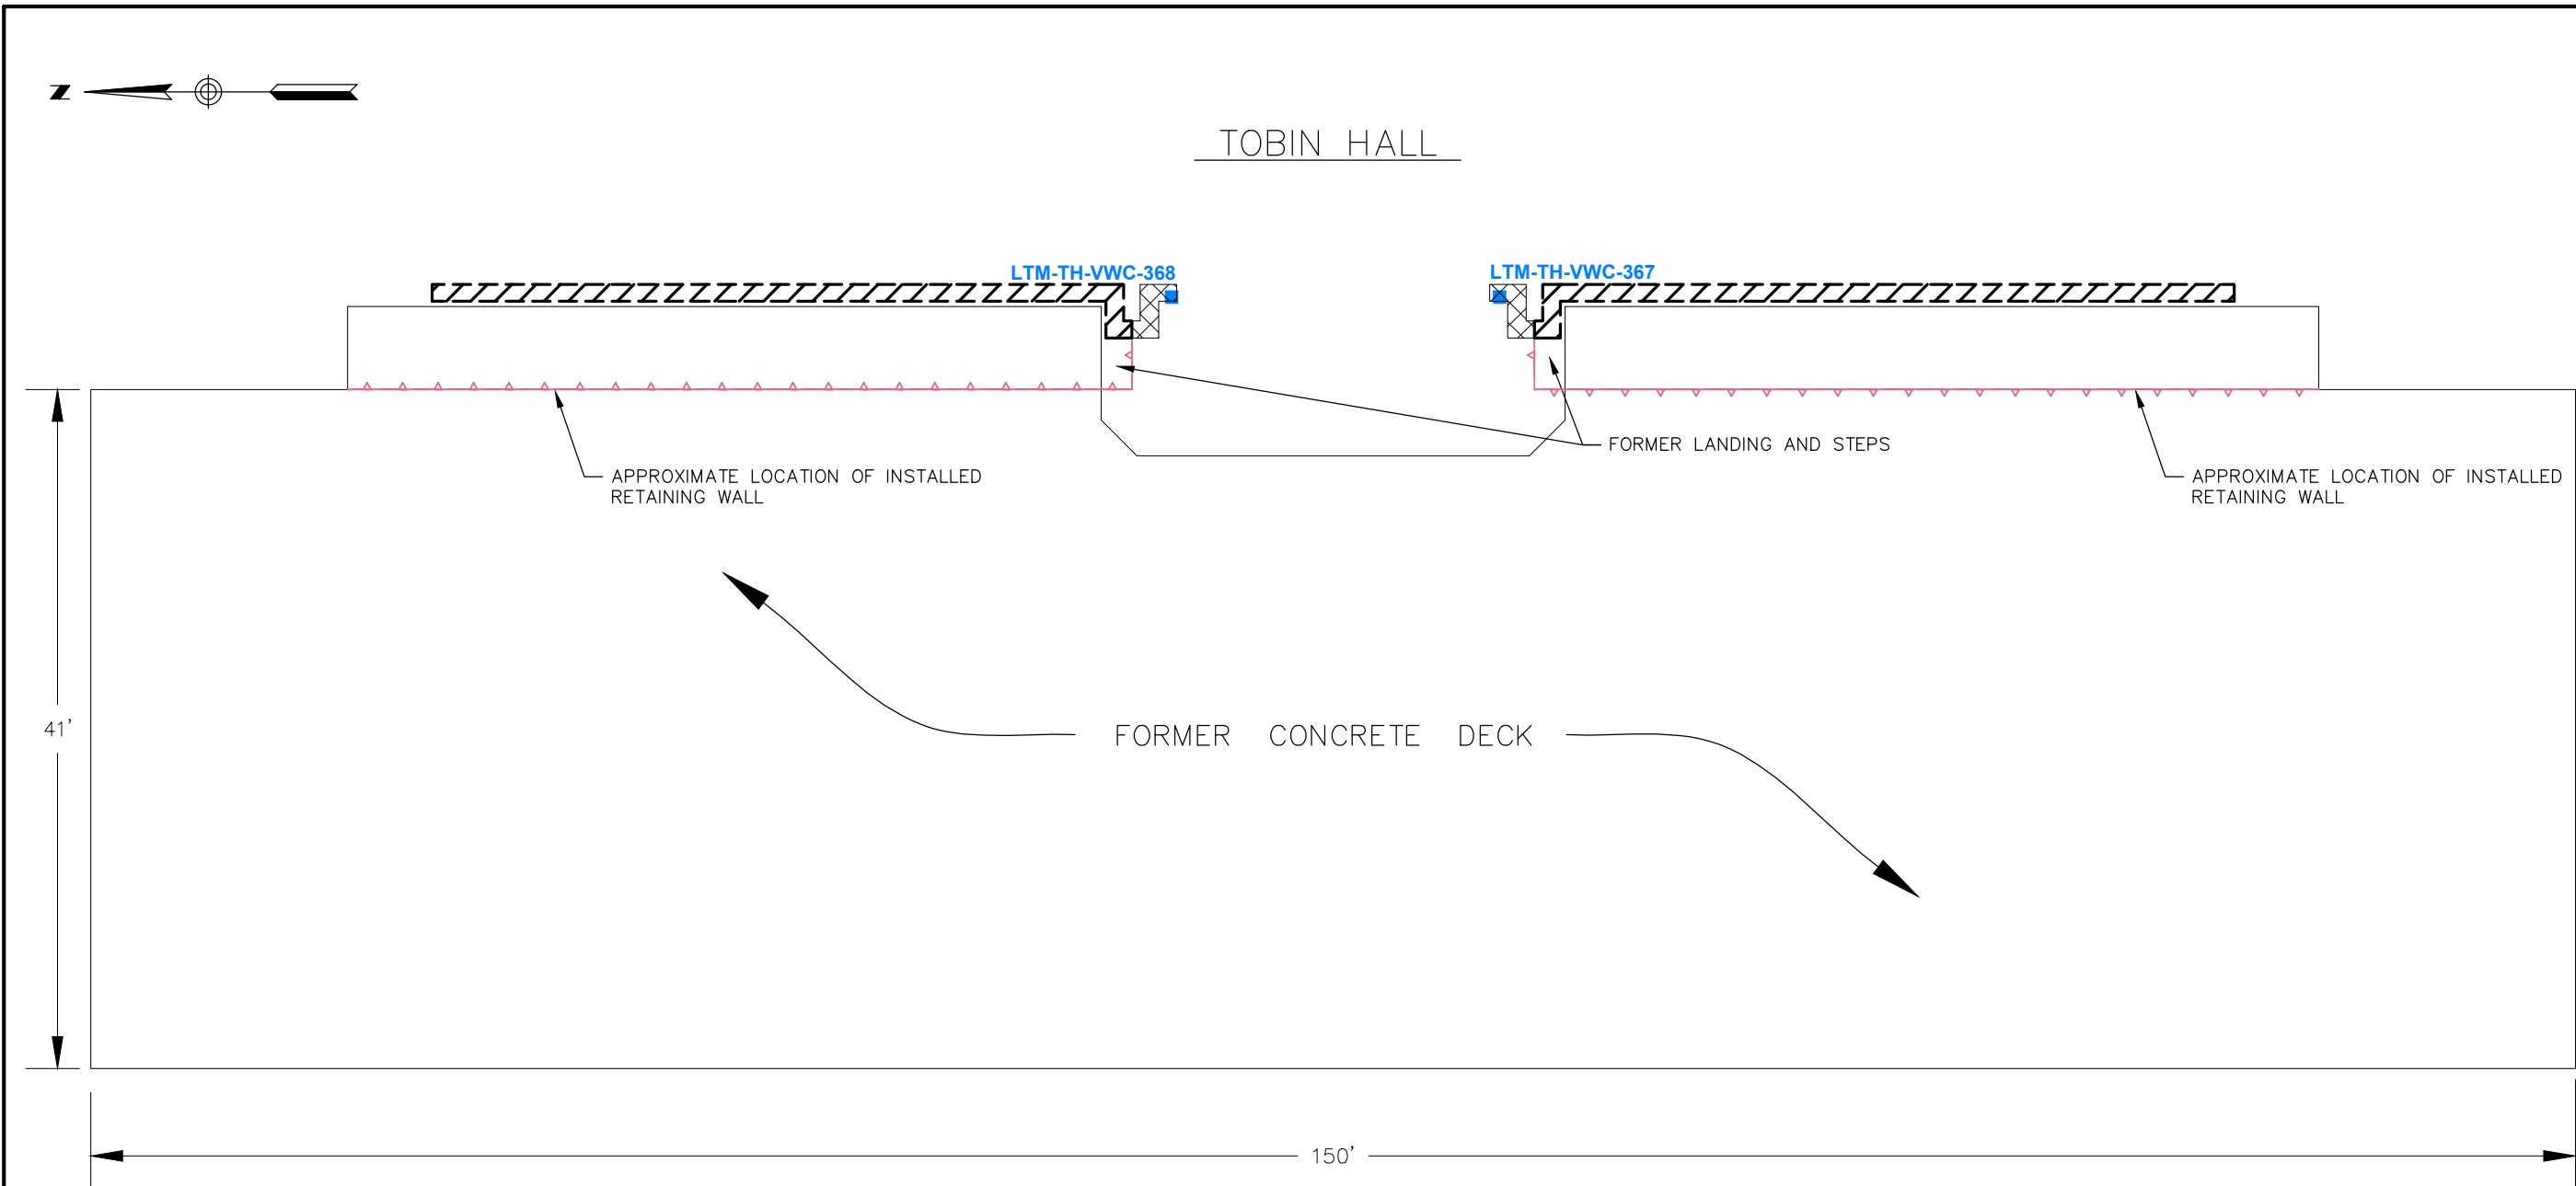
- Northern Façade Area - Sikagard 670W clear coat encapsulant was found to be flaking and peeling in select sections of the concrete as observed during previous inspections; wipe sample was collected from the flaking area and analytical results indicated that PCBs were non-detect (LTM-TH-VWC-368 at < 0.20 µg/100cm²) consistent with previous sampling events.

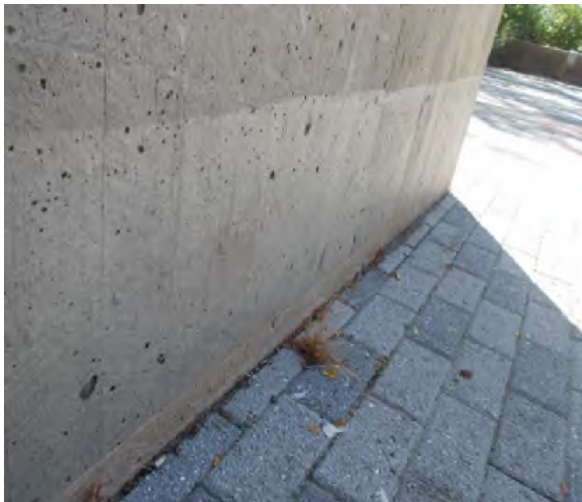
Typical Retaining Wall Application

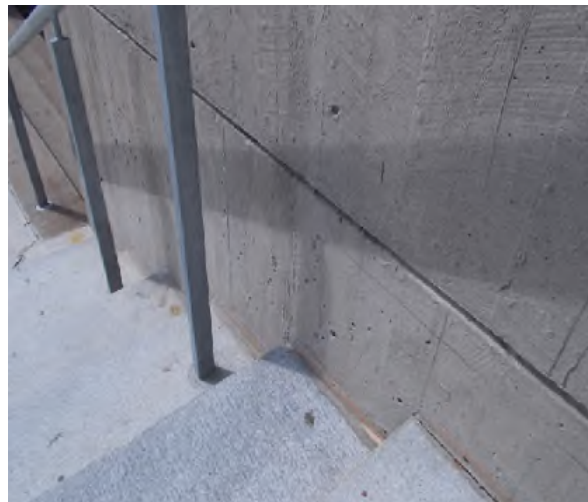
**Typical Stair Application
(shadow from railing visible as dark area)**

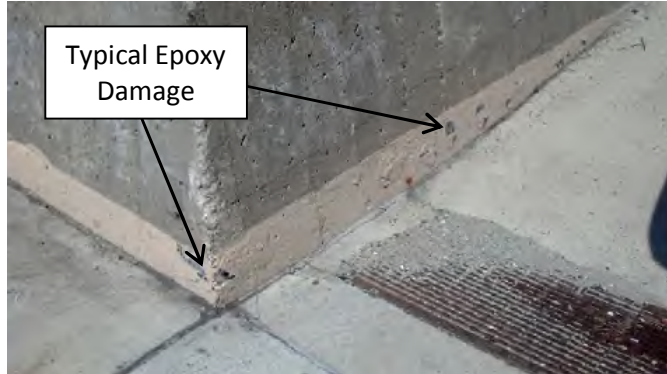
- Sikagard 62 Liquid Epoxy: The visual inspection conducted found no evidence of significant peeling, breakage, or brittleness of the coating. Overall, areas of flaking and peeling remain generally consistent with previous observations. Locations of these areas are depicted on Figure 2-1 and an example of one of the damaged areas is shown in the adjacent photo.

The isolated areas of damaged epoxy will be patched through the application of two coats of Sikagard 62 liquid epoxy to match the original application. These repairs will be conducted as part of routine maintenance in the Southwest Concourse.

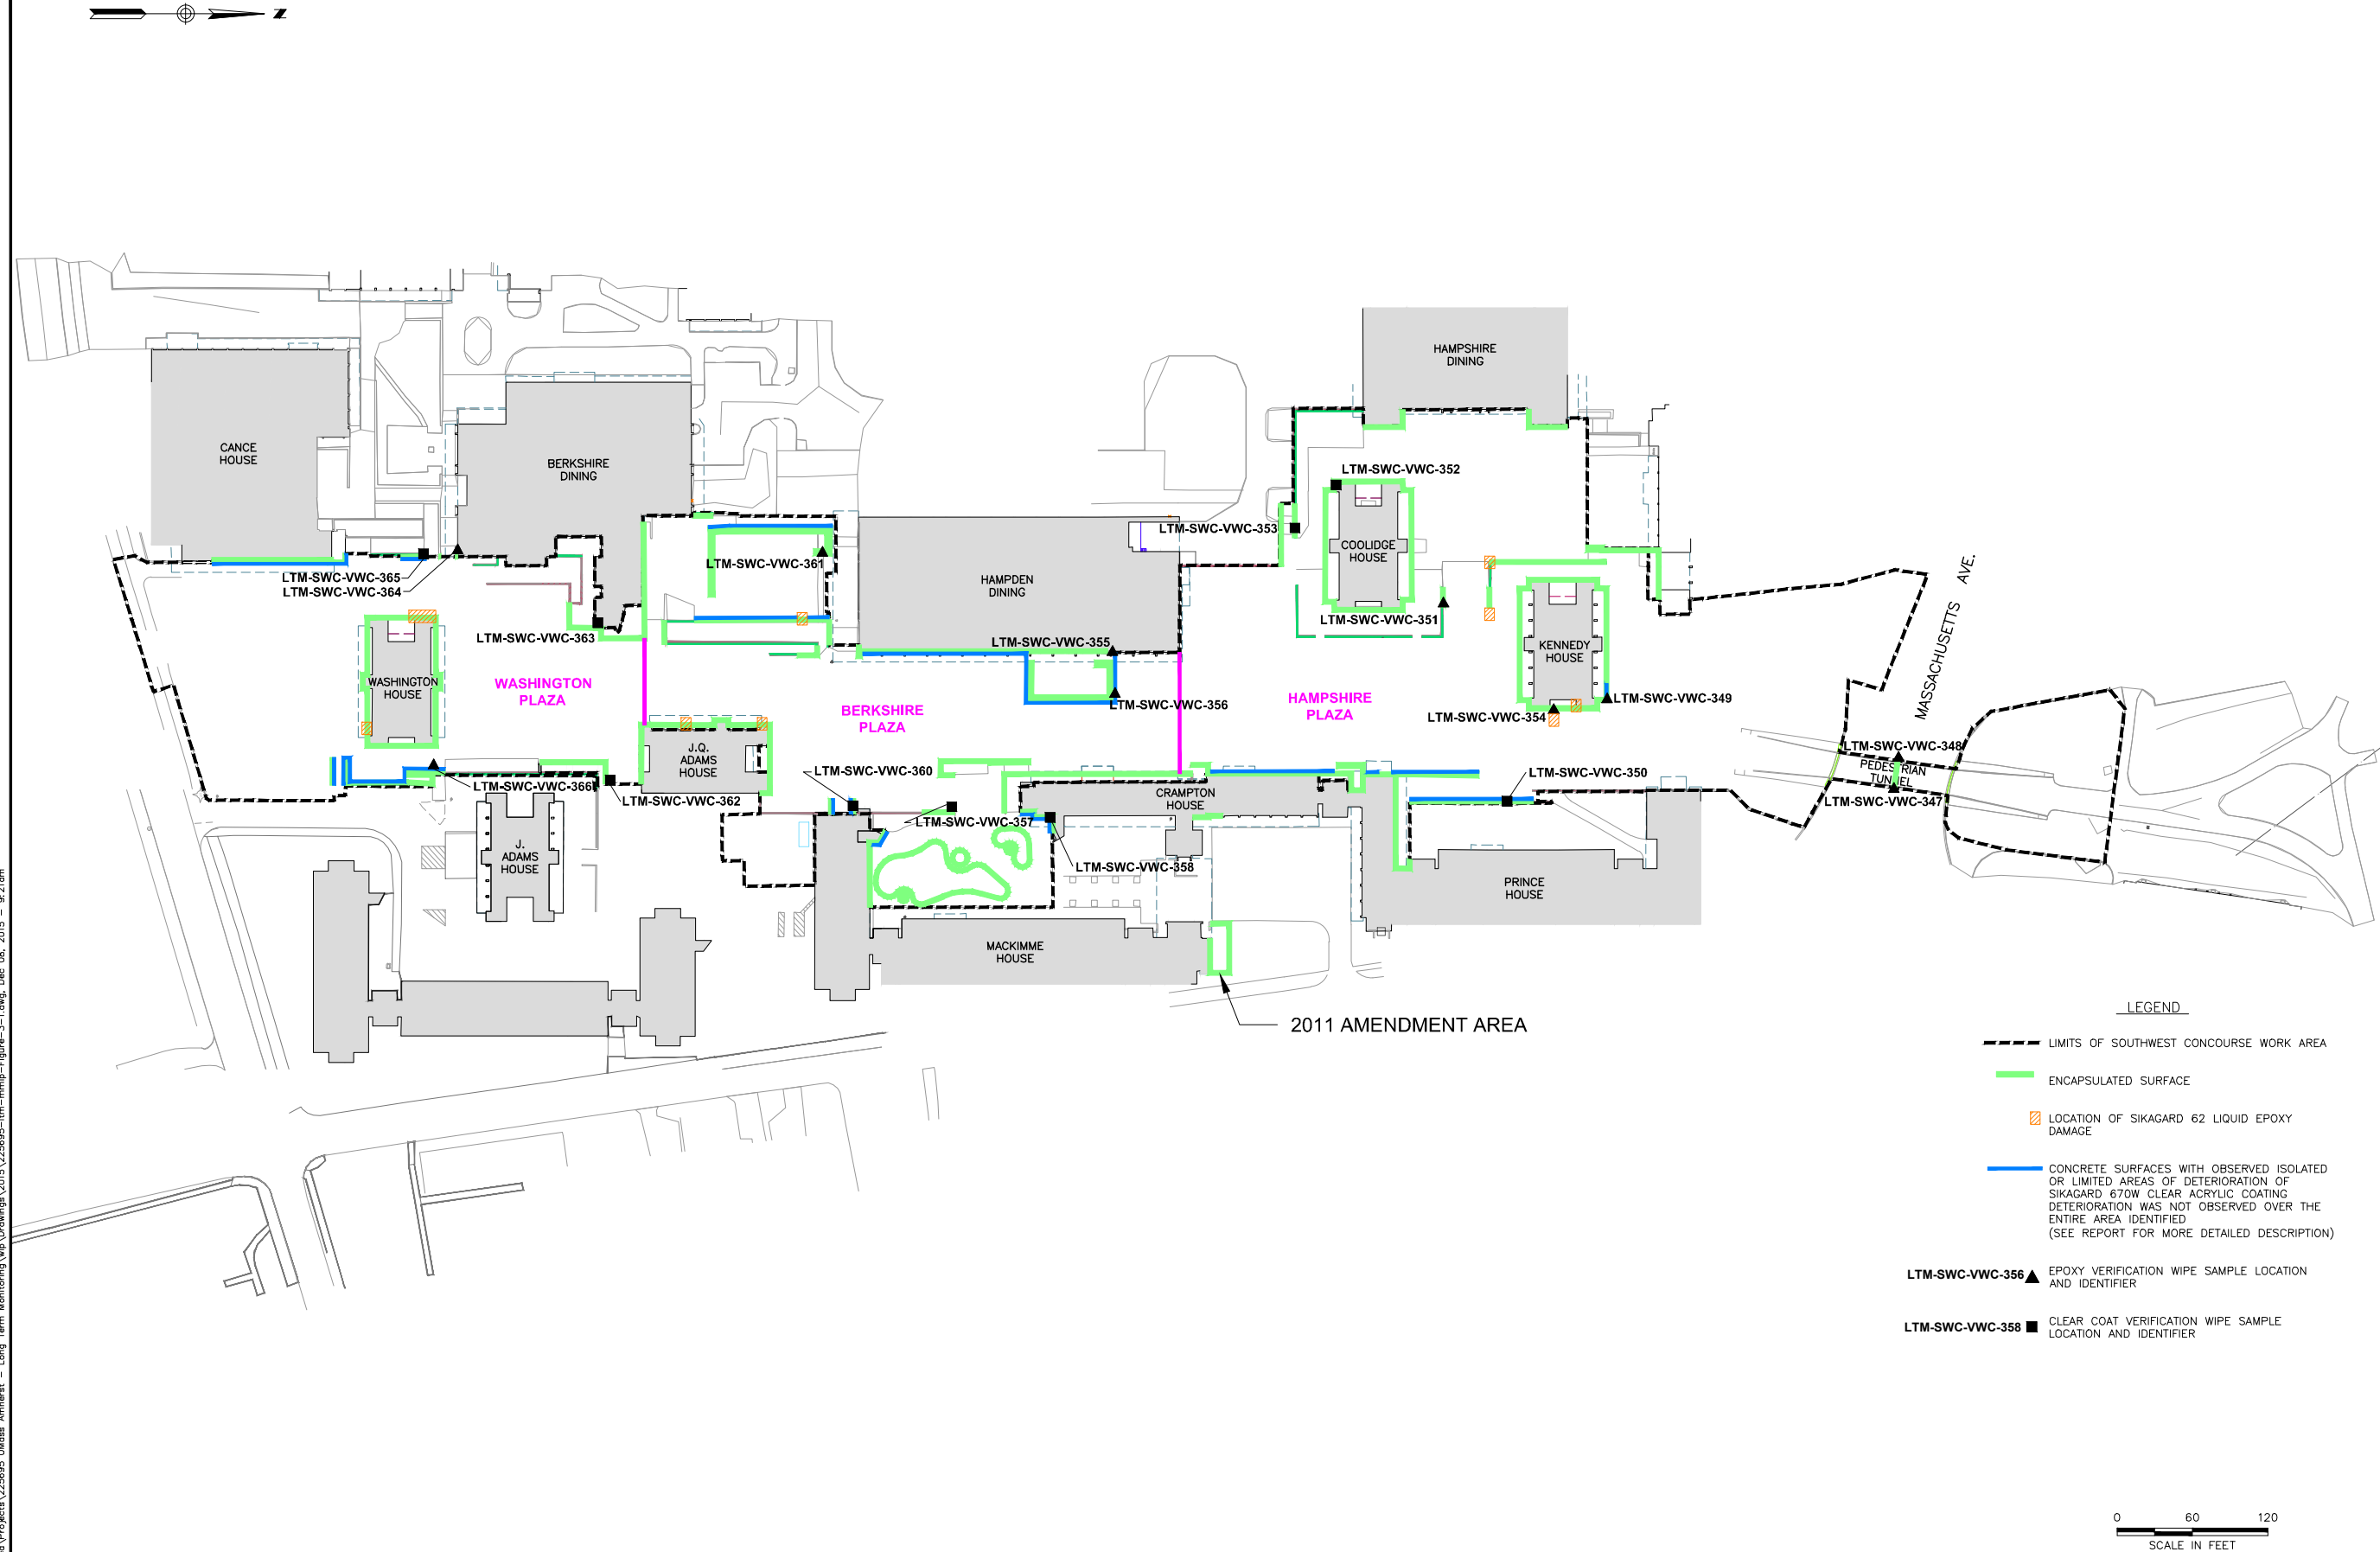
AREAS OF ENCAPSULATED SURFACES
AND OBSERVED DETEIORATION

- Sikagard 62 Liquid Epoxy: The visual inspection conducted found no evidence of significant peeling, breakage, or brittleness of the coating. However, some damage was observed at a few isolated exterior locations. Areas of observed deterioration appear to be related to physical impacts to the coating (e.g., impacts from a metal grate at the Kennedy House). Locations of these areas are depicted on Figure 2-1.

- Sikagard 670W: Visual inspection of the clear acrylic coating indicated that the coating remains in good condition over the majority of the encapsulated surfaces. Where present, areas of flaking and peeling were limited to isolated areas typically 4 to 6 inches in size (some areas were observed up to 1 foot in size). More widespread flaking and peeling was observed at two locations: the concrete retaining wall north of the Cance House, and the concrete building wall on the northeast face of the southwest end of the MacKimme House. In addition, areas of flaking and peeling of the Sikagard 670W on the concrete building wall on the southeast corner of the Crampton House appeared to be co-located with areas of visible concrete efflorescence (note, concrete efflorescence was also observed on this building wall outside the limits of the clear coat application).

The locations in which flaking and peeling were observed are depicted on Figure 2-1 (Note: the areas depicted are intended to indicate concrete surfaces on which limited areas of flaking and peeling described above were observed).

With regard to the observed flaking and peeling of the clear acrylic coating on some above grade areas, UMass is still evaluating options for different coatings that could be used on these masonry surfaces. Given the minimal additional flaking and peeling observed between 2012 and 2015, it is believed that these areas observed to date are due to conditions at the time of application and not weathering of the coating over time. Based on the limited additional flaking and peeling over time and the results of the wipe testing described above (all results non-detect or $< 1 \mu\text{g}/100 \text{ cm}^2$), these areas will continue to be included for monitoring as the coating evaluation continues.

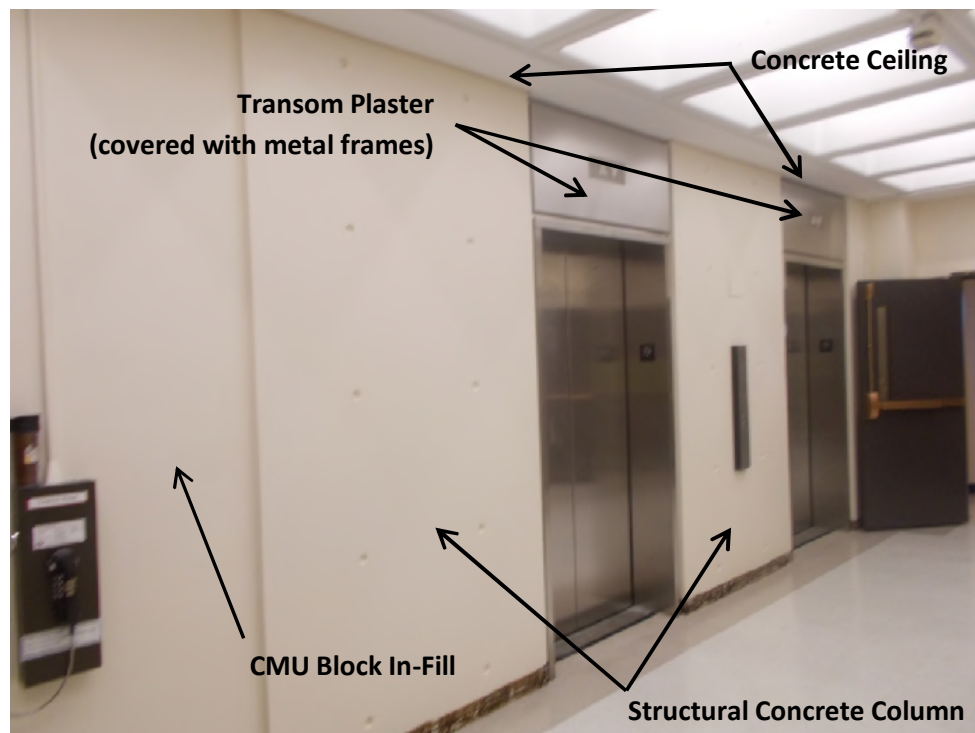
- Structural Concrete Columns – Concrete materials formerly in direct contact with the caulking and out to the first 90-degree angle (or within approximately 2 inches of the caulked joint) were encapsulated with Sika 550W acrylic coating followed by a final coat of interior latex paint. Portions of the elevator door recesses were also covered with metal frames associated with the new elevator doors. All materials on the face of the structural concrete column beyond the corner were encapsulated with latex paint.

The encapsulated surfaces associated with the elevator lobby abatement activities are shown in the photo below.

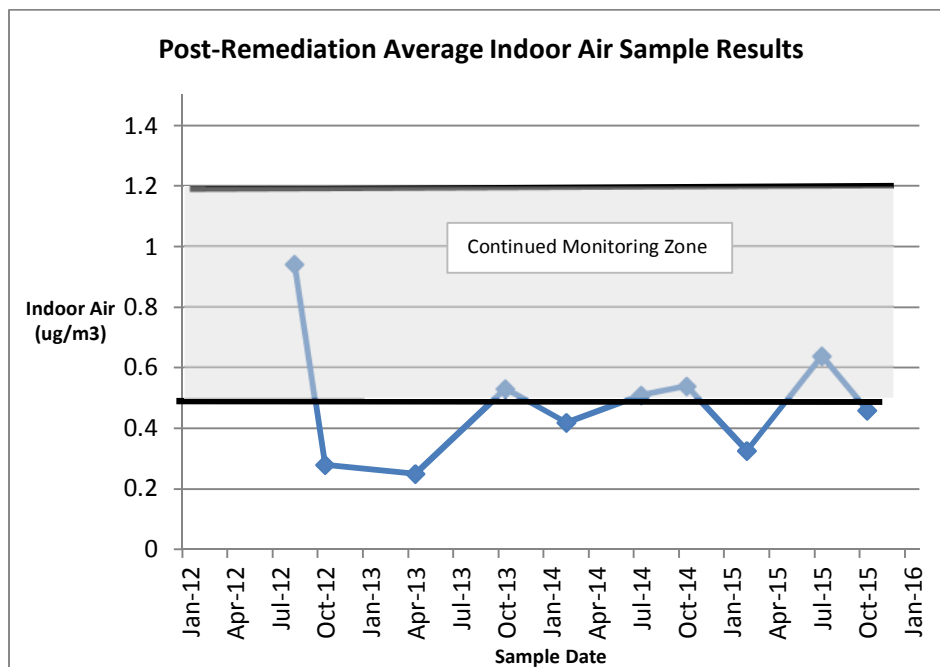
A graph of the average indoor air concentrations detected during the post-remediation sampling events is depicted below. The highest readings were observed immediately after the remediation activities and since that time, levels have stabilized to near the lower of the target levels.

Based on the 2015 monitoring activities, no corrective actions are proposed at this time.

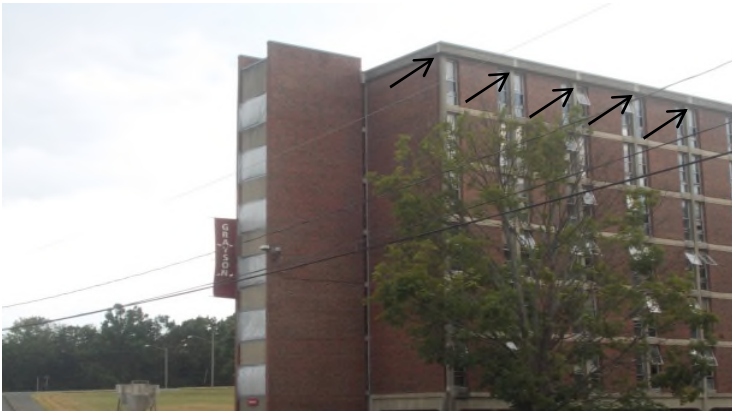
- Exterior Parapet Masonry Joints (2010): Following replacement of caulking along masonry joints at the upper parapet walls of the Field and Grayson Houses, two coats of Sikagard 62 liquid epoxy coating were applied to concrete materials formerly in direct contact with and to a distance of 6 inches from the joints in either direction (see the photograph to the right).

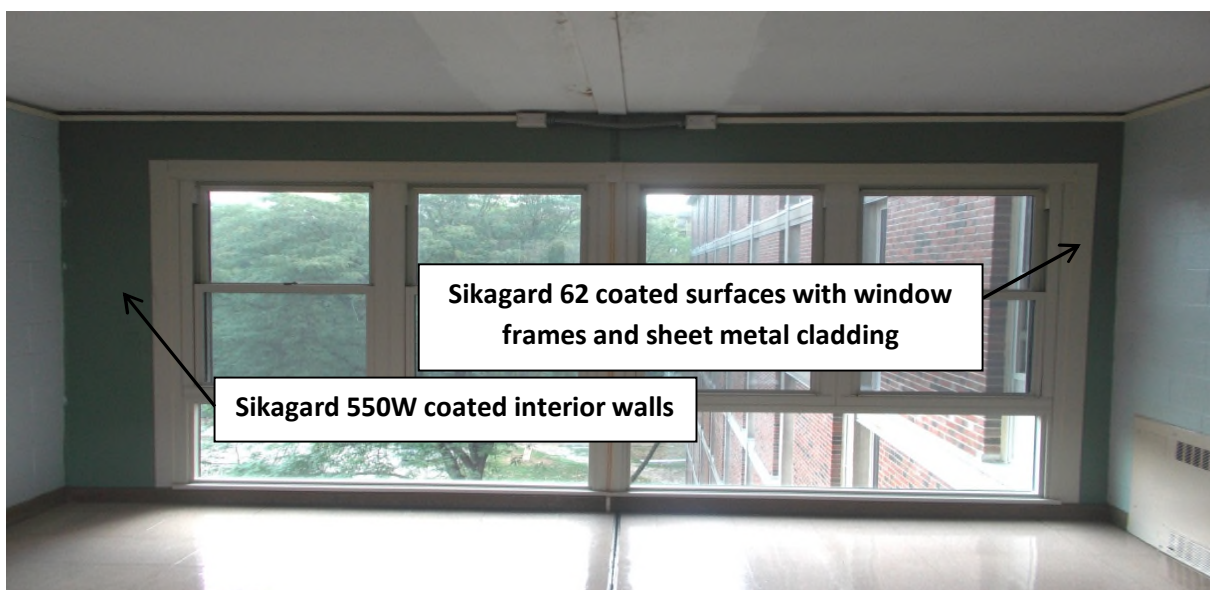
Webster House Elevator Lobby Walls

- Elevator Lobby Interior Walls – Concrete materials formerly in direct contact with caulking and to a distance of four inches from the caulked joint were encapsulated with two coats of grey Sikagard 62 epoxy coating and subsequently covered by the newly installed metal window frames and sheet metal cladding. Remaining interior wall materials to the first 90-degree angle were encapsulated with two coats of green Sikagard 550W acrylic coating (see photograph below).
- Northwest Elevation Exterior Concrete Ceiling – Materials formerly in direct contact with caulking along 100 linear feet (l.f.) of ribbon type windows on the northwest building elevation were encapsulated with two coats of grey Sikagard 62 epoxy coating and subsequently covered by the newly installed metal window frames (see Figure 4-2).

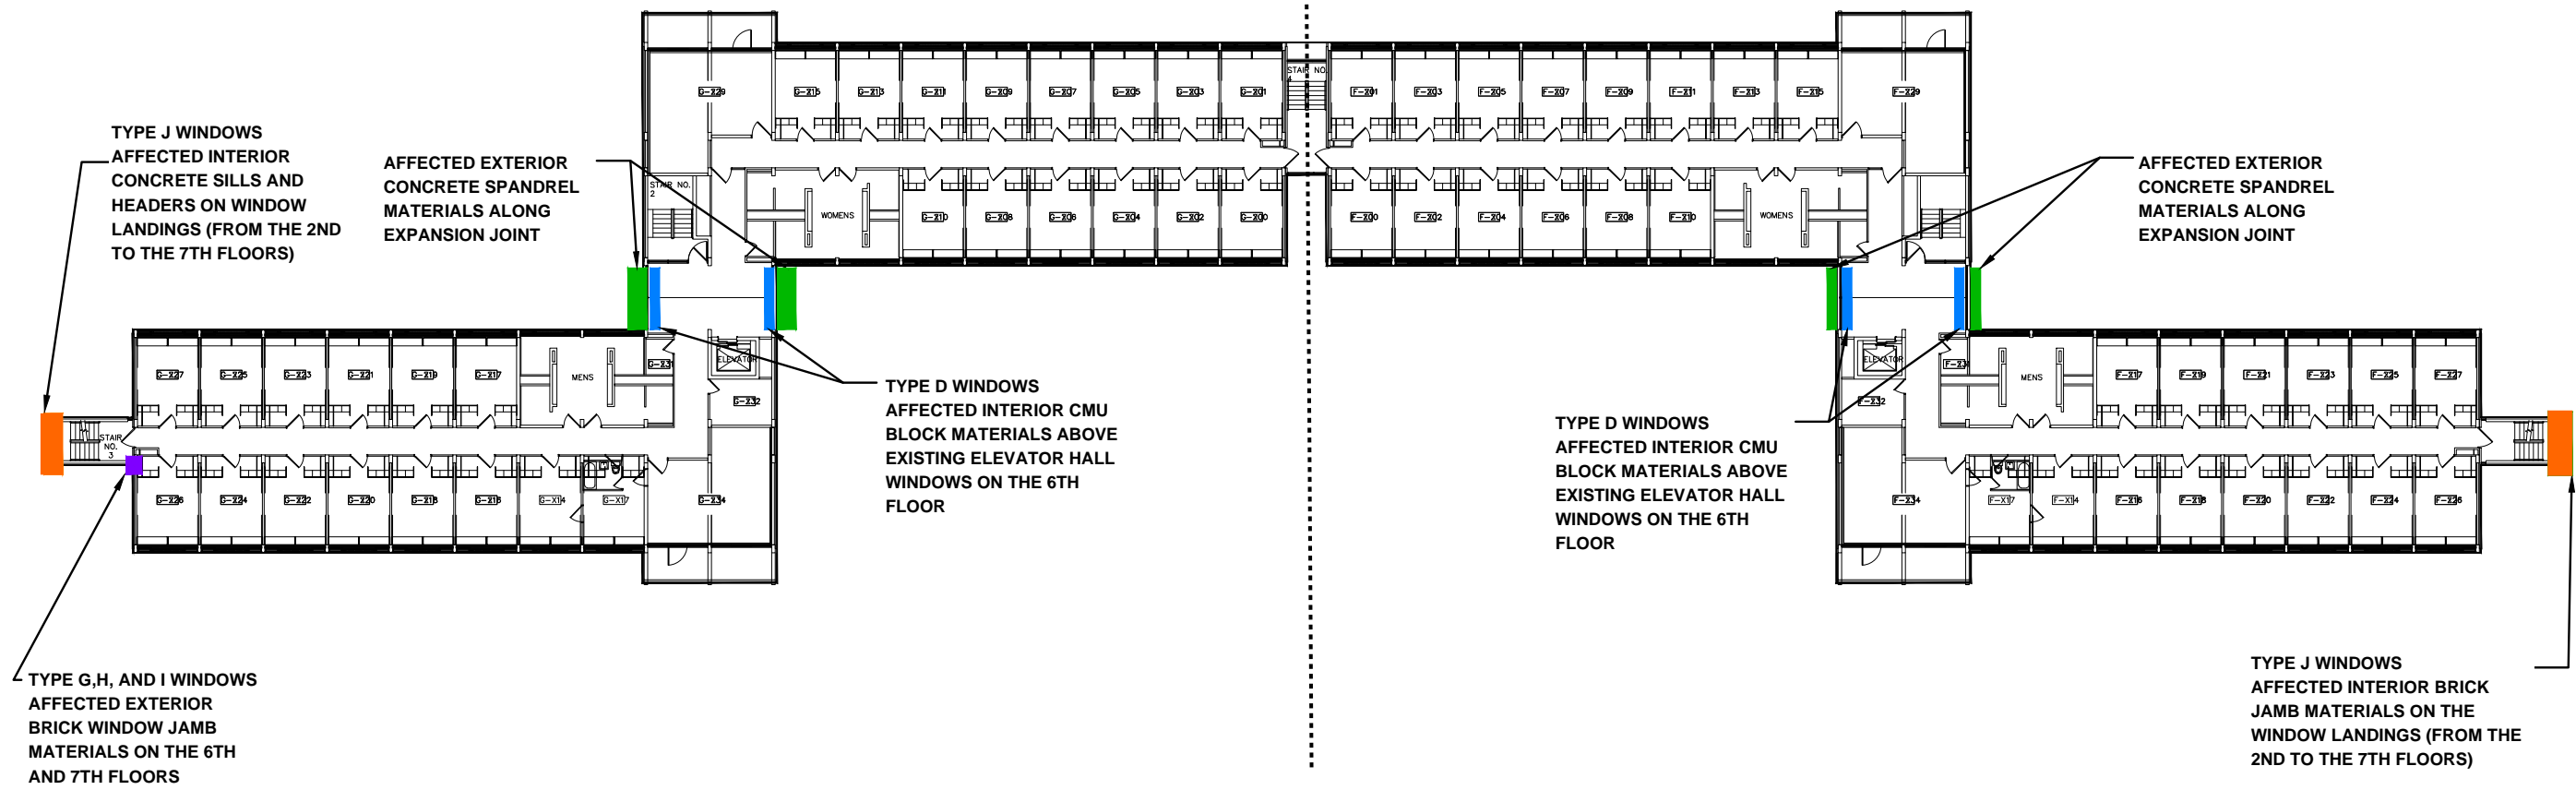
Figure 4-1

- Locations of Typical Parapet Masonry Joints
- Elevator Hall CMU Block Walls (2012 and 2013): PCBs are being managed in place at > 1 ppm at the 6th floor elevator lobby of both Field and Grayson Houses following the removal of caulked joints around Type D windows (see Figure 4-1).

- Notes:
- 1. Original design drawings by CBI Consulting, Inc. modified to show encapsulated building surfaces.
 - 2. This drawing depicts the typical building layout for the second through seventh floors of the Grayson and Field Houses.

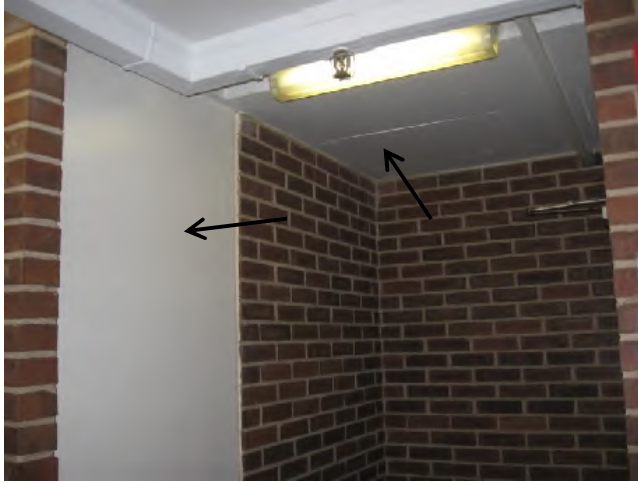
Typical Interior Encapsulated Surfaces
(Concrete Walls and Ceiling)

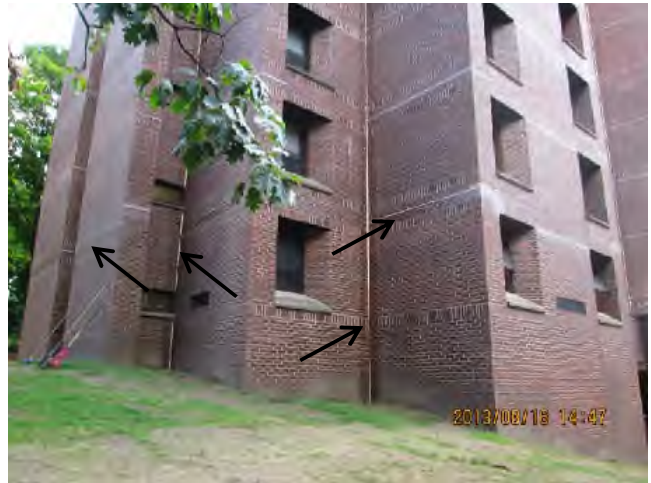
Typical Vertical and Horizontal Control Joints
(New Caulking and Clear Coating Visible)

- Sylvan Complex – due to PCB concentrations in the wipe samples of the replacement caulking at the vertical caulked joints at the McNamara building, UMass is evaluating the application of secondary barrier systems over those vertical control joints considered to be in the high occupancy area as defined specific to this project (< 8' 8" above ground surface). At this time, the final product has not been determined however, it is anticipated that it will a pre-formed silicone barrier material or similar barrier material designed to span the control joint. Details of the product selected and application will be provided upon selection/implementation.

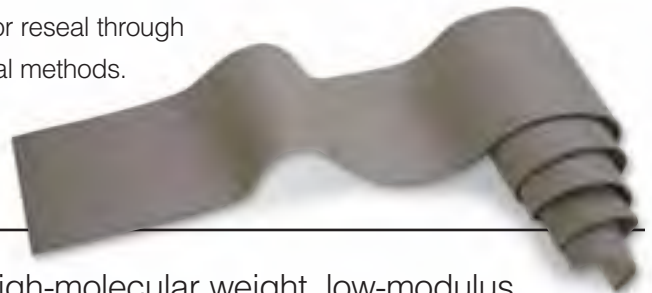
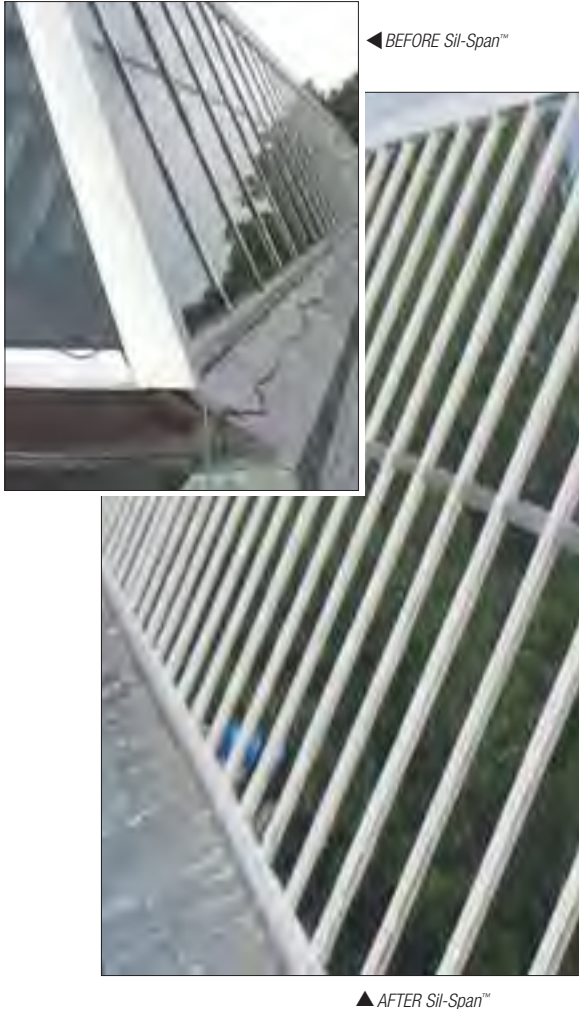
What is Sil-Span™?

With Sil-Span, restoring old sealant joints no longer requires the labor intensive steps of removing the existing failed sealant and surface preparation that can often result in substrate damage. Sil-span "bridges" over the joint to waterproof the building envelope while maintaining the original aesthetics of the substrate.

Pecora Sil-Span is made of a specially formulated high-molecular weight, low-modulus silicone compound that is extruded into preformed strips or custom shapes.

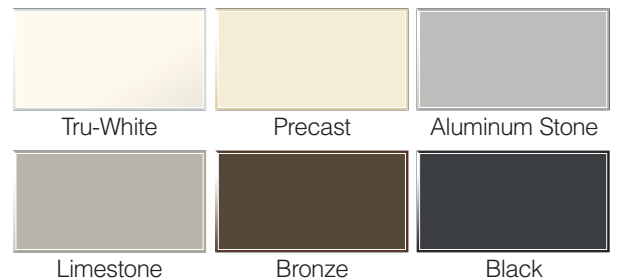
Sil-Span™ Standard Colors (Smooth Texture)

Smooth finish Sil-Span is available in the standard colors shown above. Custom colors in a smooth finish are available in special orders. The above colors represent an indication of color. For exact color matching, a cured sample is recommended.

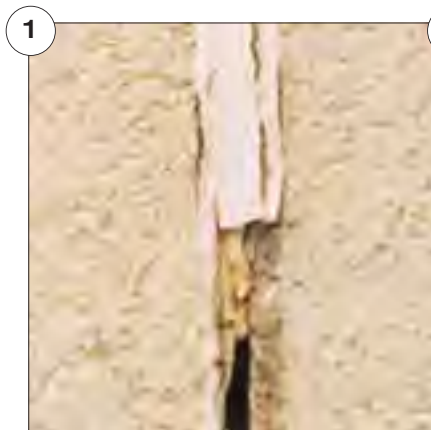
Sealant failure in expansion joint

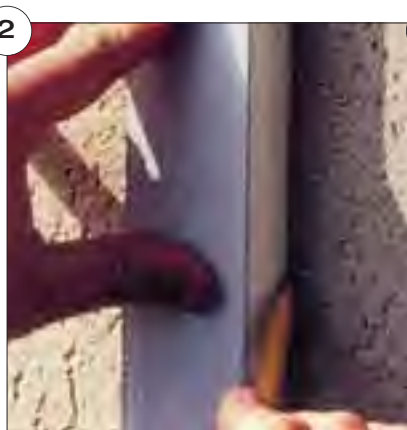
Use a straight edge to mark width of the Sil-Span to be applied

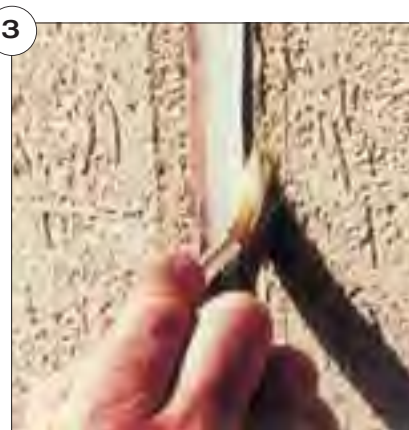
Clean area with alcohol and prime if necessary

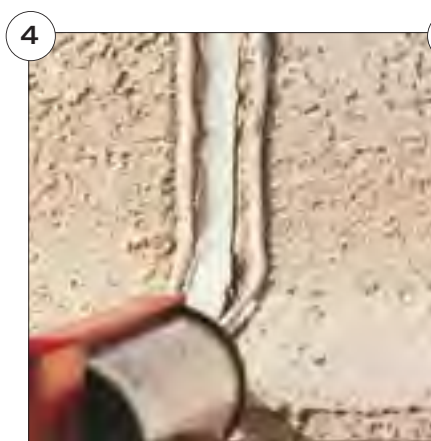
Apply Pecora 864NST adhesive/sealant to both sides of the joint

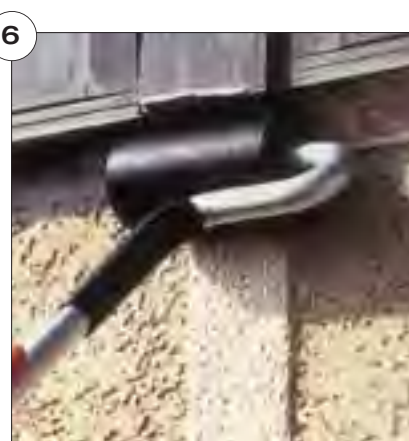
Remove excess caulk, trim ends and terminate with a cap bead of 864NST

Note: For profiles 2" or less, the bead of 864NST when applied should spread to a width of approximately 3/8". For profiles greater than 2" the bead of 864NST when applied should spread to a width of approximately 1/2". (Coverage may vary depending on porosity and texture of substrate.)
