Re: Long-Term Monitoring and Maintenance Implementation – 2018 Monitoring Results  
University of Massachusetts, Amherst, Massachusetts

On behalf of the University of Massachusetts, this report has been prepared and is being submitted to document the results from the 2018 long term monitoring activities conducted at the following buildings on the University of Massachusetts Amherst Campus:

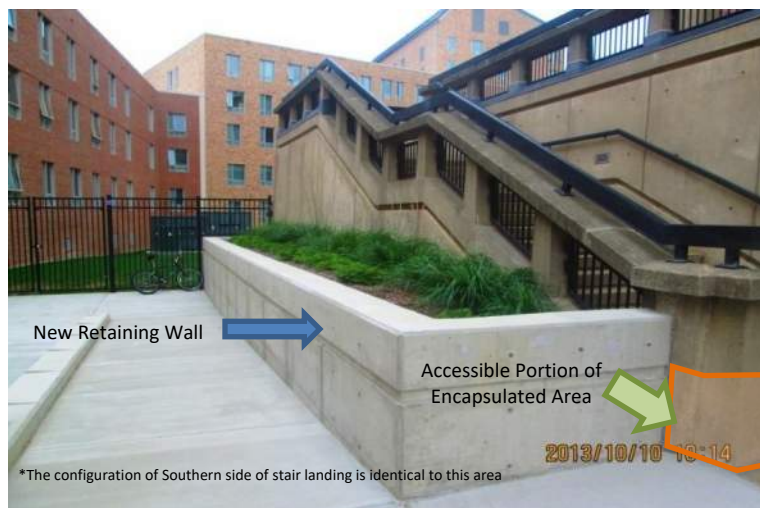
**Northern Side of Stair Landing**

*In-Place Management:* Residual PCBs on a building wall are being managed in-place following removal of concrete decking on the west side of Tobin Hall in 2011 and concrete stairs/landing in 2012. Concrete materials that contain PCBs at concentrations > 1 parts per million (ppm) remain beneath a liquid encapsulating coating (residual PCB concentration in concrete reported at a concentration of 2.37 ppm). The encapsulation extends to a distance of six inches above and six inches below the former caulked joint along approximately 80 linear feet (l.f.) of the Tobin Hall building wall and along approximately seven l.f. of the concrete façade/pillar at the north and south ends of the stairway landing. Materials were encapsulated with two coats of clear Sikagard 670W acrylic coating or two coats of Sikagard 62 liquid epoxy coating (south end of the stairwell landing only). The locations of the encapsulated surfaces are depicted on Figure 1-1. In 2013, as part of the Commonwealth Honors College construction project, a four foot high retaining wall was installed over the majority of the encapsulated surfaces. As a result, the remaining exposed encapsulated concrete surface is limited to a total of approximately 3.5 square feet of concrete at the northern and southern ends of the stair landing (i.e., seven feet of former joint to a distance of six inches above the former joints).

Photos depicting the encapsulated surfaces are presented below.

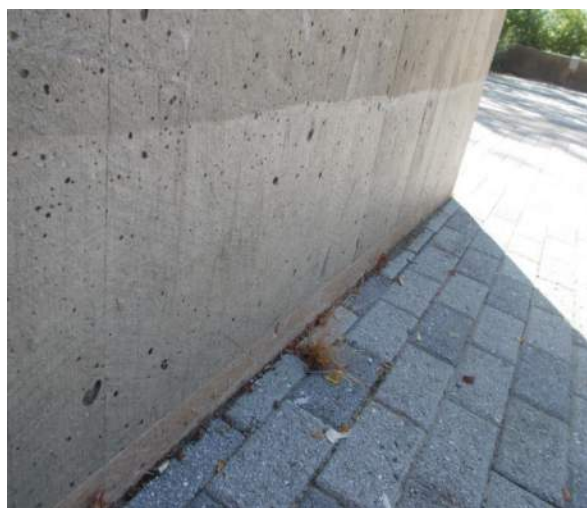
**Typical Retaining Wall Application**

The locations of the encapsulated surfaces are depicted on Figure 2-1 and typical applications are shown in the photos below.

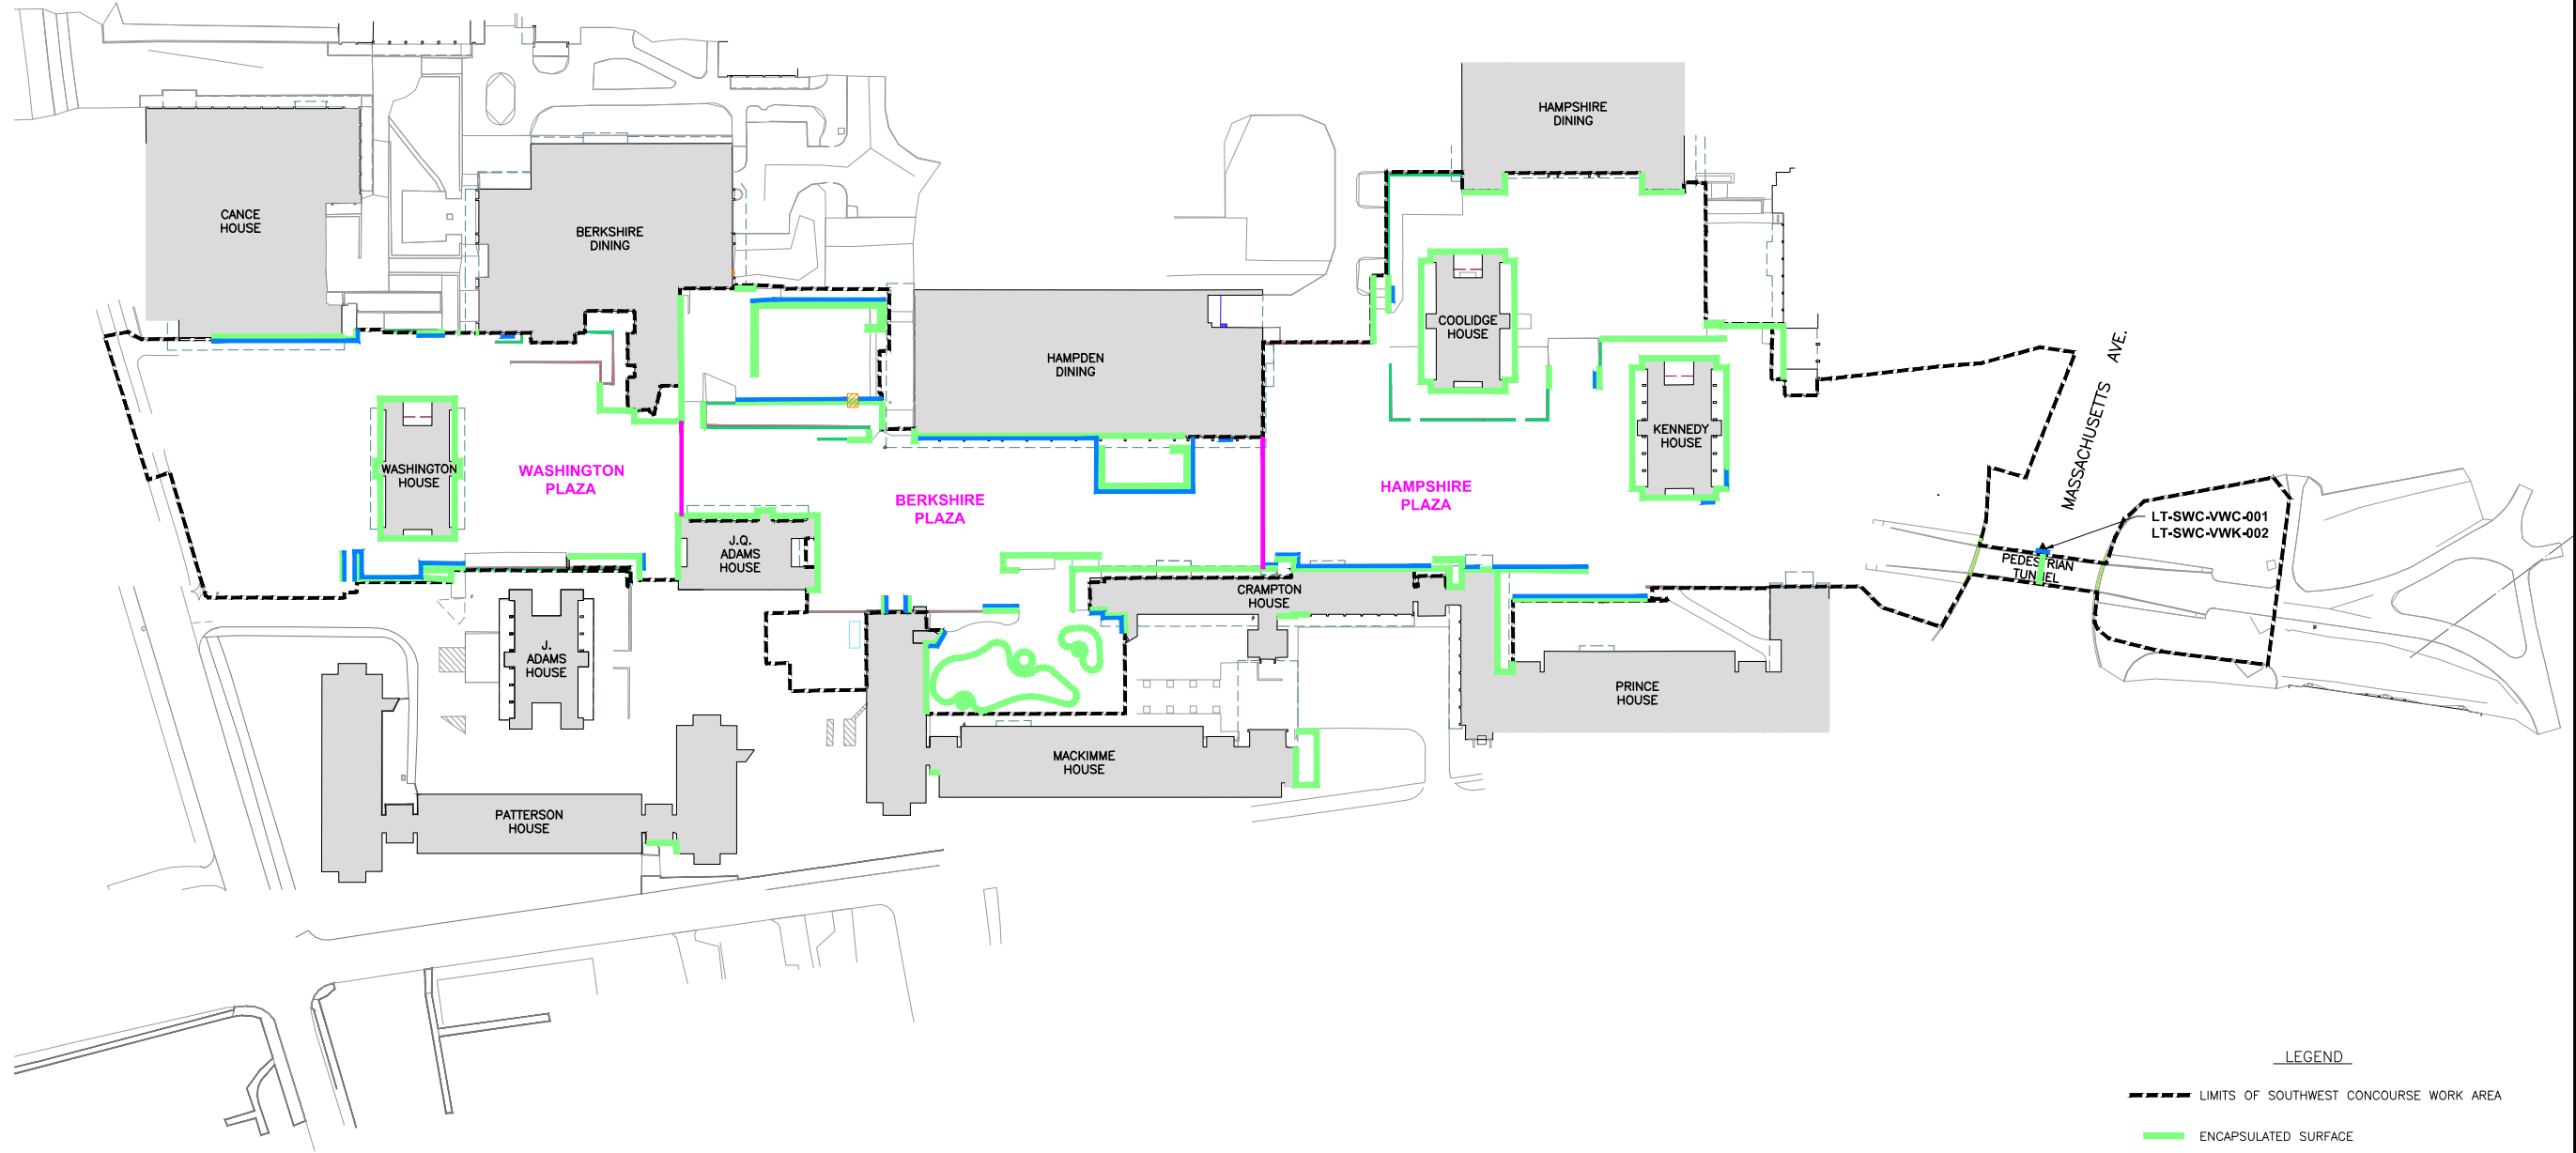
- Sikagard 62 Epoxy: The coatings were observed to be in good physical condition. Consistent with the 2017 monitoring event, one small area in the Berkshire Plaza was noted to be damaged. No additional areas of damage were observed during the inspection.
- Sikagard 670W Acrylic: Visual inspection of the clear acrylic coating indicated that the coating remains in good condition over the majority of the encapsulated surfaces with some areas of observed flaking and peeling generally consistent with previous observations. The locations in which isolated flaking and peeling were observed are depicted on Figure 2-1.
- Concrete Ceiling of Pedestrian Tunnel: Visual inspection indicated that the coatings and caulking installed within the joint were in good condition. No deterioration was observed.

- LIMITS OF SOUTHWEST CONCOURSE WORK AREA
- ENCAPSULATED SURFACE
- OBSERVED IN 2017 AND 2018 LOCATION OF SIKAGARD 62 LIQUID EPOXY DAMAGE
- CONCRETE SURFACES WITH OBSERVED ISOLATED OR LIMITED AREAS OF DETERIORATION OF SIKAGARD 670W CLEAR ACRYLIC COATING; DETERIORATION WAS NOT OBSERVED OVER THE ENTIRE AREA IDENTIFIED AND HAS REMAINED RELATIVELY CONSISTENT SINCE 2012.

Based on these results, the liquid coatings applied to concrete surfaces within the Southwest Concourse continue to be effective in encapsulating residual PCBs in masonry. The one area of damaged epoxy coating in Berkshire plaza will be repaired/reapplied by UMass during routine maintenance activities. Within the pedestrian tunnel, PCBs were reported as non-detect on the surface of the coating over the caulked joint and on the surrounding concrete. This area will be transitioned back to a bi-annual frequency for wipe sampling.

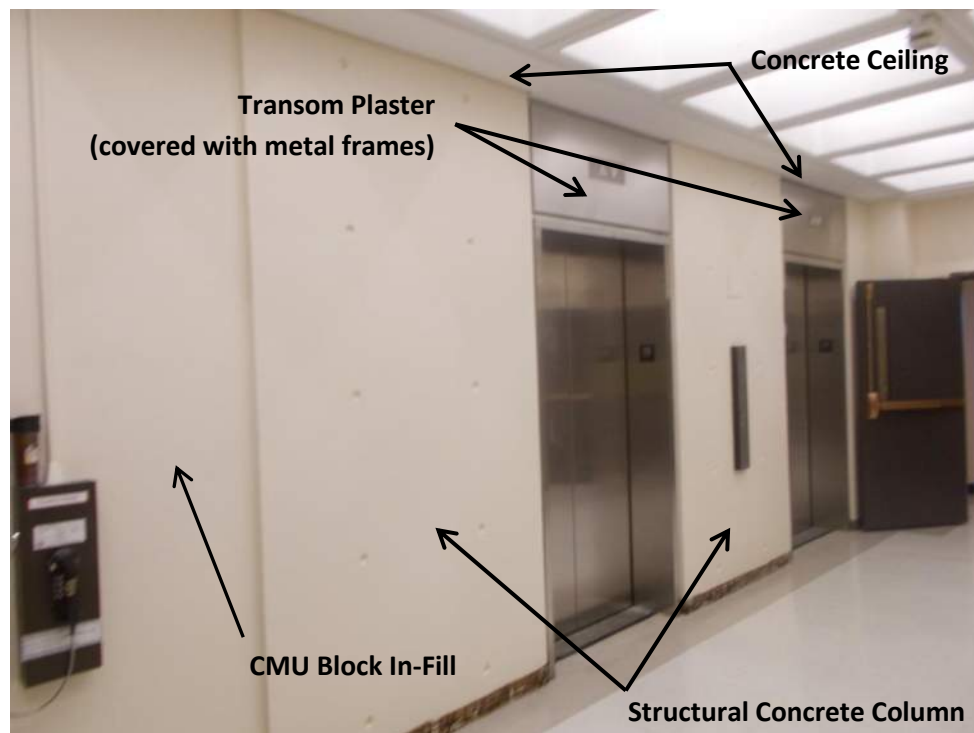
- Structural Concrete Columns – Concrete materials formerly in direct contact with the caulking and out to the first 90-degree angle (or within approximately 2 inches of the caulked joint) were encapsulated with Sika 550W acrylic coating followed by a final coat of interior latex paint. Portions of the elevator door recesses were also covered with metal frames associated with the new elevator doors. All materials on the face of the structural concrete column beyond the corner were encapsulated with latex paint.

The encapsulated surfaces associated with the elevator lobby abatement activities are shown in the photo below.

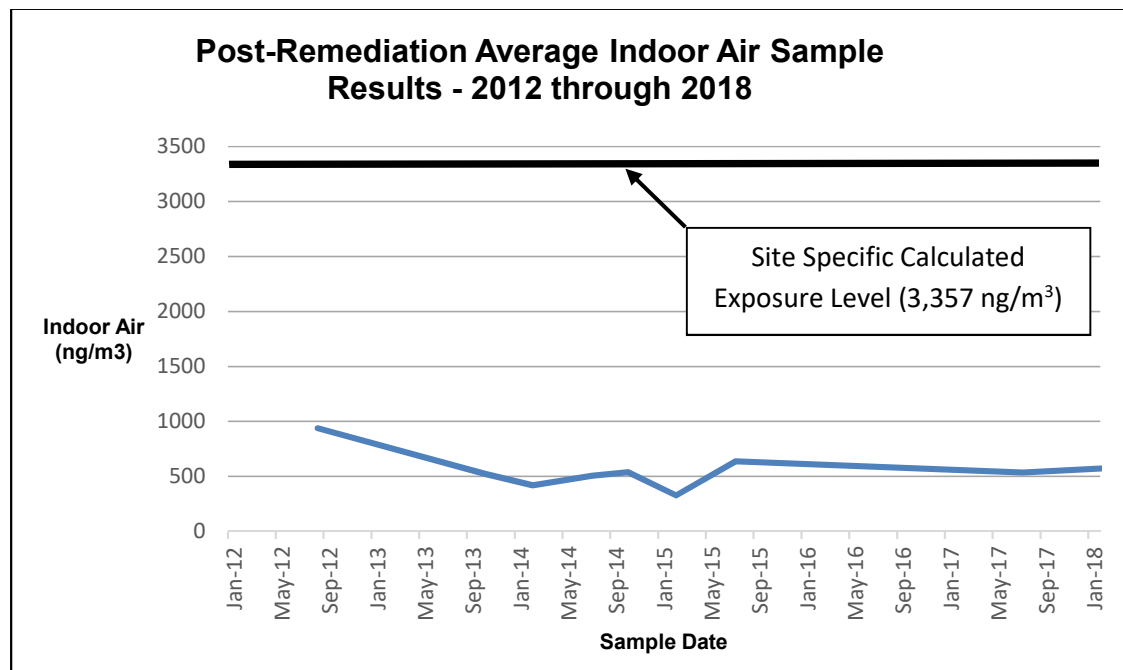
A graph of the average indoor air concentrations detected during the post-remediation sampling events is depicted below. As indicated below, all levels (average and maximum) are well below the calculated exposure level.

As shown on the graph, the highest readings were observed immediately after the remediation activities and since that time, levels have stabilized to near the lower of the target levels.

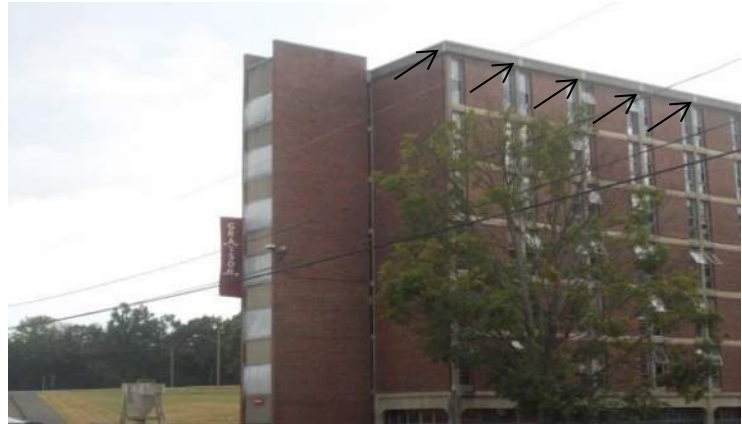
Locations of Typical Parapet Masonry Joints

- Exterior Parapet Masonry Joints (2010): Following replacement of caulking along masonry joints at the upper parapet walls of the Field and Grayson Houses, two coats of Sikagard 62 liquid epoxy coating were applied to concrete materials formerly in direct contact with and to a distance of 6 inches from the joints in either direction (see the photograph to the right).

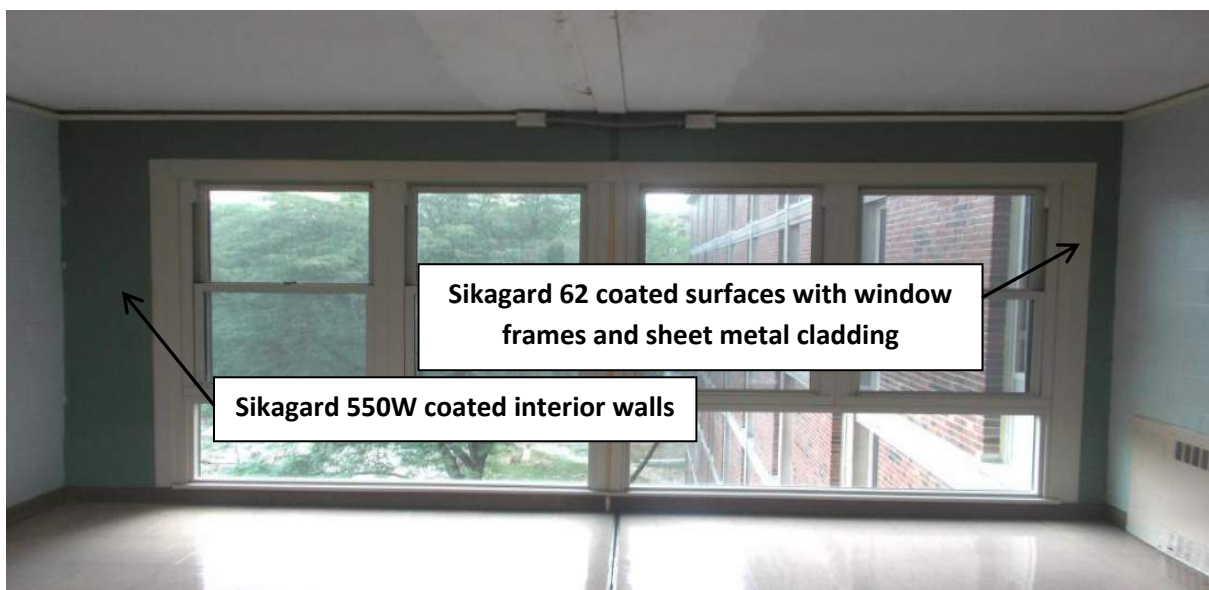
**Webster House Elevator Lobby Walls**

- Elevator Lobby Interior Walls – Concrete materials formerly in direct contact with caulking and to a distance of four inches from the caulked joint were encapsulated with two coats of grey Sikagard 62 epoxy coating and subsequently covered by the newly installed metal window frames and sheet metal cladding. Remaining interior wall materials to the first 90-degree angle were encapsulated with two coats of green Sikagard 550W acrylic coating (see photograph below).
- Northwest Elevation Exterior Concrete Ceiling – Materials formerly in direct contact with caulking along 100 linear feet (l.f.) of ribbon type windows on the northwest building elevation were encapsulated with two coats of grey Sikagard 62 epoxy coating and subsequently covered by the newly installed metal window frames (see Figure 4-2).

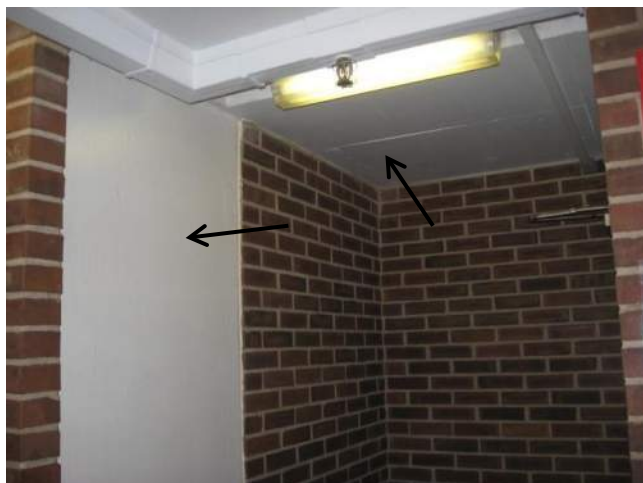
Typical Interior Encapsulated Surfaces  
(Concrete Walls and Ceiling)

Photographs of typical coating application areas are provided below.

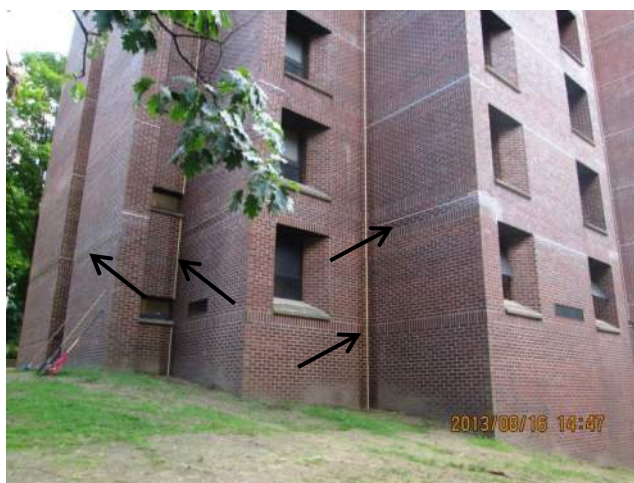
Typical Vertical and Horizontal Control Joints  
(New Caulking and Clear Coating Visible)

- Exterior Brick Within the Return of Horizontal and Vertical Control Joints (20,690 linear feet [l.f.]) – Brick materials located within the return of the horizontal and vertical control joints were encapsulated with up to three coats of Sikagard 62 liquid epoxy coating and subsequently covered with replacement caulking.

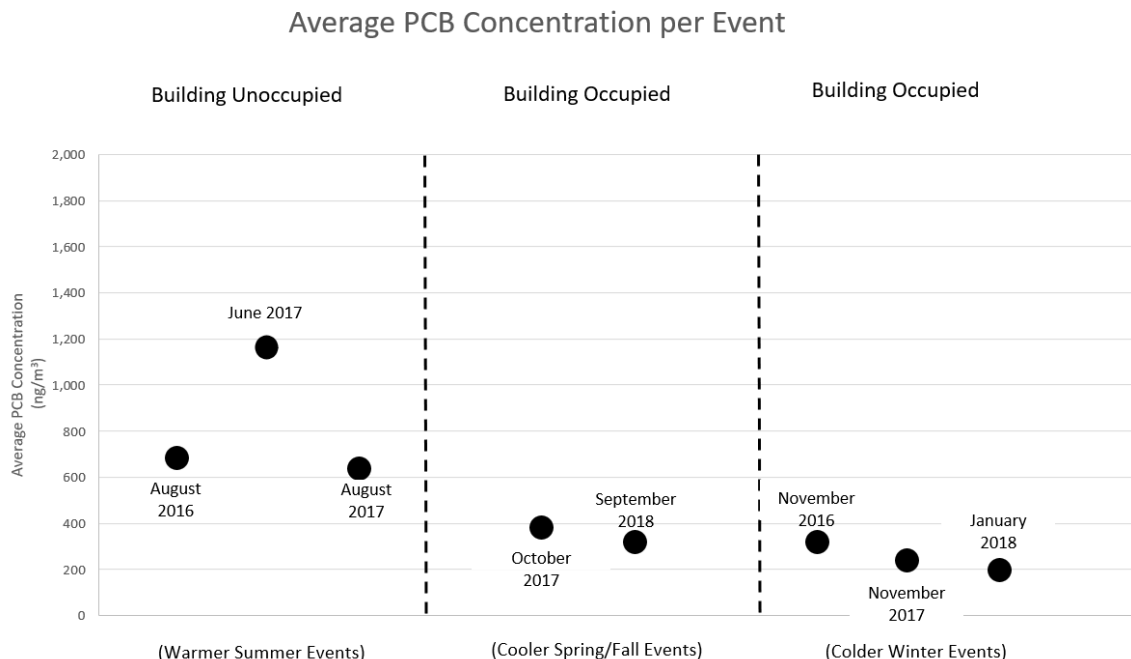
These results were also consistent with the site model developed after the 2016 sampling event which indicated that indoor air concentrations of PCBs are lower when the buildings are occupied by students with ventilation and air flow in a more typical state (the buildings are closed during the summer months with little air flow/turn over). A graph depicting the variation in average PCB concentrations between the occupied and unoccupied conditions as well as periods of different ambient temperatures is presented below.

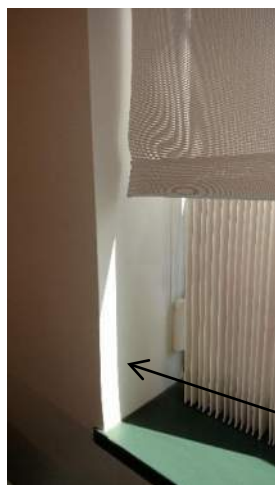
**Typical Area of In-Place Management**

*In-Place Management:* Residual PCBs on interior CMU block walls are being managed in place following a window replacement project conducted on the second floor of the Physical Plant in 2012 and 2013. The replacement project was conducted in the area formerly designated as Room 230A and currently identified as Rooms 204, 209, 210, 208, 212, and 214. The locations of the remediation and in-place management are depicted on Attachment A. Two coats of Sikagard 62 liquid epoxy coating were applied to CMU block materials to a distance of six inches from the former joints. The materials were then covered by the gypsum wall board finish materials and replacement frames.
