Re: Long-Term Monitoring and Maintenance Implementation – 2020 Monitoring Results
University of Massachusetts, Amherst, Massachusetts

**Attachment 1 – Tobin Hall
Long-Term Maintenance and Monitoring Program
In-Place Management of PCB Impacted Materials
UMass Amherst**

**Attachment 2 – Southwest Concourse Area
Long-Term Maintenance and Monitoring Program
In-Place Management of PCB Impacted Materials
UMass Amherst**

**Attachment 3 – Dubois Library
Long-Term Maintenance and Monitoring Program
In-Place Management of PCB Impacted Materials
UMass Amherst**

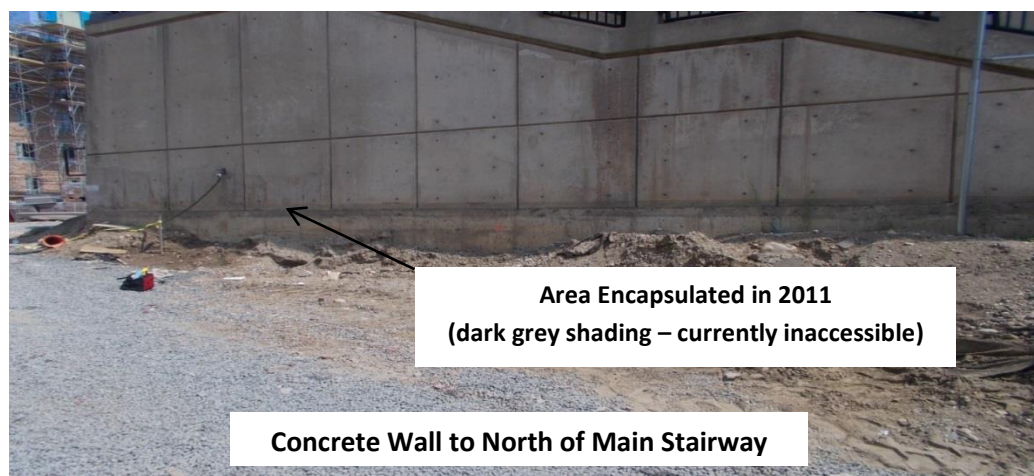
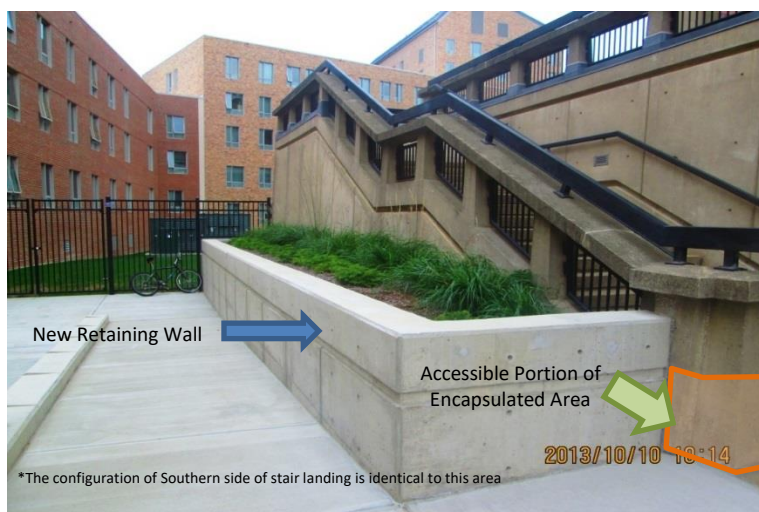
Northern Side of Stair Landing

In-Place Management: Residual PCBs on a building wall are being managed in-place following removal of concrete decking on the west side of Tobin Hall in 2011 and concrete stairs/landing in 2012. Concrete materials that contain PCBs at concentrations > 1 parts per million (ppm) remain beneath a liquid encapsulating coating (residual PCB concentration in concrete reported at a concentration of 2.37 ppm). The encapsulation extends to a distance of six inches above and six inches below the former caulked joint along approximately 80 linear feet (l.f.) of the Tobin Hall building wall and along approximately seven l.f. of the concrete façade/pillar at the north and south ends of the stairway landing. Materials were encapsulated with two coats of clear Sikagard 670W acrylic coating or two coats of Sikagard 62 liquid epoxy coating (south end of the stairwell landing only). The locations of the encapsulated surfaces are depicted on Figure 1-1. In 2013, as part of the Commonwealth Honors College construction project, a four-foot-high retaining wall was installed over the majority of the encapsulated surfaces. As a result, the remaining exposed encapsulated concrete surface is limited to a total of approximately 3.5 square feet of concrete at the northern and southern ends of the stair landing (i.e., seven feet of former joint to a distance of six inches above the former joints).

Photos depicting the encapsulated surfaces are presented below.

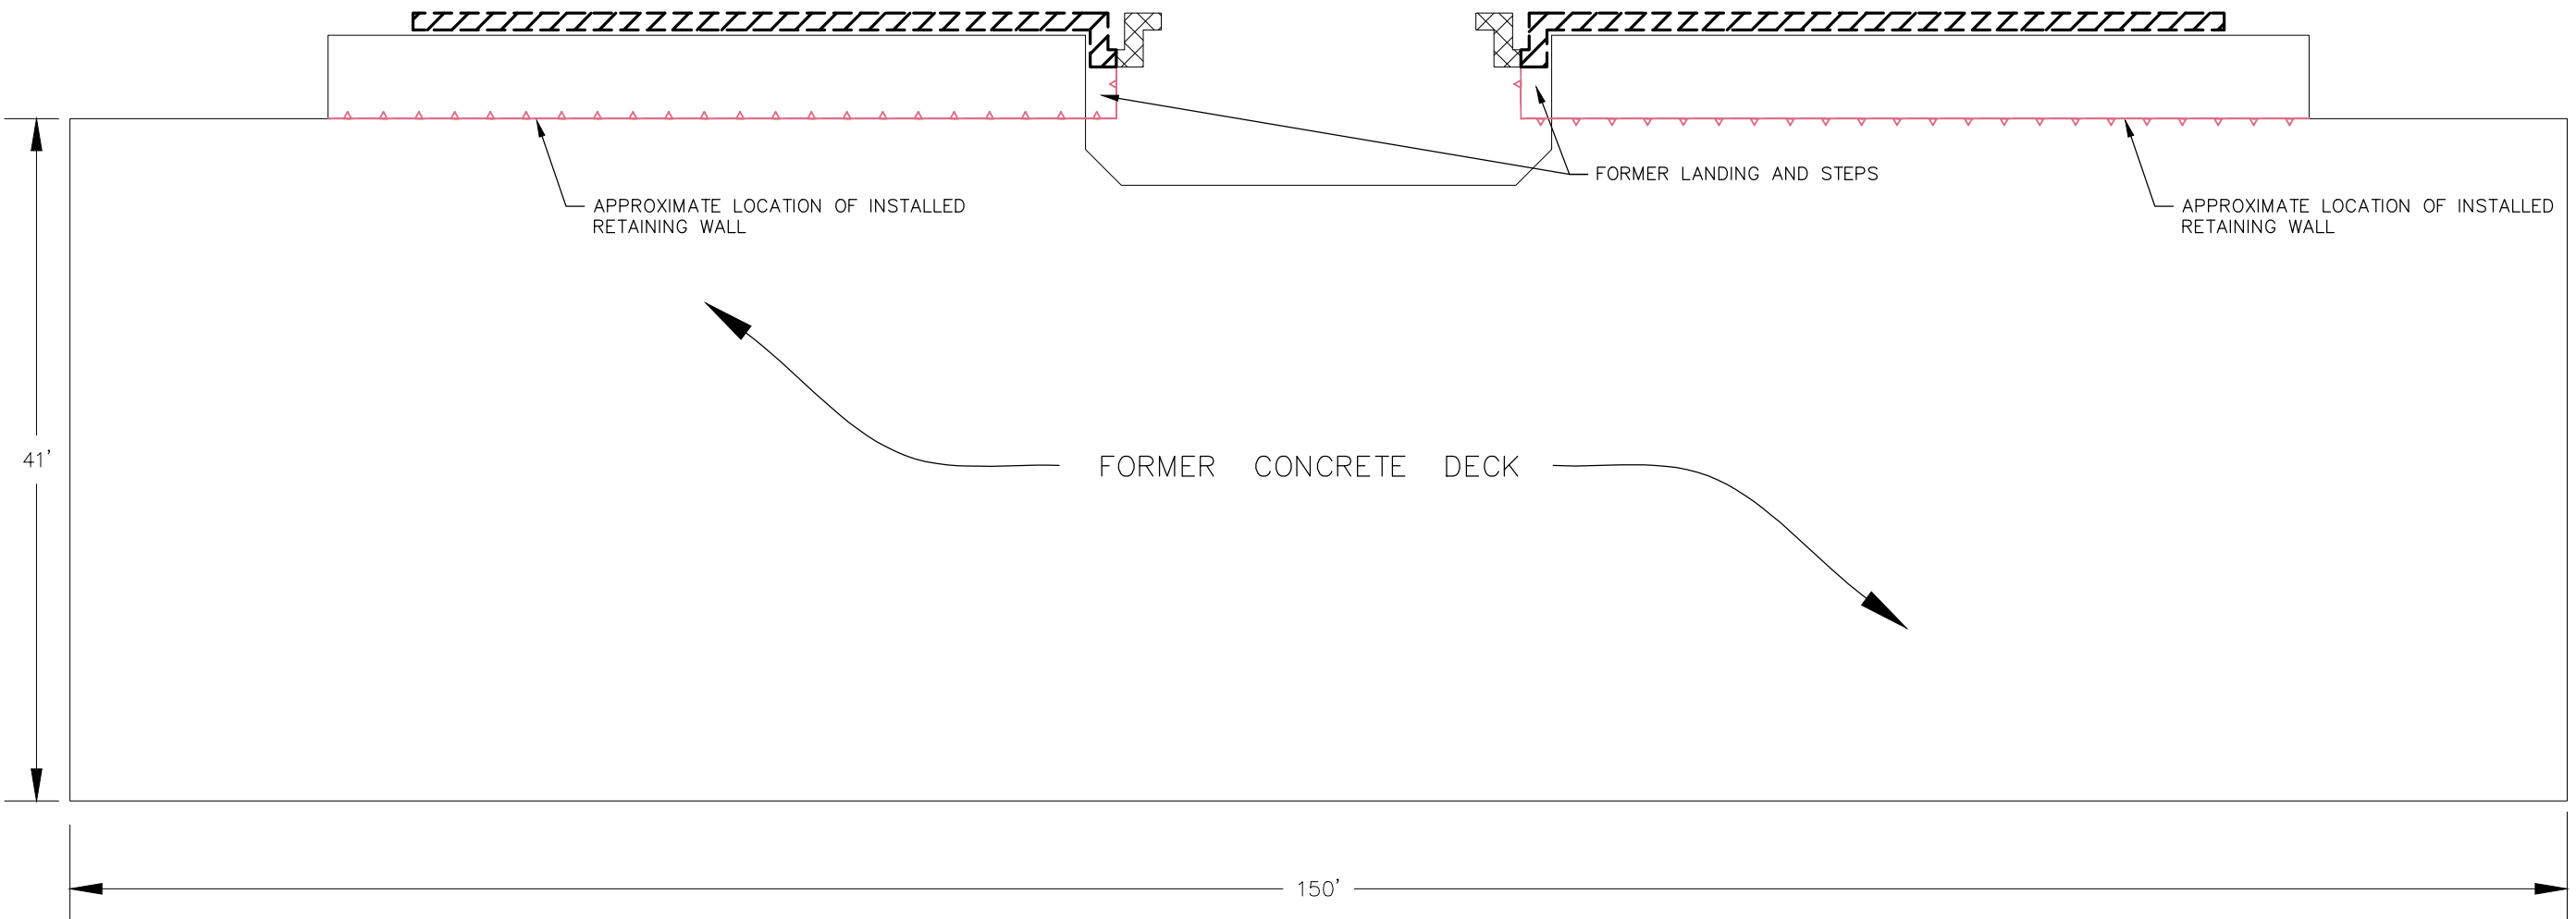
TOBIN HALL

Between 2012 and 2019 annual visual inspections of encapsulated surfaces indicated that the coatings on accessible portions of the encapsulated surfaces remained in good physical condition with the exception of a small, isolated area of epoxy coating deterioration directly adjacent to a hose connection on the northern retaining wall (the area was subsequently covered in 2013 with the installation of a four foot high retaining wall) and some flaking and peeling of the Sikagard 670W clear coating applied to a limited portion of the concrete on the northern retaining wall. Based on the observed flaking and peeling, in 2017 UMass applied two coats of Sikagard 62 epoxy coating to the accessible portion of the northern retaining wall where the clear coating had been observed to be flaking and peeling during previous events.

Results of visual inspections indicated that the epoxy coatings on accessible portions of the retaining walls were in good physical condition.

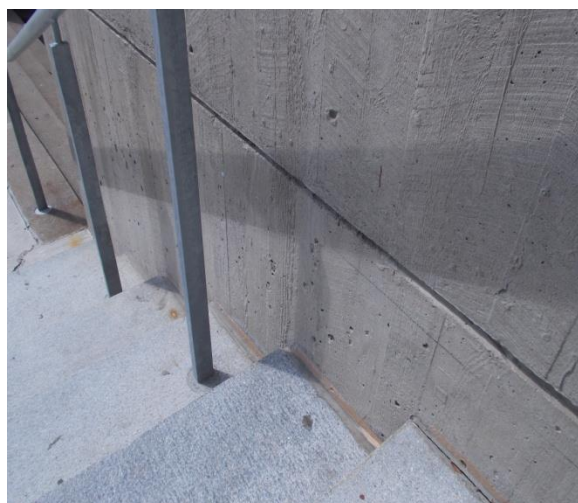
**Typical Stair Application
(shadow from railing visible as dark area)**

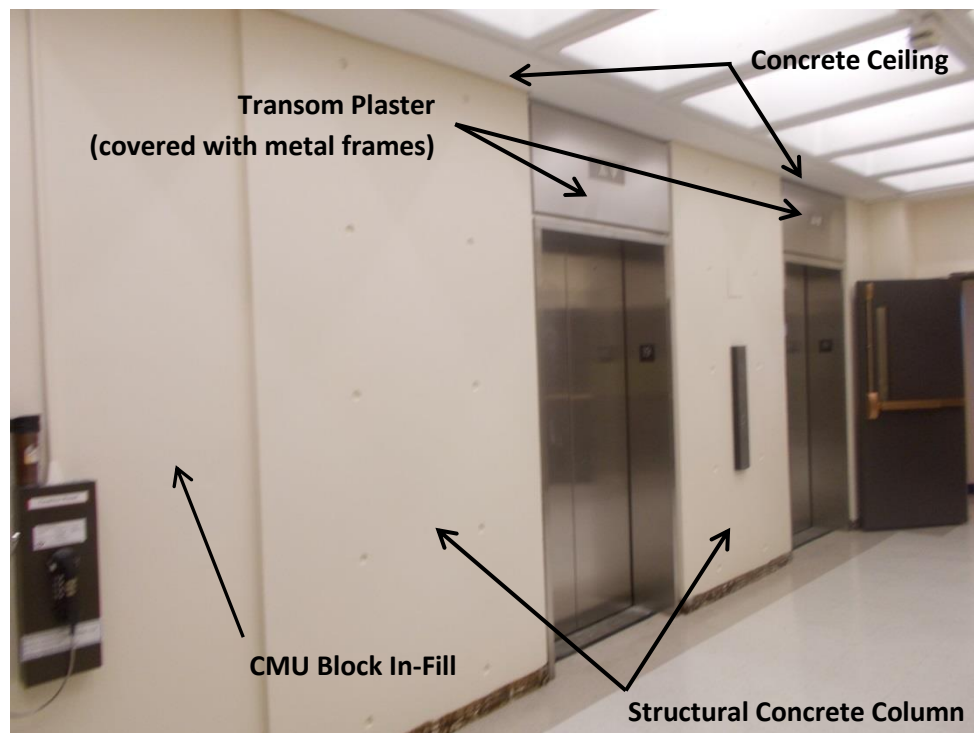
- Structural Concrete Columns – Concrete materials formerly in direct contact with the caulking and out to the first 90-degree angle (or within approximately 2 inches of the caulked joint) were encapsulated with Sika 550W acrylic coating followed by a final coat of interior latex paint. Portions of the elevator door recesses were also covered with metal frames associated with the new elevator doors. All materials on the face of the structural concrete column beyond the corner were encapsulated with latex paint.

The encapsulated surfaces associated with the elevator lobby abatement activities are shown in the photo below.

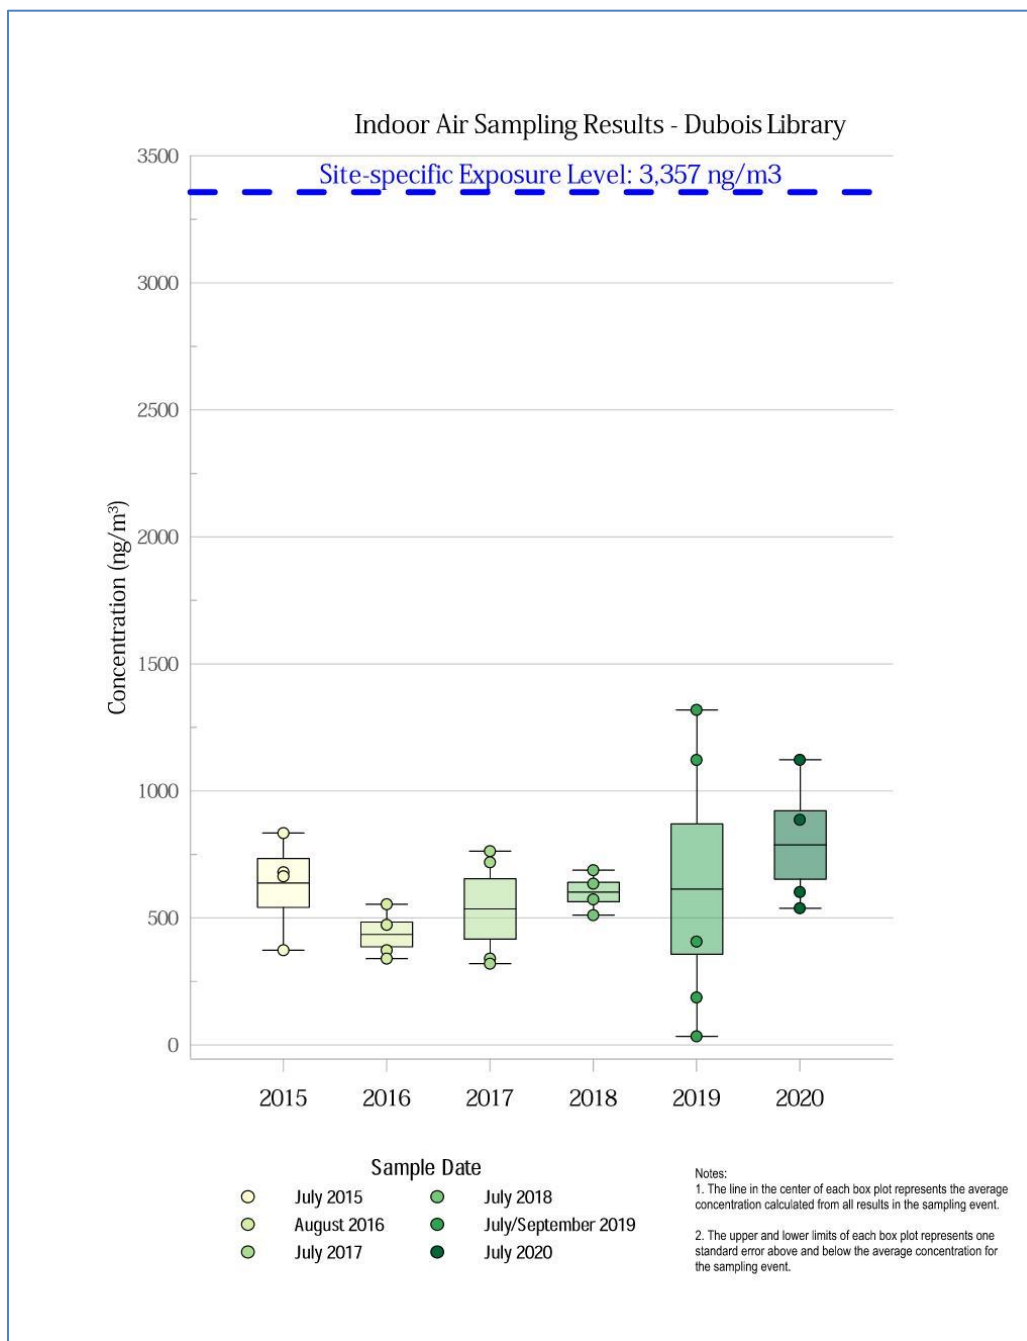
The complete analytical results are included in Attachment 7. A summary of the analytical results from the 2020 event and the previous five events (2015 to 2019) is presented on Table 3-1 and on the box plot chart on the following page.

Based on the 2020 monitoring activities, no corrective actions are proposed at this time.

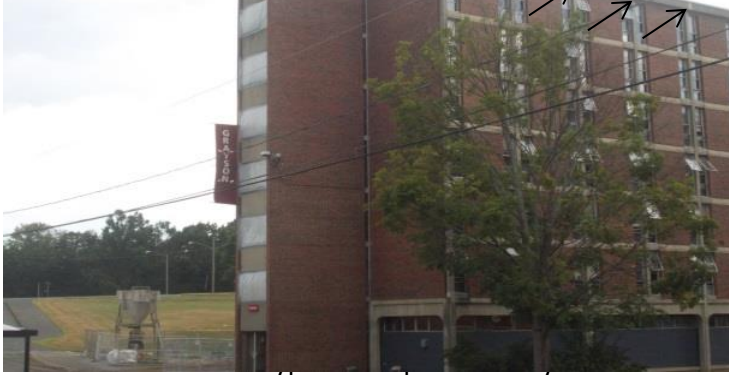
- Exterior Parapet Masonry Joints (2010): Following replacement of caulking along masonry joints at the upper parapet walls of the Field and Grayson Houses, two coats of Sikagard 62 liquid epoxy coating were applied to concrete materials formerly in direct contact with and to a distance of 6 inches from the joints in either direction (see the photograph to the right).

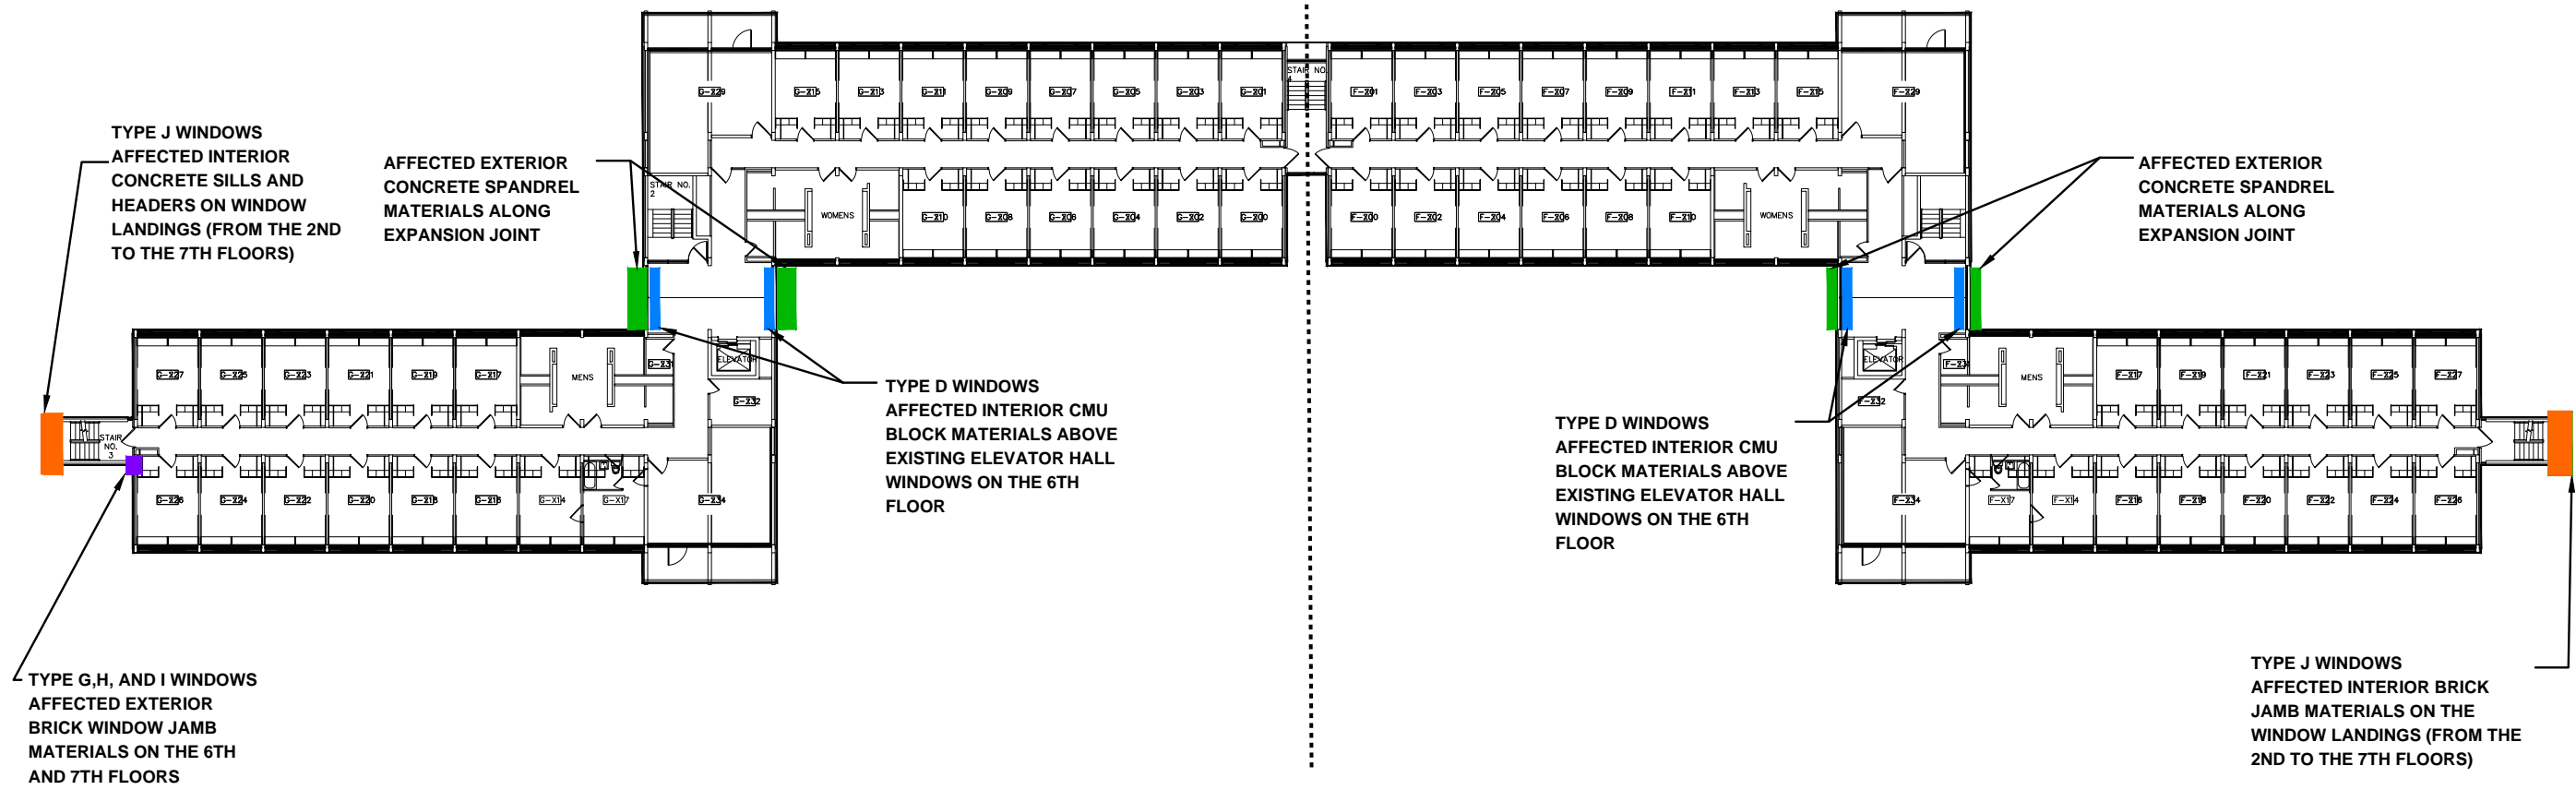
- Elevator Hall CMU Block Walls (2012 and 2013): PCBs are being managed in place at > 1 ppm at the 6th floor elevator lobby of both Field and Grayson Houses following the removal of caulked joints around Type D windows (see Figure 4-1).

- Grayson House Exterior Narrow Stairwell Window Jambs (2012): Brick materials on the jambs of the northern stairwell west elevation narrow stairwell windows on the sixth and seventh floors formerly in direct contact with the exterior perimeter window caulking and to the end of the window recess (the first 90-degree angle) have been encapsulated using two coats of Sikagard 62 epoxy coating and the replacement window frames/sheet metal flashing (see Figure 4-1).

- Grayson House Interior Stairwell Concrete Sills (2012): Concrete window sill and header materials at the northern stairwell landings from the second through seventh floors formerly in direct contact with the interior perimeter window caulking and to the first 90-degree angle (approximately two inches) have been encapsulated using two coats of Sikagard 62 epoxy coating and the replacement window frames (see Figure 4-1).

- Field House Interior Stairwell Brick Jambs (2012): Brick window jamb materials at the southern stairwell landings from the second floor through seventh floors formerly in direct contact with the interior perimeter window caulking and to a distance of two inches (i.e., the extent of the replacement window frames) have been encapsulated using two coats of Sikagard 62 epoxy coating and the replacement window frames (see Figure 4-1).

- Notes:
- 1. Original design drawings by CBI Consulting, Inc. modified to show encapsulated building surfaces.
 - 2. This drawing depicts the typical building layout for the second through seventh floors of the Grayson and Field Houses.

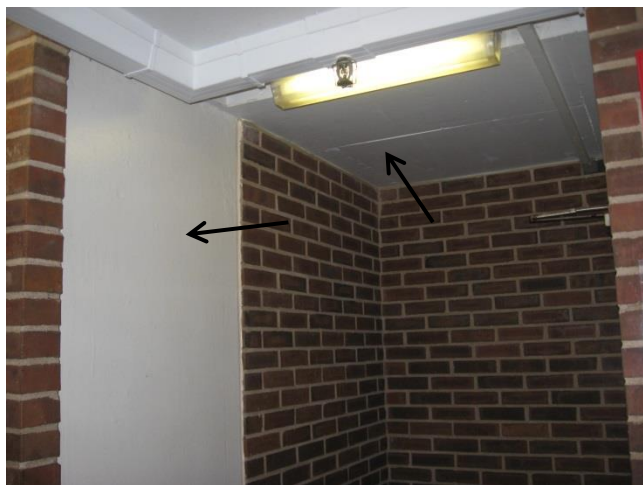
Typical Interior Encapsulated Surfaces
(Concrete Walls and Ceiling)

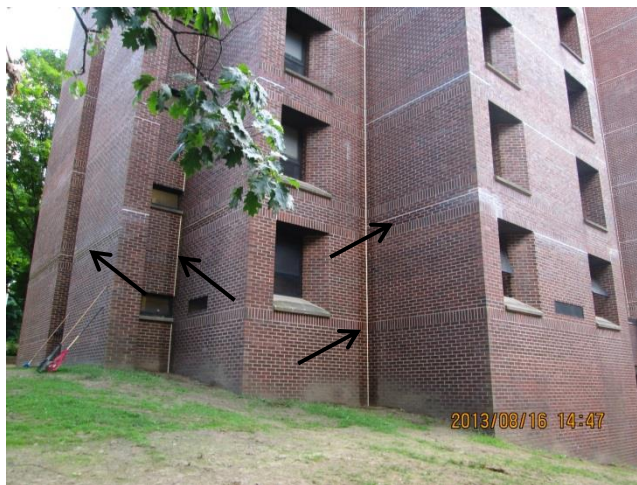
Typical Vertical and Horizontal Control Joints
(New Caulking and Clear Coating Visible)

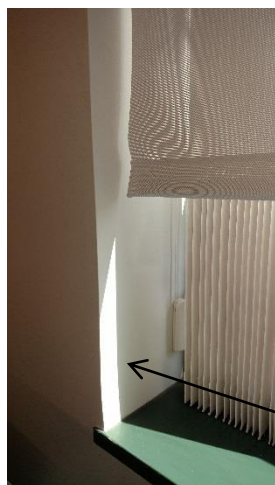
In-Place Management: Residual PCBs on interior CMU block walls are being managed in place following a window replacement project conducted on the second floor of the Physical Plant in 2012 and 2013. The replacement project was conducted in the area formerly designated as Room 230A and currently identified as Rooms 204, 209, 210, 208, 212, and 214. The locations of the remediation and in-place management are depicted on Attachment A. Two coats of Sikagard 62 liquid epoxy coating were applied to CMU block materials to a distance of six inches from the former joints. The materials were then covered by the gypsum wall board finish materials and replacement frames.

Typical Area of In-Place Management

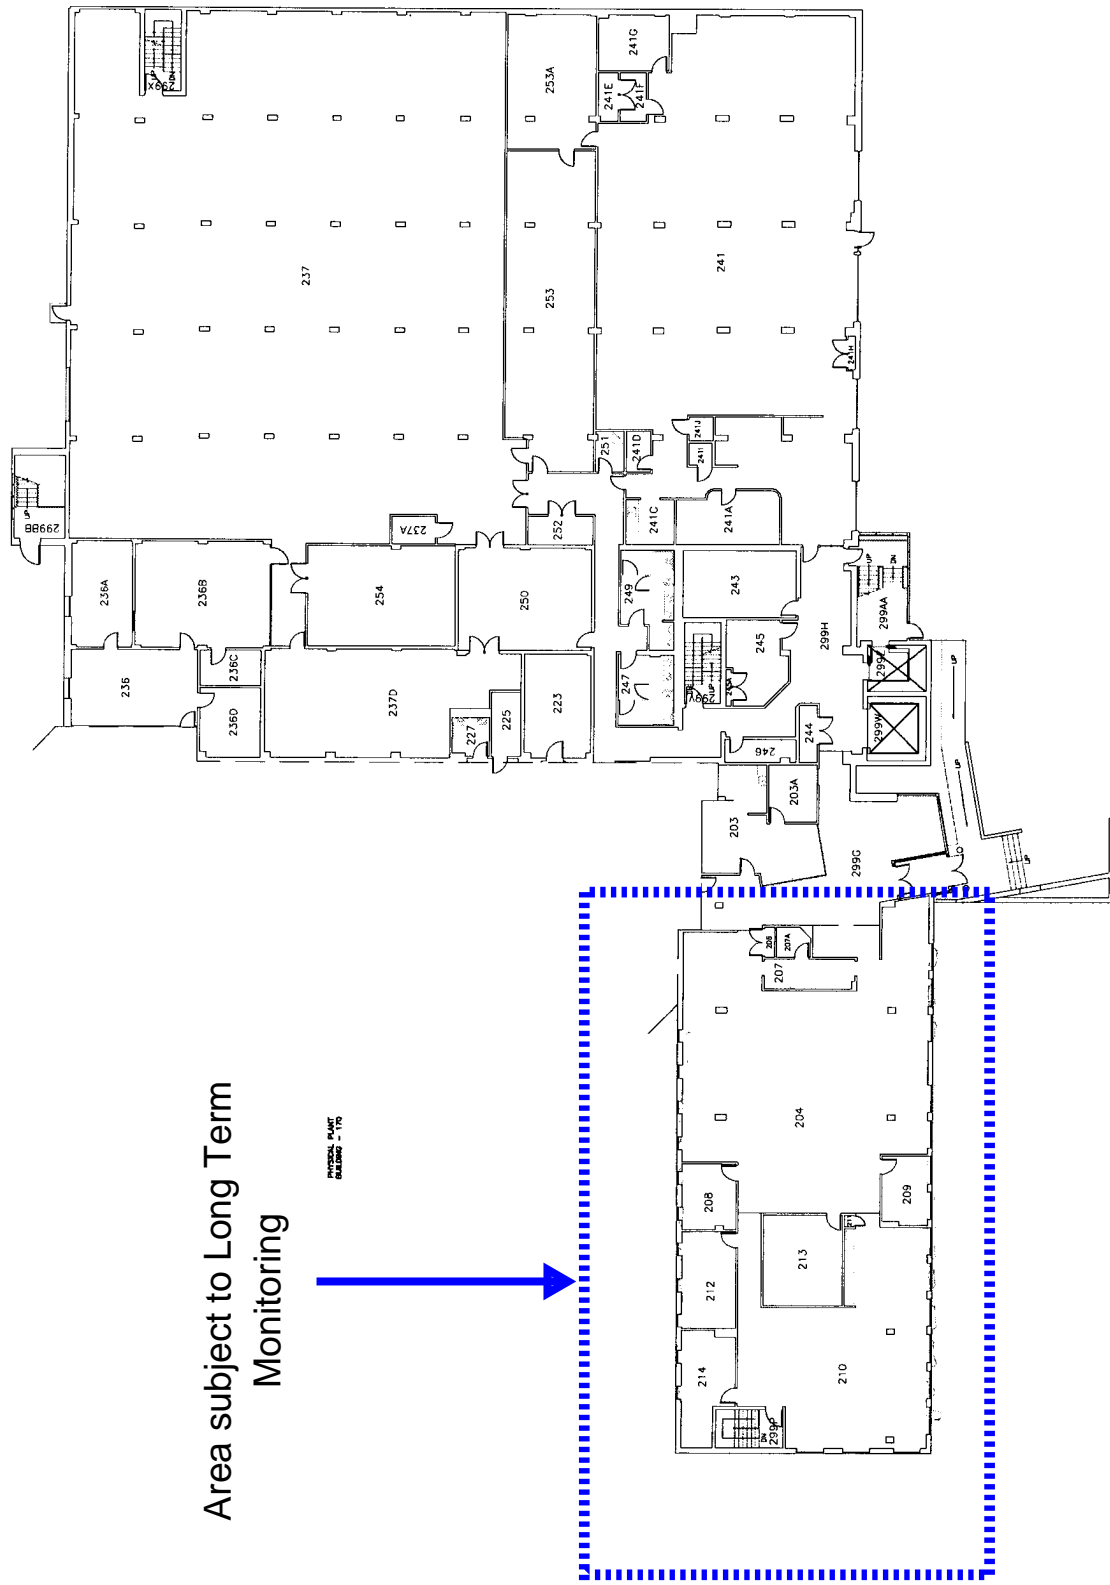
Attachment A Second Floor Physical Plant

Area subject to Long Term Monitoring
