PCB COMPLETION REPORT

University of
Massachusetts

Southwest Concourse
Amherst, Massachusetts

223505.00
University of
Massachusetts
February 2011

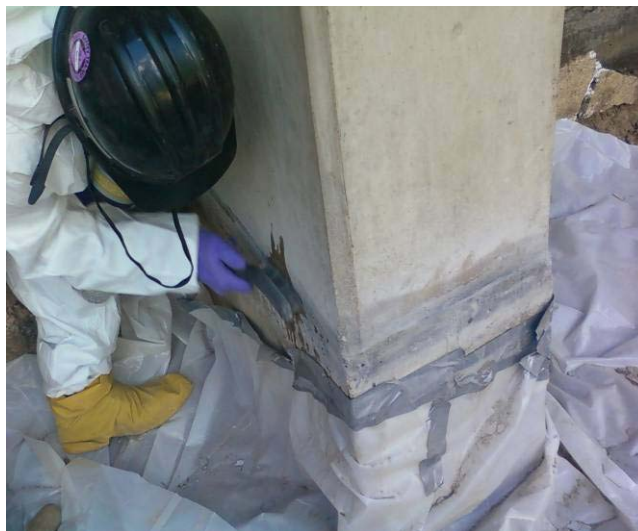
- During the removal of PCB containing materials (caulking, soils, concrete), surficial wetting techniques were employed to control dust generation. In caulking removal areas, polyethylene sheeting was applied beneath the joint to collect any caulking during the removal.

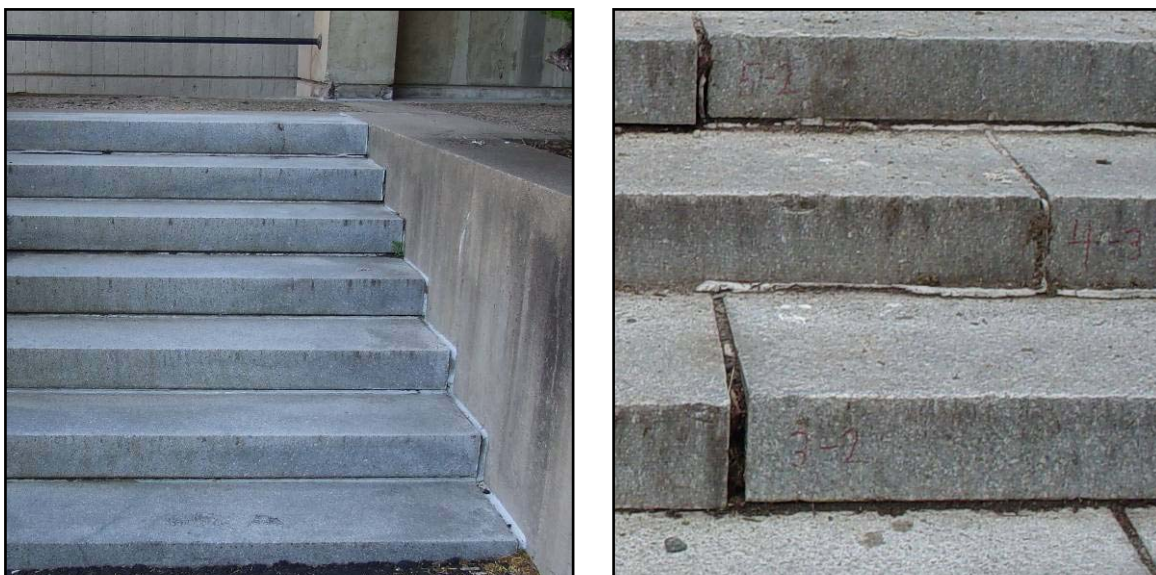
During the initial assessment, suspect caulking materials were observed at two types of locations associated with granite stairs, as shown below:

Photo above left: Horizontal joints spanning the width of the staircase, beneath the overlap between two consecutive granite slabs; also includes the joint at the top edge of the uppermost stair and the bottom edge of the lowest stair where these stairs abut concrete or another paved surface. Caulking is also present at the horizontal and vertical joints between the edge of the stairs and abutting walls.

Photo above right: Horizontal and vertical joints (the rise and run of each step) at the short edge of each stair where it abuts another slab in a wider staircase (often deteriorated or missing at many locations).

Gross removal of caulking was performed from each granite stair prior to its removal from the staircase. The caulking was removed by cutting or scraping with hand tools, or by using a mechanical caulking removal gun. No grinding or saw cutting (i.e., excessive dust-generating techniques) was used directly on the caulking. All removed caulking was containerized and disposed as > 50 ppm PCB wastes. During this process some remnants of caulking remained on the steps.

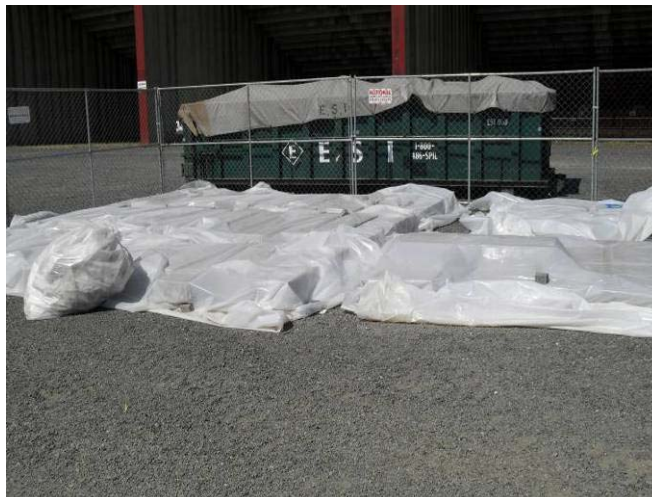
Each step was then lifted from the foundation, wrapped in polyethylene sheeting and transported via flat bed truck to a staging/decontamination area. This decontamination area was located in a vacated parking area adjacent but outside the limits of the Southwest concourse area. While staged and prior to decontamination, the steps were totally encapsulated in polyethylene sheeting. See photograph to the right.

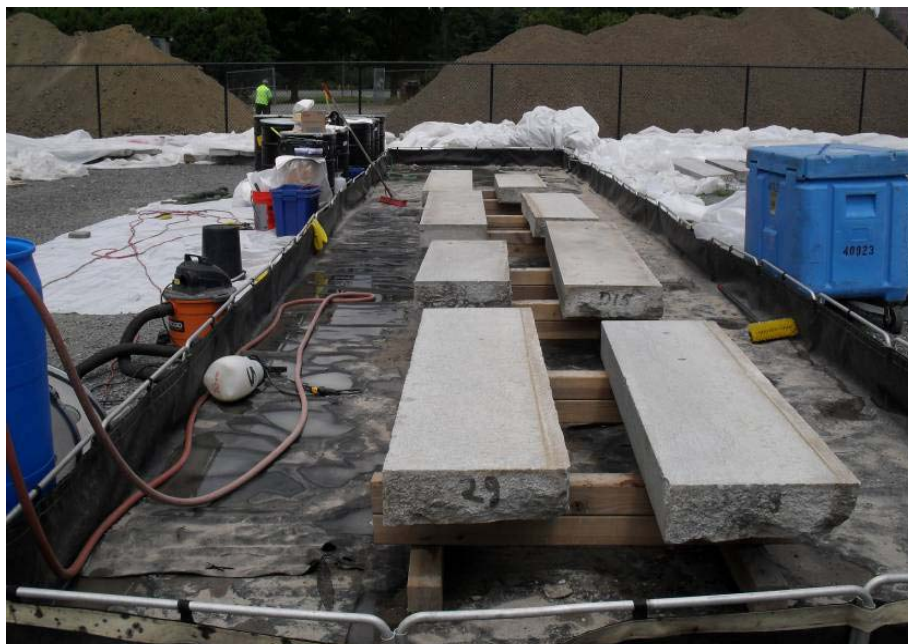
Initially, remnant caulking from the steps was removed by mechanical scraping and scrubbing; however, this method was not resulting in sufficient caulking removal (the first several steps were still observed to have remnant caulking adhered to some of the former joint locations). Dry ice blasting was pilot tested and shown to be effective in removal of the visible caulking remnants. As such, dry ice blasting was conducted within poly containment in the overall decontamination area. A photograph of the containment and step decontamination area is shown to the right (dry ice poly containment not shown).

Following the dry ice blasting, each step was decontaminated via chemical washing with a chemical extraction solvent (CAPSUR) following the manufacturer's recommended procedures for hand applications: the product was applied and

scrubbed in using hand brushes for the full five minute dwell time; during the agitation, the surface of the granite was kept wet with CAPSUR at all times; following the five minute dwell time, all free liquid was vacuumed from the granite; and a layer of rinse water was applied to the granite and then vacuumed. This procedure was repeated three times followed by a triple water rinse after the final application.

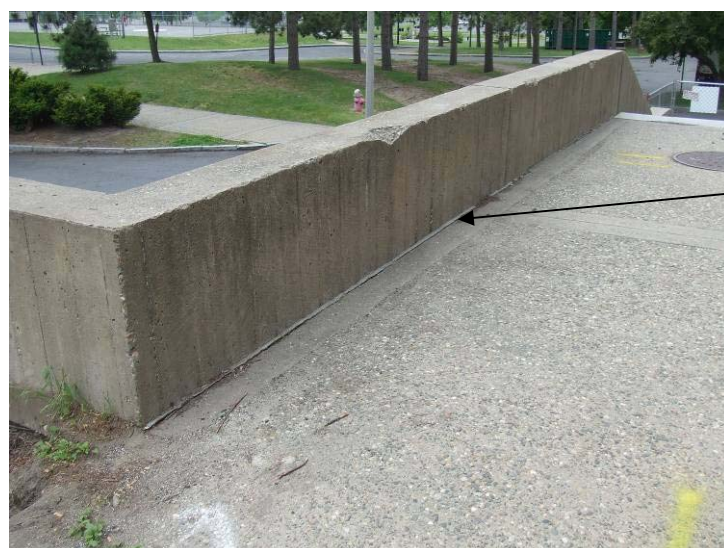
Caulking at joint between pad and concrete retaining wall

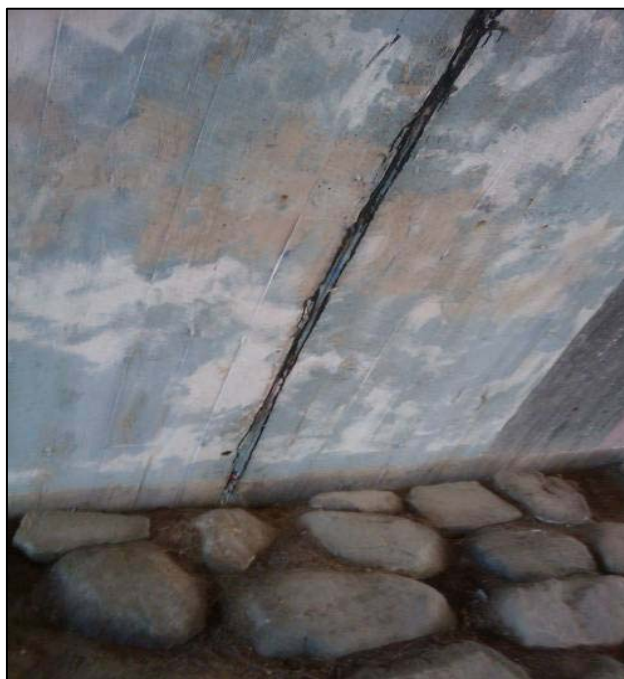
An outdoor pedestrian tunnel is located on the northern end of the project work area and consists of an approximately 94 foot long concrete archway tunnel beneath Massachusetts Avenue. As presented in Section 7 of the Remediation Plan, PCB containing caulking was located at an expansion joint at approximately the mid point of the concrete ceiling archway (40 linear feet) and at caulked expansion joints approximately every 10 feet along a concrete curbing on both sides of the tunnel.

The work within the Tunnel as part of the concourse revitalization project included replacing the concrete slab on the ground surface, painting the archway ceiling (including removing/replacing the expansion joint caulking on the ceiling), and installing other aesthetic features to promote the use of the tunnel as opposed to students using the street surface crossing.

The first component of the plan was to remove the caulking, which was removed following the procedures described in Section 4 of the Remediation Plan. All caulking was removed by physical means and containerized for off-site disposal as ≥ 50 ppm PCB wastes. Following removal, the joint was visually inspected to ensure that all caulking was removed to the maximum extent practicable. This process was also repeated for the caulking on the concrete curb. The archway caulking was replaced (as described below); however, new caulking was not applied to the concrete curbing.

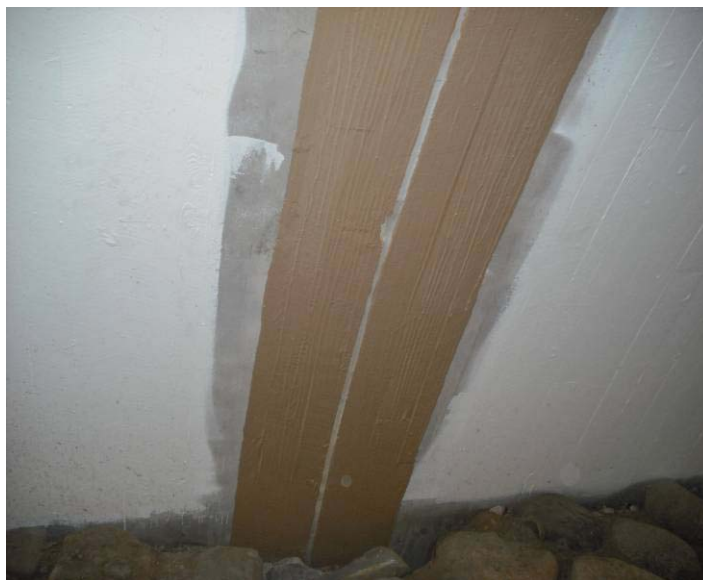
The concrete in former direct contact with the caulking (inside the return of the joint with PCBs at 309 ppm) was encapsulated with two coats of the Sikagard 62 epoxy coating (tan color), followed by new caulking. The Sikagard 62 epoxy was also applied to the concrete located within 12 inches of the joint in two coats of contrasting color followed by an elastomeric acrylic coating as a top coat (white color). The remaining portions of the ceiling were coated with the white elastomeric acrylic coating. A photograph of the encapsulated area is shown to the right.

Following the application of the encapsulants, baseline wipe samples were collected for PCB analyses. Given the accelerated project schedule, weekend work was on-going throughout the project. During a weekend activity, the new caulking was applied to the archway joint prior to collecting the baseline wipe samples. Upon inspection, new caulking was not applied to a small section of the joint near the base of the joint; therefore, a wipe sample was collected from this location. As indicated on Table 2-4, a result of 7 ug/wipe (calculated to be 24 ug/100cm²) was detected in this sample. To confirm this result, new caulking from a section of the joint was removed and a wipe sample collected from the underlying epoxy surface. This wipe sample result was 4.1 ug/wipe (calculated to be 7.16 ug/100cm²). Given these results, a wipe of the new caulking was collected and detected PCBs at 3.66 ug/100cm². A sample from the encapsulated concrete adjacent to the joint was collected and PCBs were not detected in this sample above the laboratory's minimum reporting limit. All sample results are summarized on Table 2-4 and the laboratory reports are provided in Appendix C.

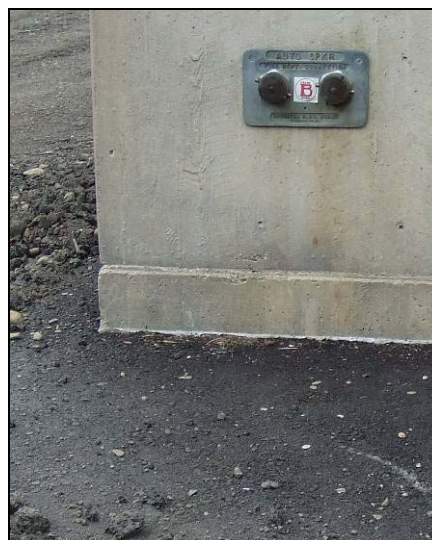
- Joints between granite stairs and walls (horizontal and vertical seams; see Photo 1)
- Joints between paved ground surfaces and walls (horizontal seams; see Photo 2)
- Joints between a building wall and the end of a retaining wall (vertical seams; see Photo 3)

Photo 2 (Top Right): Caulking joints between paved ground surfaces and walls.

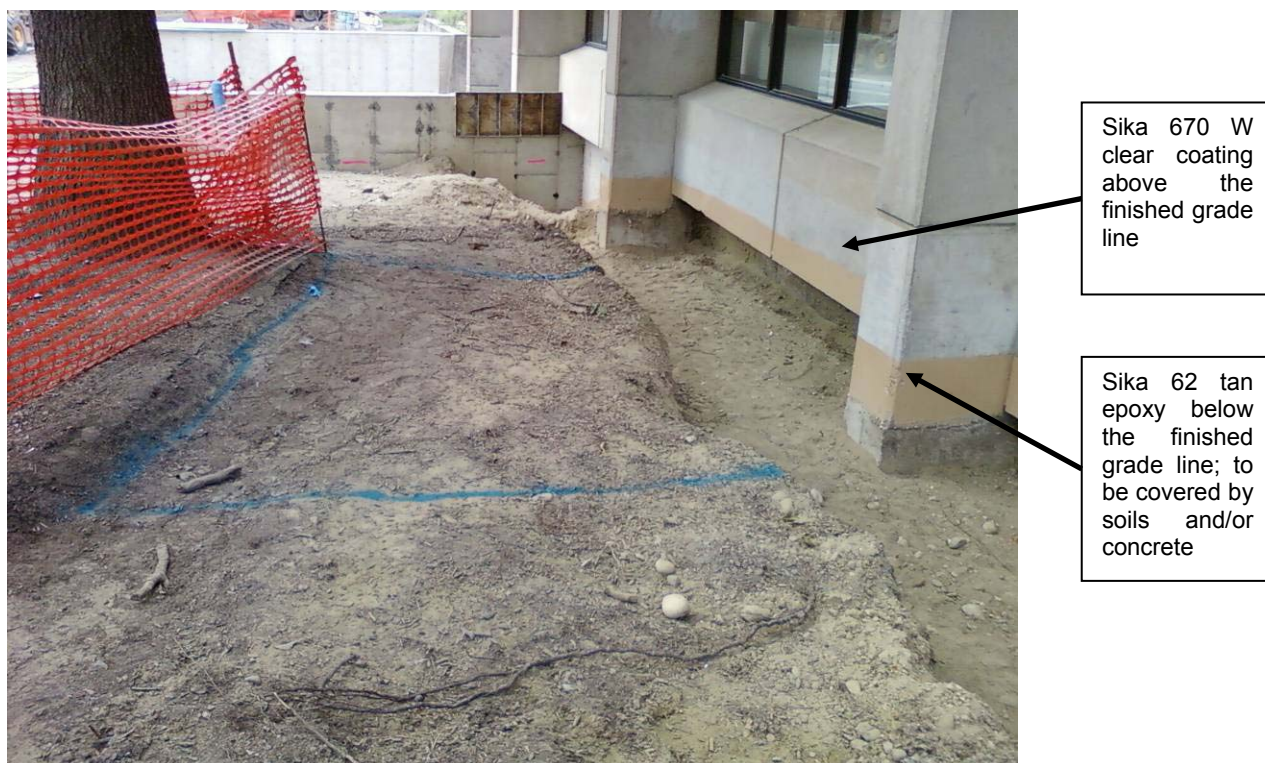
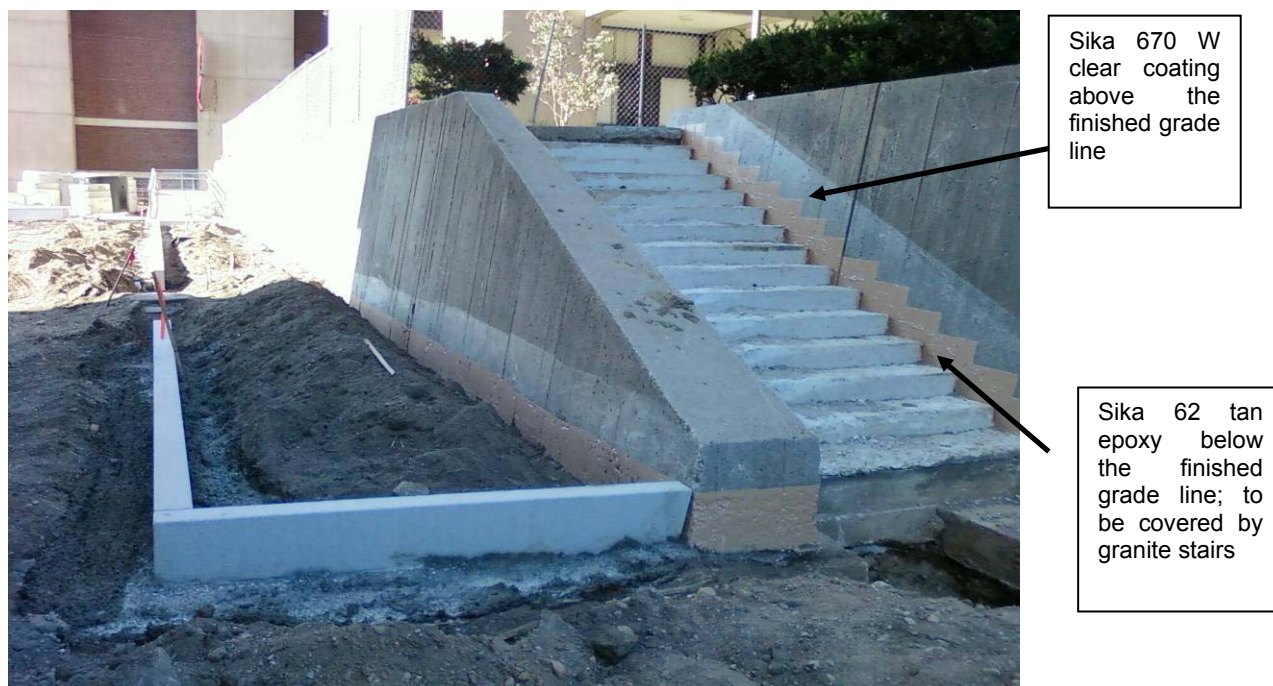
Concrete in areas not scheduled for removal and within the limits of the encapsulation was manually cleaned to remove latent dust, dirt, and debris to the extent required to allow for encapsulant application. Following caulk removal and surface preparation, two coats of the Sikagard 62 colored epoxy was applied over the former location of the caulked joint, to a minimum distance of 12 inches below the caulked joint, and to a distance of the final finished grade above the caulked joint, if the final grade was above the former caulked joint location. A tan color was selected by the project architects and team. Given that this coating will be below final grade, contrasting colors were not applied since future inspections of the coating will not be possible. As part of the project, the epoxy is being covered by the final finished material which will include, depending on location, concrete, concrete brick pavers, or landscape materials. Concrete to a distance of no less than 12 inches above the caulked joint or finished grade was encapsulated using the Sikagard 670W clear acrylic coating. Figure 2-8 depicts the locations of the encapsulant surfaces throughout the site.

Photographs of the encapsulant coatings are shown below.

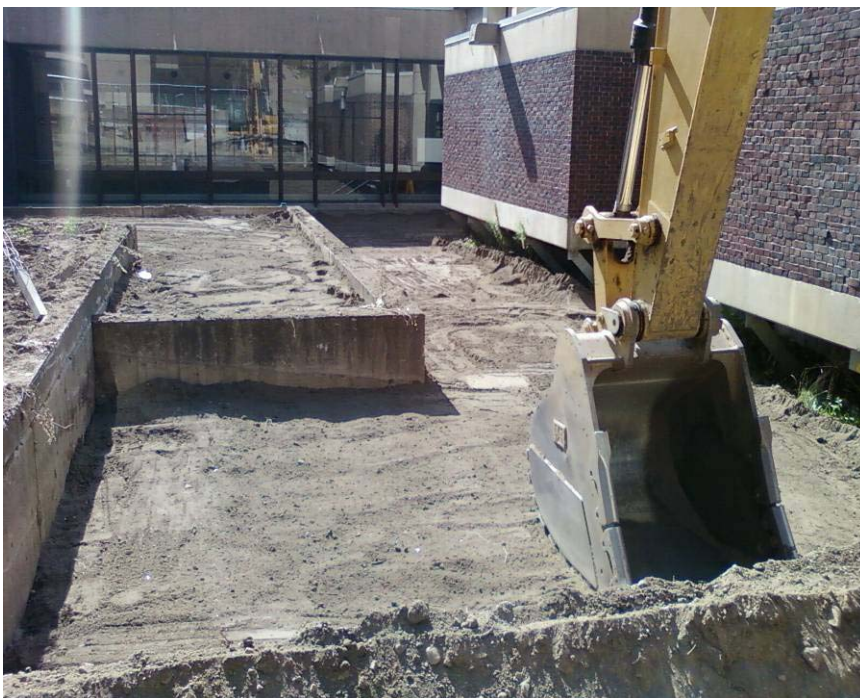
All soils designated for removal as part of the concourse replacement project that have PCB concentrations in excess of 1 ppm were excavated and transported off-site for disposal at an approved facility as bulk PCB remediation waste. All excavated soil was stored in lined, marked, and covered roll-off containers in accordance with 40 CFR 761.40 and 761.65.
