December 22, 2022

Re: Long-Term Monitoring and Maintenance of PCB Encapsulated Surfaces  
2022 Monitoring Results  
University of Massachusetts, Amherst, Massachusetts

**Attachment 1 – Tobin Hall  
Long-Term Maintenance and Monitoring Program  
In-Place Management of PCB Impacted Materials  
UMass Amherst**

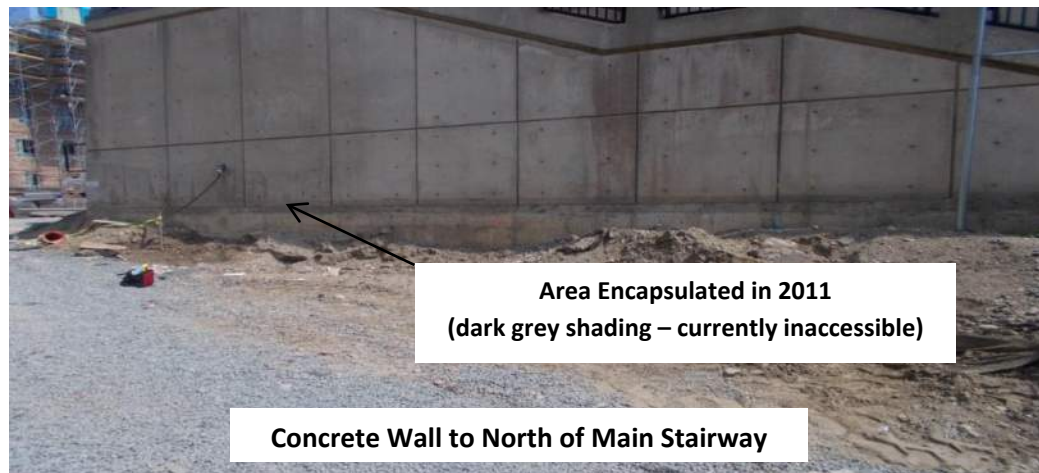
*In-Place Management:* Residual PCBs on a building wall are being managed in-place following removal of concrete decking on the west side of Tobin Hall in 2011 and concrete stairs/landing in 2012. Concrete materials that contain PCBs at concentrations > 1 parts per million (ppm) remain beneath a liquid encapsulating coating (residual PCB concentration in concrete reported at a concentration of 2.37 ppm). The encapsulation extends to a distance of six inches above and six inches below the former caulked joint along approximately 80 linear feet (l.f.) of the Tobin Hall building wall and along approximately seven l.f. of the concrete façade/pillar at the north and south ends of the stairway landing. Materials were encapsulated with two coats of clear Sikagard 670W acrylic coating or two coats of Sikagard 62 liquid epoxy coating (south end of the stairwell landing only). The locations of the encapsulated surfaces are depicted on Figure 1-1. In 2013, as part of the Commonwealth Honors College construction project, a four-foot-high retaining wall was installed over the majority of the encapsulated surfaces. As a result, the remaining exposed encapsulated concrete surface is limited to a total of approximately 3.5 square feet of concrete at the northern and southern ends of the stair landing (i.e., seven feet of former joint to a distance of six inches above the former joints).

Photos depicting the encapsulated surfaces are presented below.

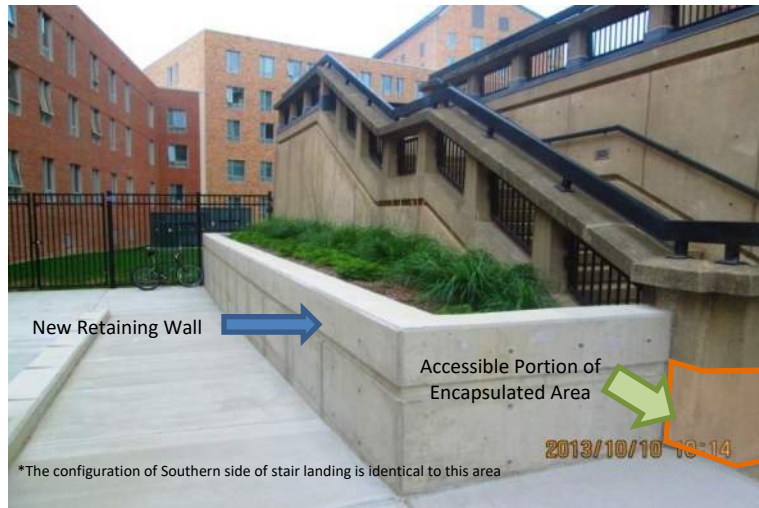
Baseline Verification Data Summary      **Northern Side of Stair Landing**      Wipe samples were collected in August 2011 from the building wall encapsulated with Sikagard 670W clear acrylic coating as part of the decking removal project. Analytical results reported PCBs as non-detect ( $< 0.20 \mu\text{g}/100 \text{ cm}^2$ ) in both samples. One baseline wipe sample was collected from the epoxy coated concrete surfaces as part of the stair landing removal project in 2012. Analytical results reported PCBs as non-detect ( $< 0.20 \mu\text{g}/100 \text{ cm}^2$ ).

Results of visual inspections indicated that the epoxy coatings on accessible portions of the retaining walls were in good physical condition with the exception of an area of flaking epoxy on the east side of the southern column consistent with what was observed during the 2021 monitoring.

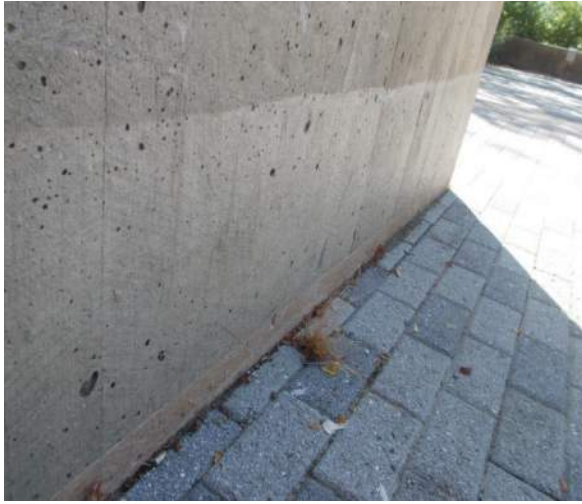
**Typical Retaining Wall Application**

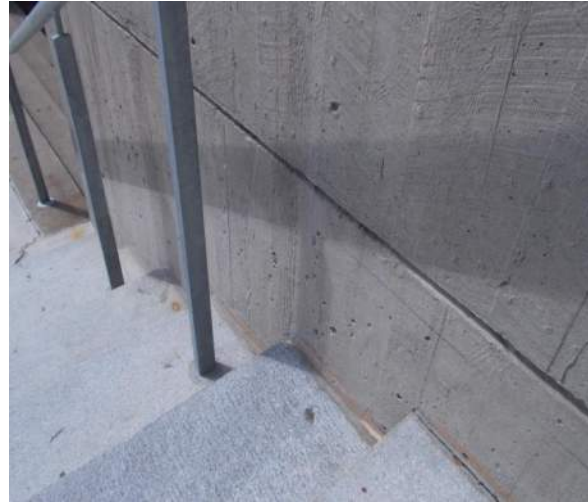
**Typical Stair Application  
(shadow from railing visible as dark area)**

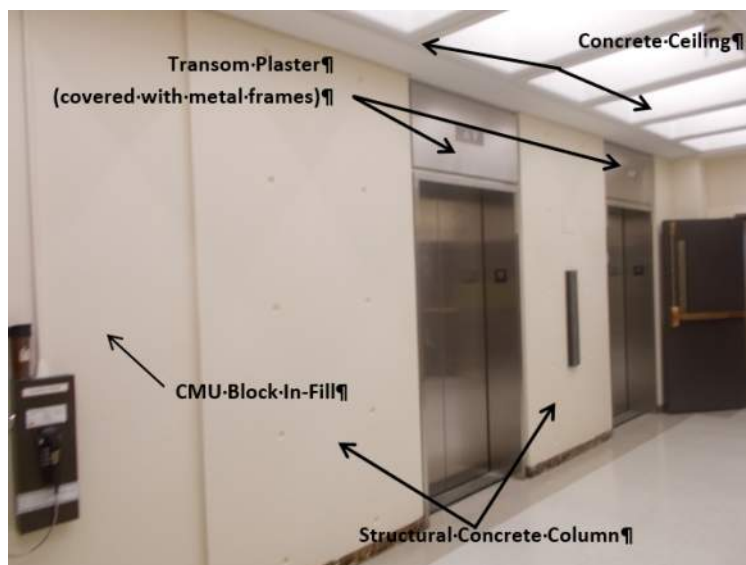
- Structural Concrete Columns – Concrete materials formerly in direct contact with the caulking and out to the first 90-degree angle (or within approximately 2 inches of the caulked joint) were encapsulated with Sika 550W acrylic coating followed by a final coat of interior latex paint. Portions of the elevator door recesses were also covered with metal frames associated with the new elevator doors. All materials on the face of the structural concrete column beyond the corner were encapsulated with latex paint.

The encapsulated surfaces associated with the elevator lobby abatement activities are shown in the photo below.

Visual inspections of encapsulated surfaces were conducted during the annual monitoring event on July 27, 2022. Coatings were observed to be in good physical condition with no signs of wear or damage.

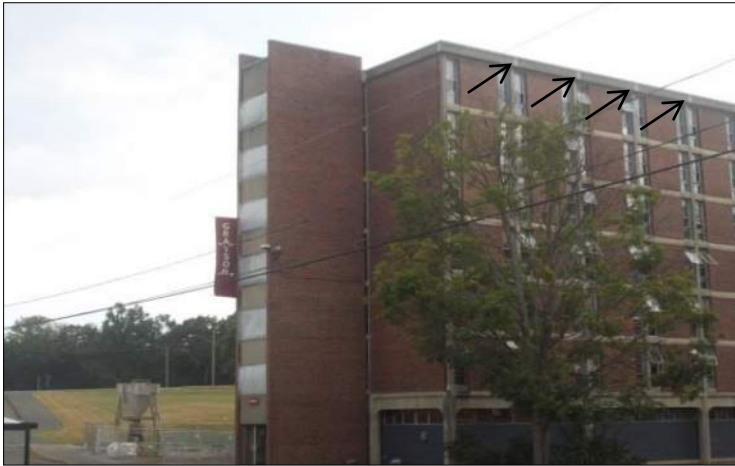
- Exterior Parapet Masonry Joints (2010): Following replacement of caulking along masonry joints at the upper parapet walls of the Field and Grayson Houses, two coats of Sikagard 62 liquid epoxy coating were applied to concrete materials formerly in direct contact with and to a distance of 6 inches from the joints in either direction (see the photograph to the right).

- Locations of Typical Parapet Masonry Joints
- Elevator Hall CMU Block Walls (2012 and 2013): PCBs are being managed in place at > 1 ppm at the 6<sup>th</sup> floor elevator lobby of both Field and Grayson Houses following the removal of caulked joints around Type D windows (see Figure 4-1).

- Field and Grayson Houses:
  - Exterior Parapet Masonry Joints – Coated concrete surfaces surrounding the exterior parapet masonry joints were inspected and found no evidence of deterioration of the coating.

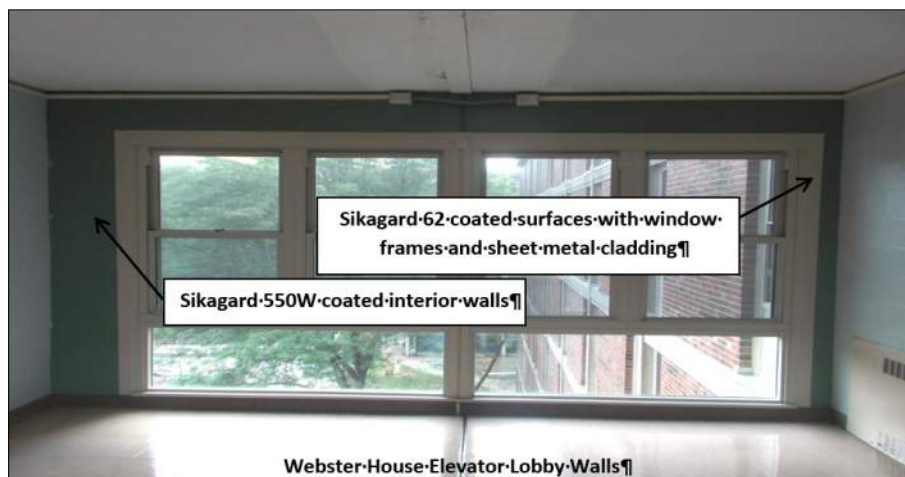
- Elevator Lobby Interior Walls – Concrete materials formerly in direct contact with caulking and to a distance of four inches from the caulked joint were encapsulated with two coats of grey Sikagard 62 epoxy coating and subsequently covered by the newly installed metal window frames and sheet metal cladding. Remaining interior wall materials to the first 90-degree angle were encapsulated with two coats of green Sikagard 550W acrylic coating (see photograph below).

- Webster House - No signs of damage were observed to the sheet metal cladding and window frames on the northwest building elevation. Sheet metal cladding and liquid coatings in the elevator lobby areas were observed to be in good condition with no signs of wear or damage.

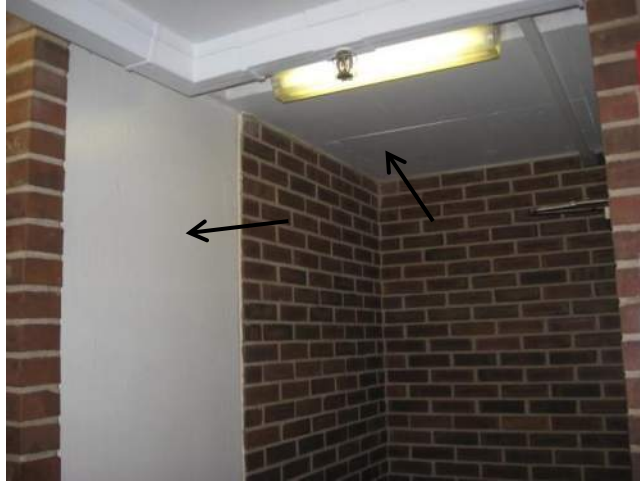
Typical Interior Encapsulated Surfaces  
(Concrete Walls and Ceiling)

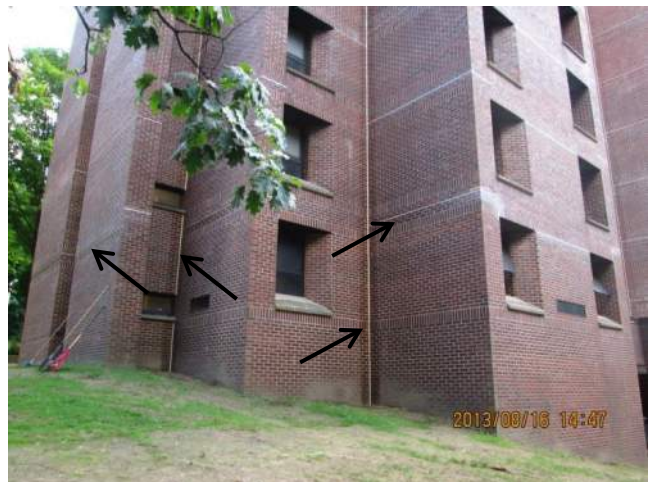
Typical Vertical and Horizontal Control Joints  
(New Caulking and Clear Coating Visible)

- Exterior Expansion Joint Caulking: Visual inspection of the caulking within the horizontal and vertical controls joints indicated that the caulking was in good physical condition with no damaged or missing sections observed.
- Exterior Brick Surfaces: Visual inspection of the Sikagard 670W clear acrylic coating applied along the exterior horizontal and vertical controls joints indicated that the coating remains in good condition over the majority of encapsulated surfaces with isolated areas of flaking and peeling consistent with previous monitoring events.
- Interior Concrete Columns/Walls/Ceilings: Visual inspection indicated that coatings installed to masonry materials were in good condition. No deterioration was observed.

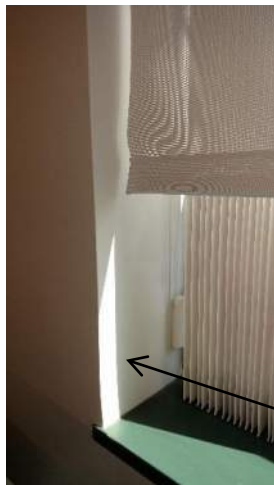
*In-Place Management:* Residual PCBs on interior CMU block walls are being managed in place following a window replacement project conducted on the second floor of the Physical Plant in 2012 and 2013. The replacement project was conducted in the area formerly designated as Room 230A and currently identified as Rooms 204, 209, 210, 208, 212, and 214. The locations of the remediation and in-place management are depicted on Attachment A. Two coats of Sikagard 62 liquid epoxy coating were applied to CMU block materials to a distance of six inches from the former joints. The materials were then covered by the gypsum wall board finish materials and replacement frames.

**Typical Area of In-Place Management**

Woodard & Curran personnel performed the visual inspections of the interior finish materials for signs of damage or deterioration. The replacement window frames and gypsum wall board materials were observed to be in good condition with no signs of damage or wear.
