Re: Long-Term Monitoring and Maintenance Implementation – 2021 Monitoring Results
University of Massachusetts, Amherst, Massachusetts

Attachment 1 – Tobin Hall
Long-Term Maintenance and Monitoring Program
In-Place Management of PCB Impacted Materials
UMass Amherst

**Attachment 2 – Southwest Concourse Area
Long-Term Maintenance and Monitoring Program
In-Place Management of PCB Impacted Materials
UMass Amherst**

**Attachment 3 – Dubois Library
Long-Term Maintenance and Monitoring Program
In-Place Management of PCB Impacted Materials
UMass Amherst**

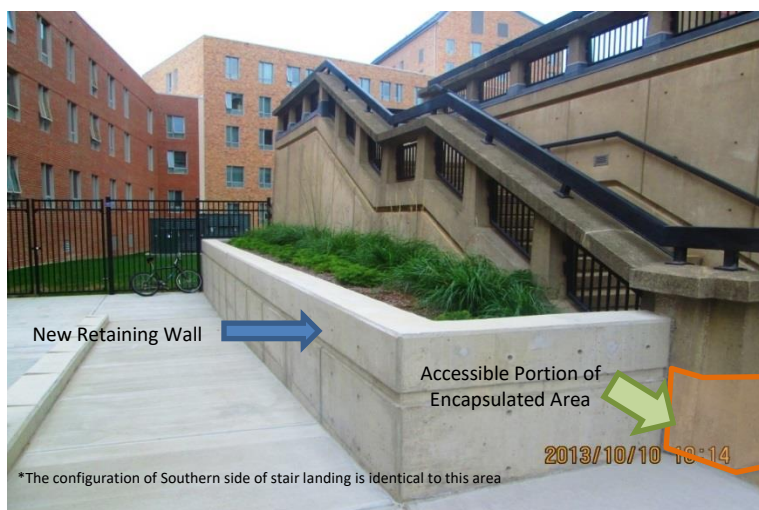
Northern Side of Stair Landing

In-Place Management: Residual PCBs on a building wall are being managed in-place following removal of concrete decking on the west side of Tobin Hall in 2011 and concrete stairs/landing in 2012. Concrete materials that contain PCBs at concentrations > 1 parts per million (ppm) remain beneath a liquid encapsulating coating (residual PCB concentration in concrete reported at a concentration of 2.37 ppm). The encapsulation extends to a distance of six inches above and six inches below the former caulked joint along approximately 80 linear feet (l.f.) of the Tobin Hall building wall and along approximately seven l.f. of the concrete façade/pillar at the north and south ends of the stairway landing. Materials were encapsulated with two coats of clear Sikagard 670W acrylic coating or two coats of Sikagard 62 liquid epoxy coating (south end of the stairwell landing only). The locations of the encapsulated surfaces are depicted on Figure 1-1. In 2013, as part of the Commonwealth Honors College construction project, a four-foot-high retaining wall was installed over the majority of the encapsulated surfaces. As a result, the remaining exposed encapsulated concrete surface is limited to a total of approximately 3.5 square feet of concrete at the northern and southern ends of the stair landing (i.e., seven feet of former joint to a distance of six inches above the former joints).

Photos depicting the encapsulated surfaces are presented below.

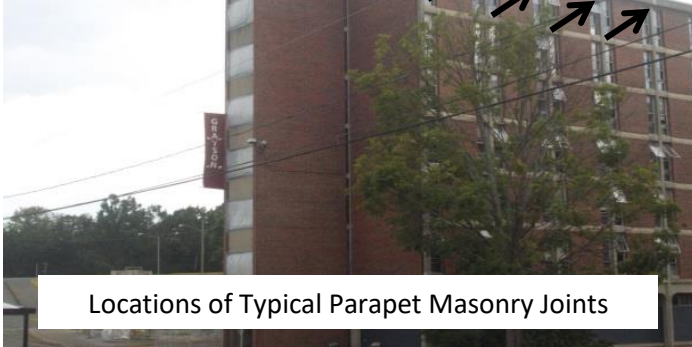
- Exterior Parapet Masonry Joints (2010): Following replacement of caulking along masonry joints at the upper parapet walls of the Field and Grayson Houses, two coats of Sikagard 62 liquid epoxy coating were applied to concrete materials formerly in direct contact with and to a distance of 6 inches from the joints in either direction (see the photograph to the right).
