Re: PCB Remediation – Sylvan Residential Complex
University of Massachusetts
Amherst, Massachusetts

**ATTACHMENT 1: PCB REMEDIATION PROJECT
STATUS UPDATE – BROWN
RESIDENCE**

This status report summarizes the PCB remediation activities conducted for the building envelope repair project and the Americans with Disabilities Act (ADA) restroom upgrade project. PCB remediation activities associated with each of these projects were substantially completed between May and August 2011. Previous communications regarding the ADA restroom upgrade project were made to your office on behalf of UMass by Environmental Compliance Services (ECS); however, as previously communicated, UMass is requesting that these two projects be “linked” into an overall Approval for PCB remediation activities at the three Sylvan Residence complex buildings. This status report is being submitted to provide additional information in support of this Approval.

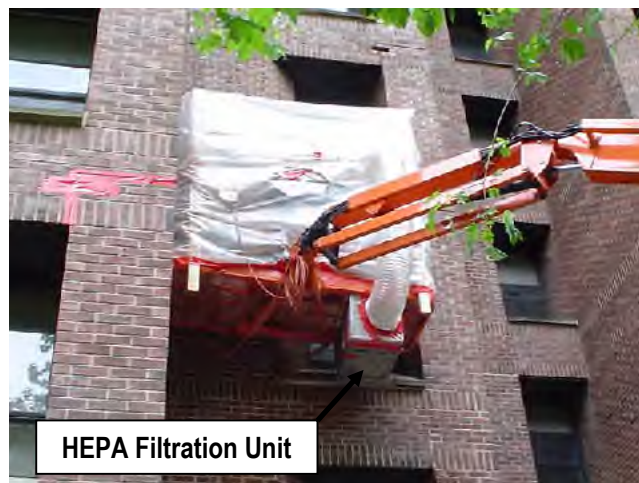
For the building envelope repair project, polyethylene sheeting was placed on the ground surfaces adjacent to the building below the active removal areas. Water misting was the primary means of dust control throughout the remediation activities. Removal of the ≥ 50 ppm PCB containing caulking from vertical and horizontal control joints was conducted within polyethylene containment structures constructed on the lift boom (see photo to the right). HEPA filtration was also utilized for additional dust controls during the removal of the horizontal and vertical control joints on the boom lift (negative pressure controls were not established, the HEPA filtration was used to provide additional dust controls within the containment structure constructed on the lift booms). Work areas

on the roof top for removal of building or penthouse parapet walls, Roof Top Unit (RTU) enclosure walls, and penthouse control joints were demarcated with caution tape and PCB work area signage at the perimeter of the work area. Polyethylene sheeting was placed on the scaffolding and/or roof top surfaces below each area.
