December 29, 2014

Re: Long-Term Monitoring and Maintenance Implementation – 2014 Monitoring Results  
University of Massachusetts, Amherst, Massachusetts

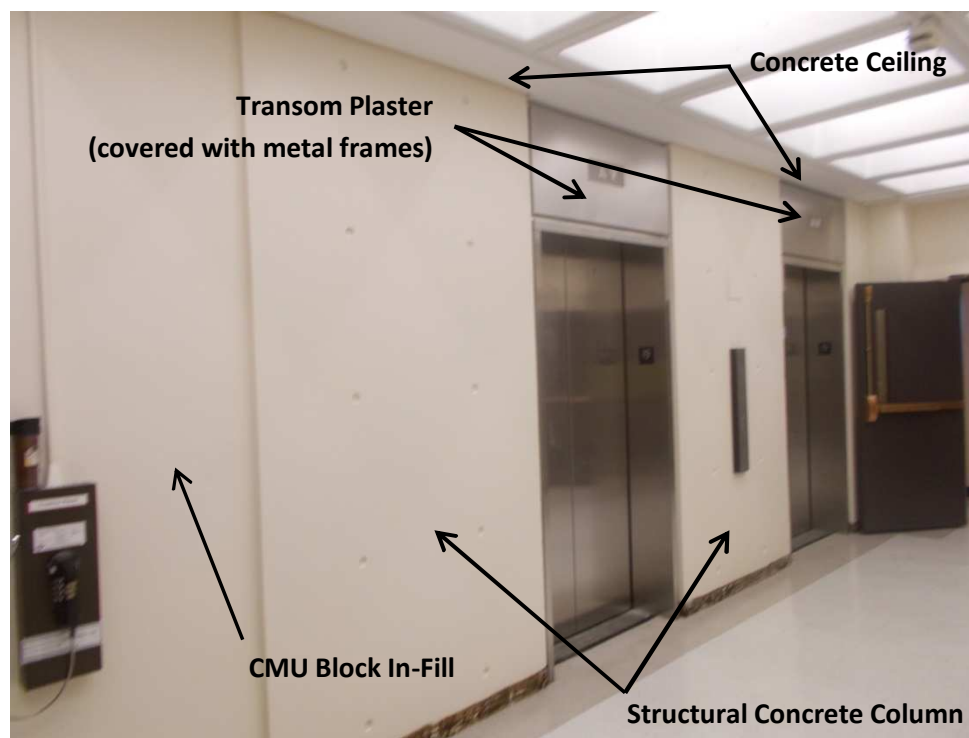
The encapsulated surfaces associated with the elevator lobby abatement activities are shown in the photo below.

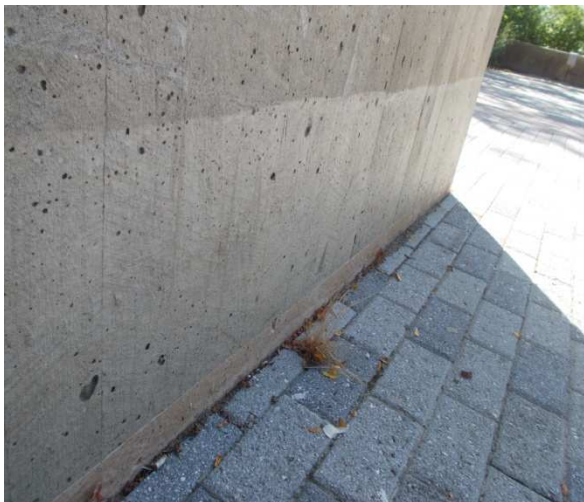
**Typical Retaining Wall Application**

The locations of the encapsulated surfaces are depicted on Figure 3-1 and typical applications are shown in the photos below.

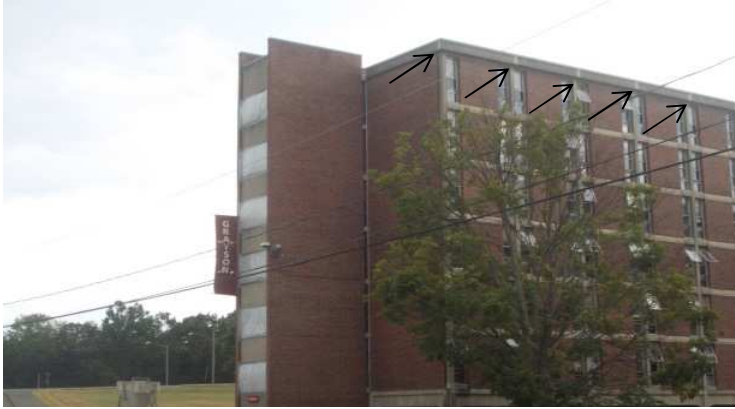
- Exterior Parapet Masonry Joints (2010): Following replacement of caulking along masonry joints at the upper parapet walls of the Field and Grayson Houses, two coats of Sikagard 62 liquid epoxy coating were applied to concrete materials formerly in direct contact with and to a distance of 6 inches from the joints in either direction (see the photograph to the right).

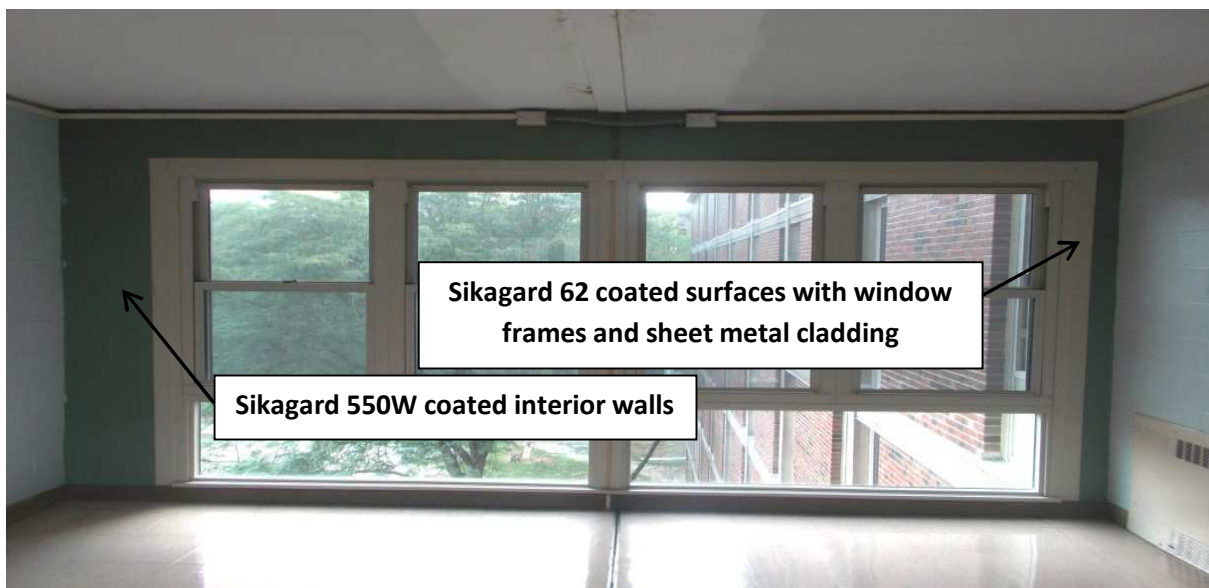
**Webster House Elevator Lobby Walls**

- Elevator Lobby Interior Walls (maximum residual PCB concentration in masonry 7.2 ppm) – Concrete materials formerly in direct contact with caulking and to a distance of four inches from the caulked joint were encapsulated with two coats of grey Sikagard 62 epoxy coating and subsequently covered by the newly installed metal window frames and sheet metal cladding. Remaining interior wall materials to the first 90-degree angle were encapsulated with two coats of green Sikagard 550W acrylic coating (see photograph below).

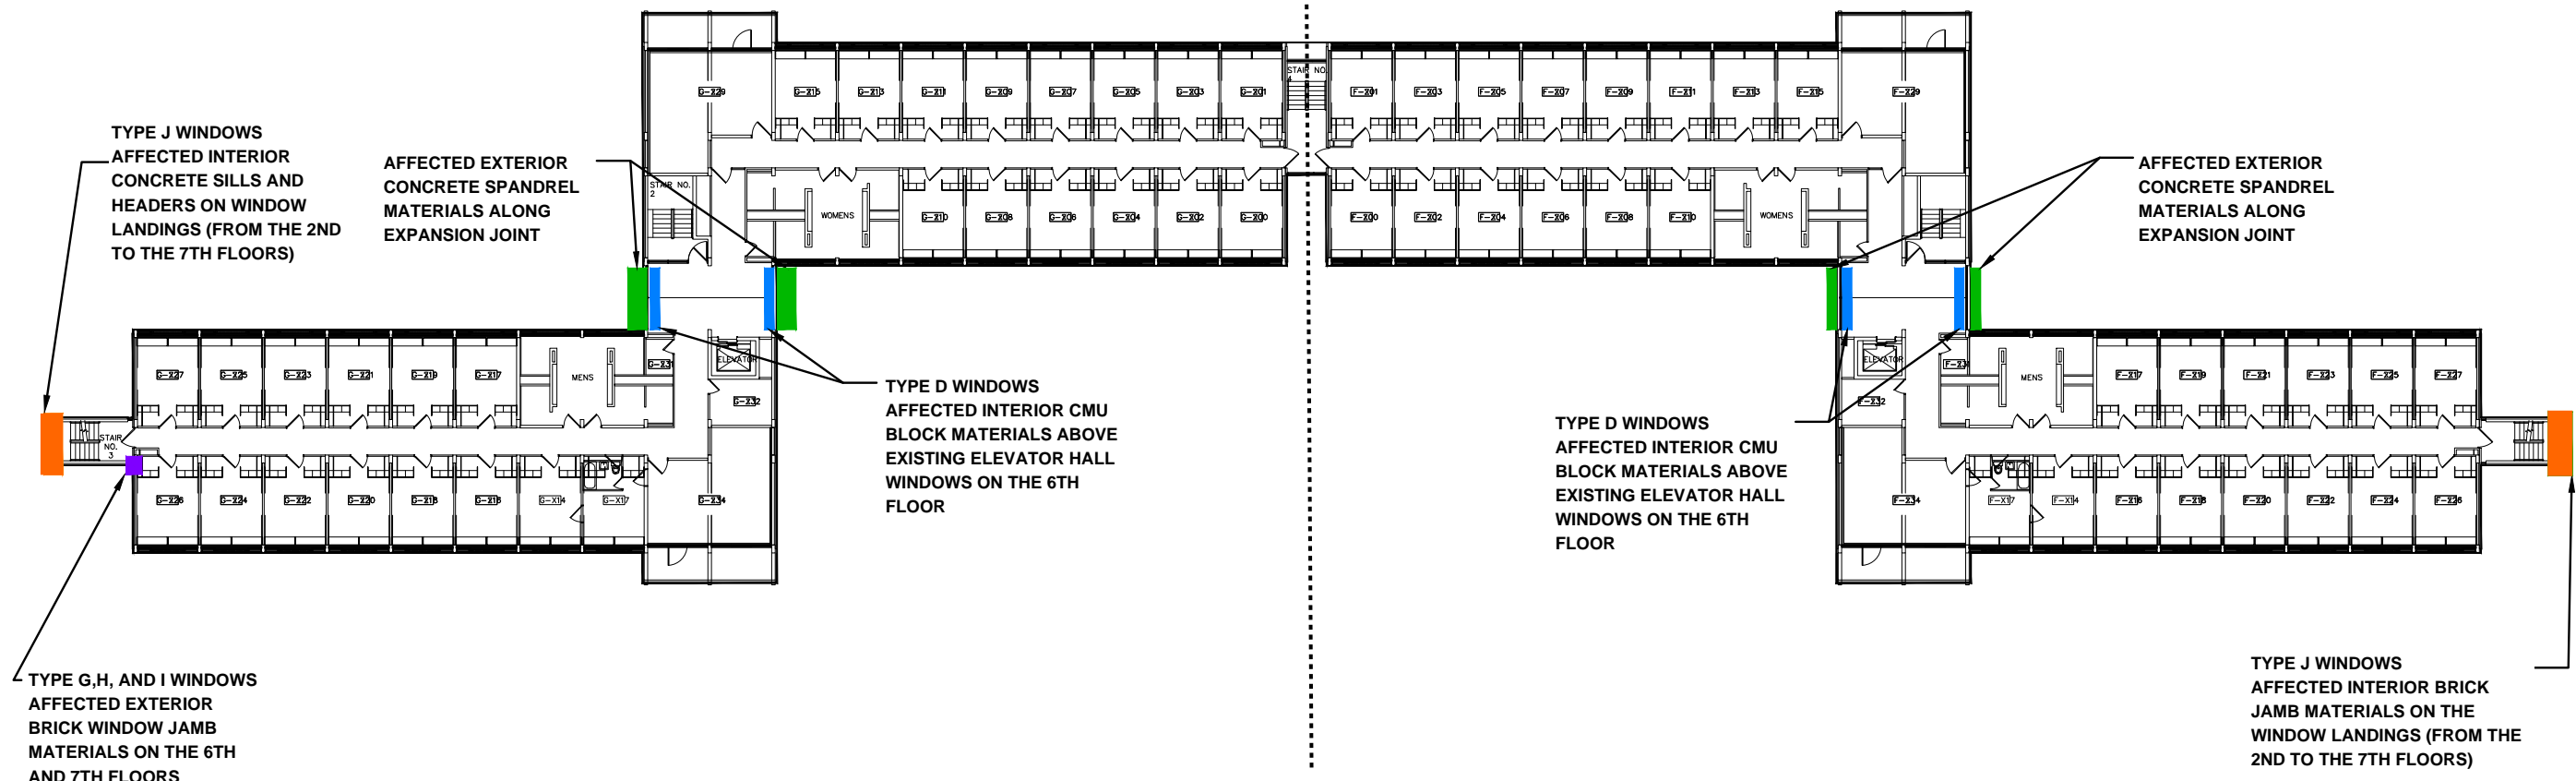
Figure 4-1

- Locations of Typical Masonry Joints
- Elevator Hall CMU Block Walls (2012 and 2013): PCBs are being managed in place at > 1 ppm at the 6<sup>th</sup> floor elevator lobby of both Field and Grayson Houses following the removal of caulked joints around Type D windows (see Figure 4-1).

- Concrete Spandrel Beams (2012 and 2013): Exterior concrete spandrel beam materials on the north and south elevations (located in line with the Elevator Hall Windows) formerly in direct contact with the concrete expansion joint caulking and to a distance of three inches in either direction have been encapsulated using two coats of Sikagard 62 epoxy coating (see Figure 4-1).

- Grayson House Exterior Narrow Stairwell Window Jambs (2012): Brick materials on the jambs of the northern stairwell west elevation narrow stairwell windows on the sixth and seventh floors formerly in direct contact with the exterior perimeter window caulking and to the end of the window recess (the first 90-degree angle) have been encapsulated using two coats of Sikagard 62 epoxy coating and the replacement window frames/sheet metal flashing (see Figure 4-1).

- Grayson House Interior Stairwell Concrete Sills (2012): Concrete window sill and header materials at the northern stairwell landings from the second through seventh floors formerly in direct contact with the interior perimeter window caulking and to the first 90-degree angle (approximately two inches) have been encapsulated using two coats of Sikagard 62 epoxy coating and the replacement window frames (see Figure 4-1).

- Field House Interior Stairwell Brick Jambs (2012): Brick window jamb materials at the southern stairwell landings from the second floor through seventh floors formerly in direct contact with the interior perimeter window caulking and to a distance of two inches (i.e., the extent of the replacement window frames) have been encapsulated using two coats of Sikagard 62 epoxy coating and the replacement window frames (see Figure 4-1).
