Re: Long-Term Monitoring and Maintenance Implementation – 2019 Monitoring Results  
University of Massachusetts, Amherst, Massachusetts

**Attachment 1 – Tobin Hall  
Long-Term Maintenance and Monitoring Program  
In-Place Management of PCB Impacted Materials  
UMass Amherst**

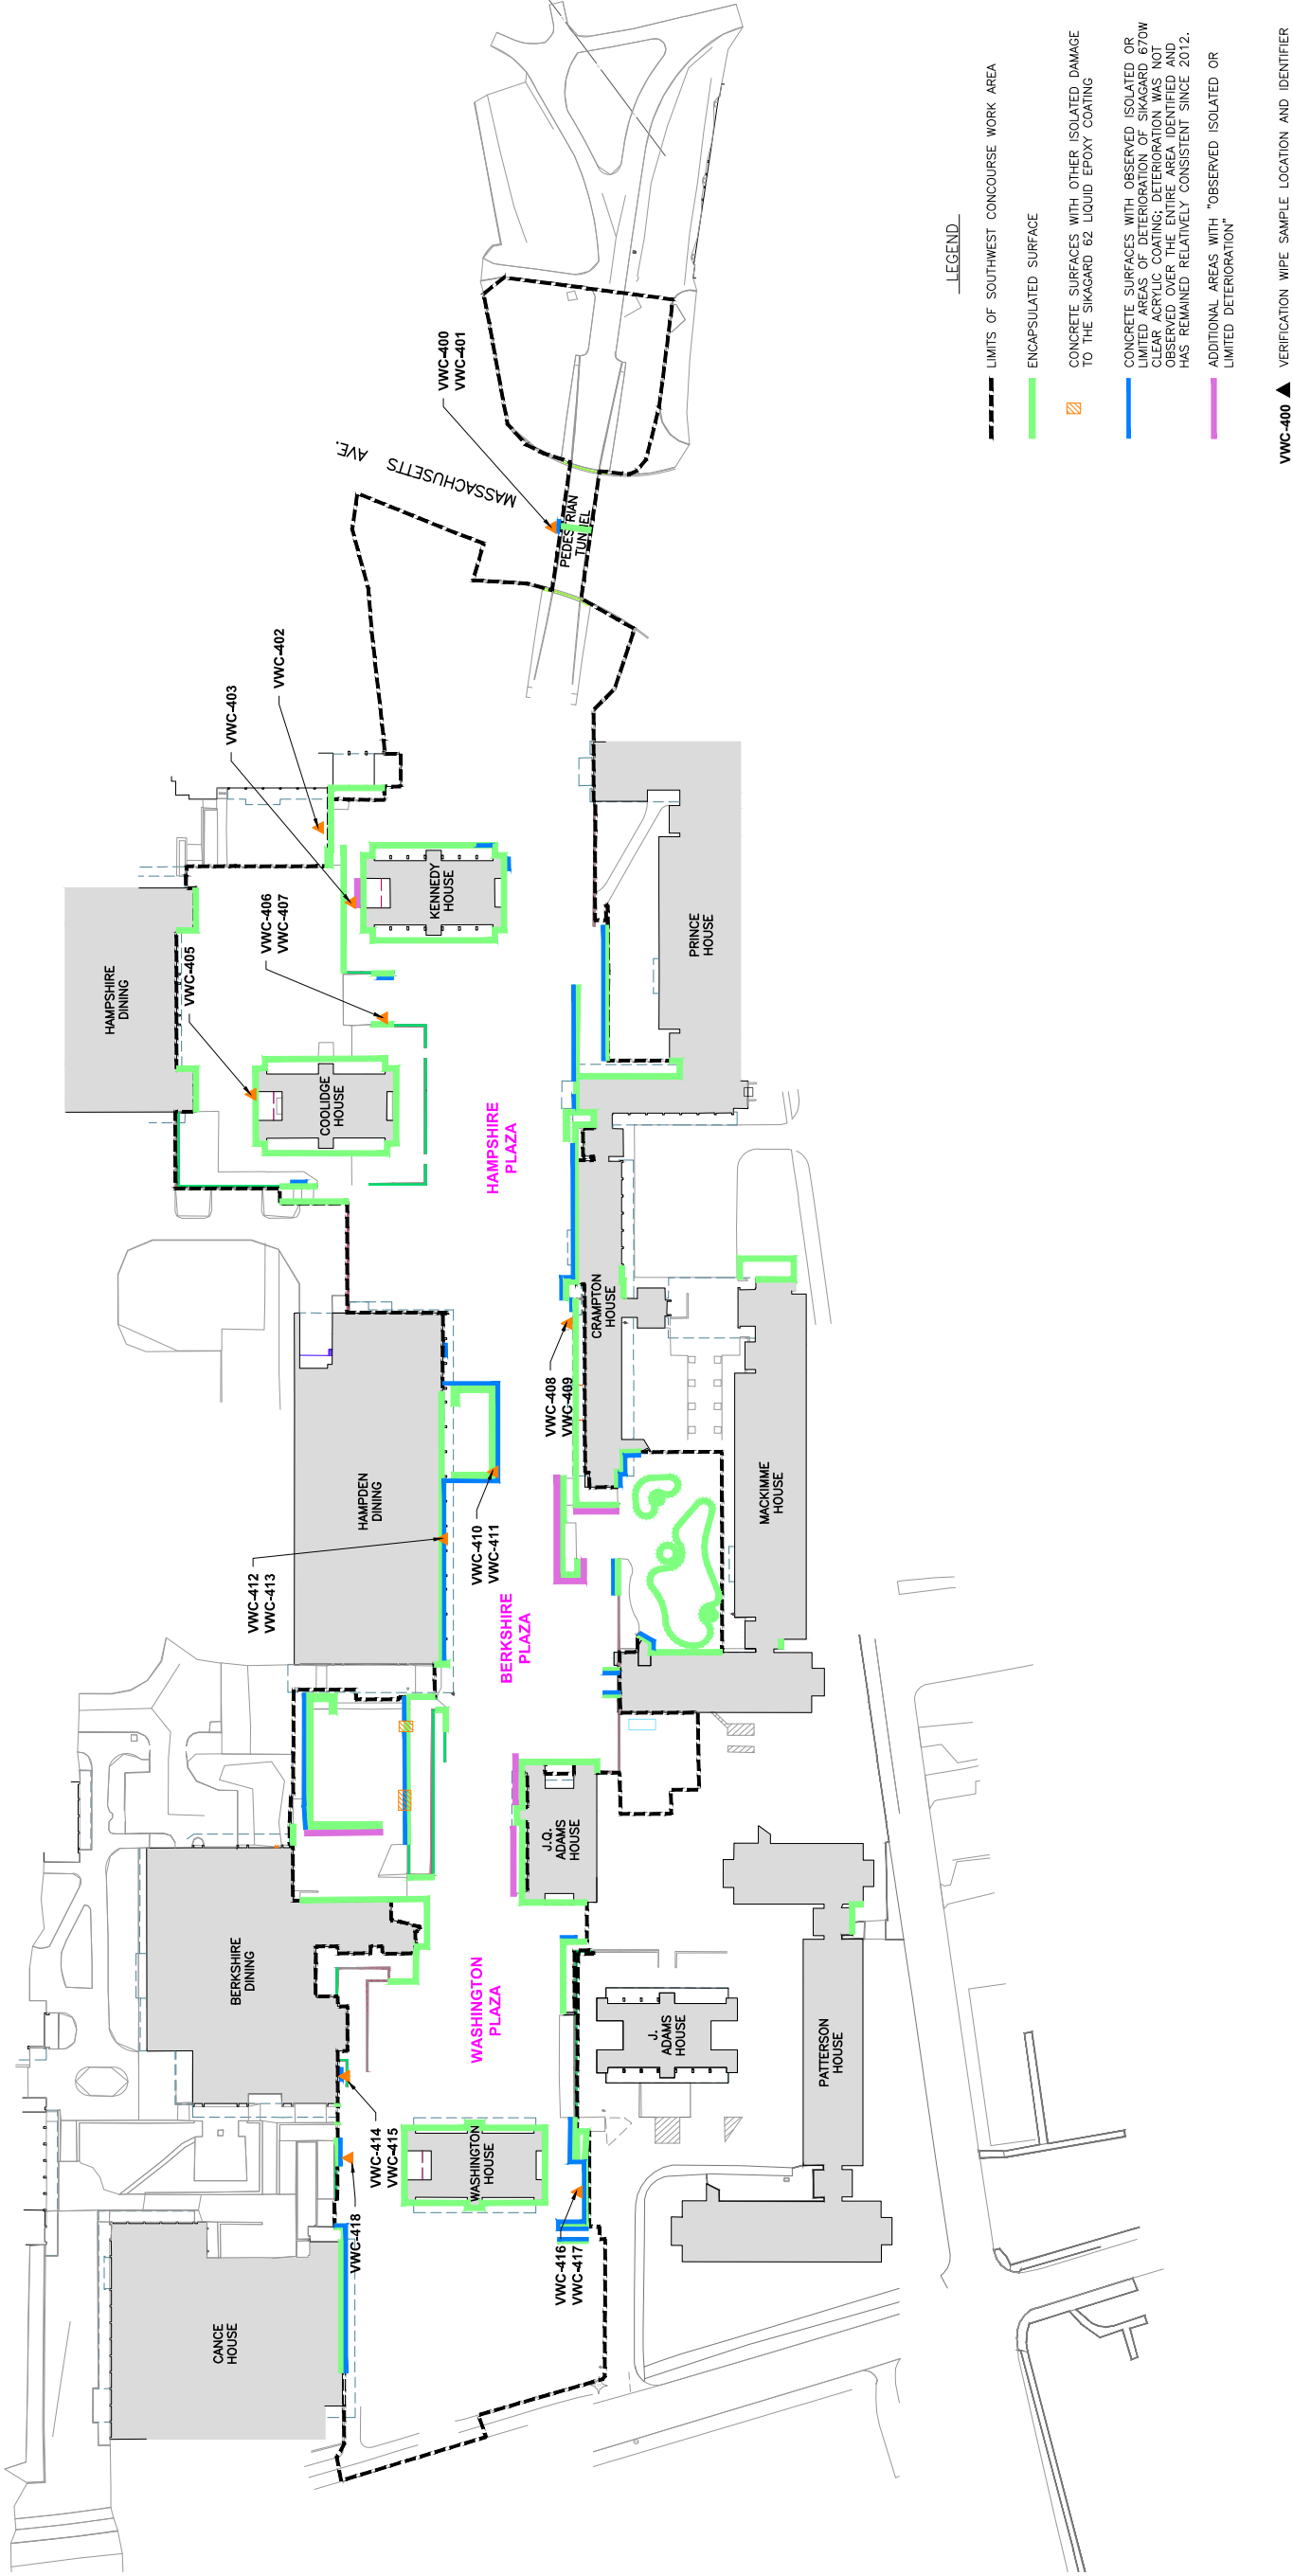
- Sikagard 62 Liquid Epoxy: The visual inspections found no evidence of significant peeling, breakage, or brittleness of the coating. Overall, areas of flaking and peeling were observed in isolation locations and remained generally consistent between inspections with some additional areas observed periodically. In 2017, UMass re-applied epoxy to surfaces observed to have been damaged during previous monitoring. Visual inspections conducted during the 2017 monitoring event confirmed the application of the epoxy coatings to the previously reported damaged areas and one additional small area was observed to be damaged in the Berkshire Plaza (< 1 square foot).

- Sikagard 670W: Visual inspection of the clear acrylic coating indicated that the coating remains in good condition over the majority of the encapsulated surfaces. Some areas of flaking and peeling were observed but in general they were limited to isolated areas typically 4 to 6 inches in size (some areas were observed up to 1 foot in size). The areas of flaking and peeling remained relatively consistent between sampling events indicating that the issues may have been present at the time of application and not indicative of long-term wear of the coatings.

- Sikagard 62 Epoxy: The coatings were observed to be in good physical condition. One additional isolated area of damage was observed on a retaining wall in the Berkshire Plaza.
- Sikagard 670W Acrylic: Visual inspection of the clear acrylic coating indicated that the coating remains in good condition over much of the encapsulated surfaces however, some new areas of observed flaking and peeling were observed within the Berkshire Plaza. The observed flaking and peeling were consistent with other areas described above.
- Concrete Ceiling of Pedestrian Tunnel: Visual inspection of the paint and caulking within the joint indicated the materials remain in good condition.
- The locations of the encapsulated surfaces and areas of observed damage or flaking and peeling are presented on Figure 2-1.

Based on these results, the liquid coatings applied to concrete surfaces within the Southwest Concourse continue to be effective in encapsulating residual PCBs in masonry. Minor damage to the epoxy coating was observed in Berkshire Plaza. Repairs to the epoxy will continue to be made as part of routine maintenance activities within the concourse.

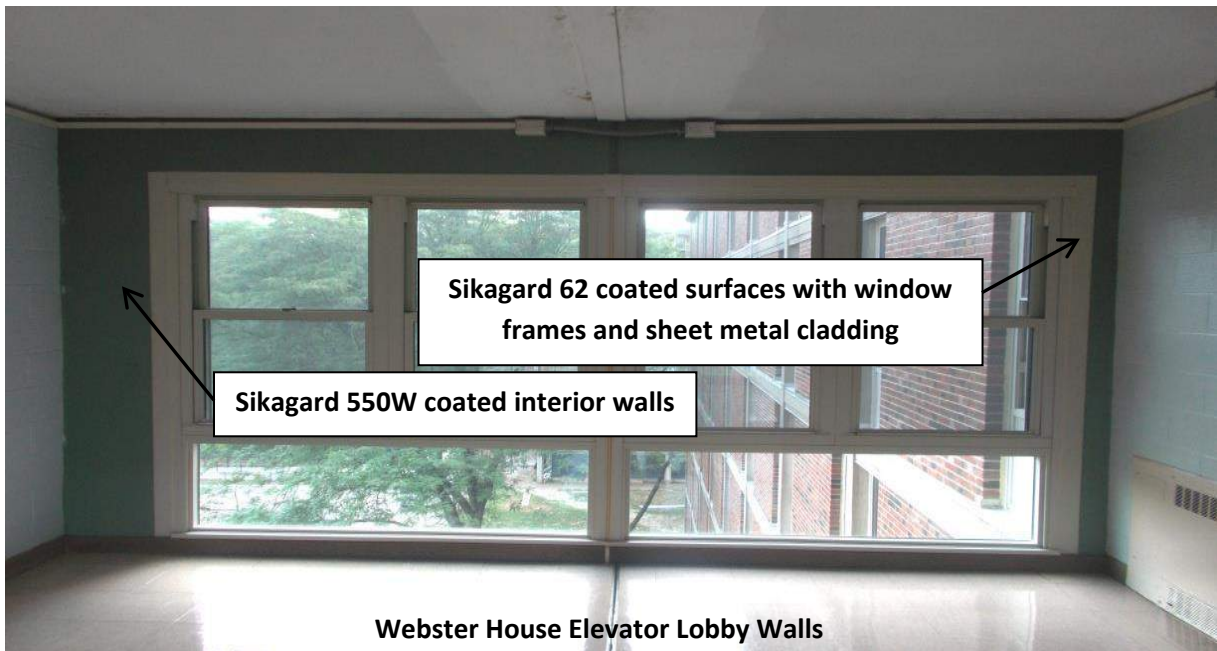
- Elevator Lobby Interior Walls – Concrete materials formerly in direct contact with caulking and to a distance of four inches from the caulked joint were encapsulated with two coats of grey Sikagard 62 epoxy coating and subsequently covered by the newly installed metal window frames and sheet metal cladding. Remaining interior wall materials to the first 90-degree angle were encapsulated with two coats of green Sikagard 550W acrylic coating (see photograph below).
- Northwest Elevation Exterior Concrete Ceiling – Materials formerly in direct contact with caulking along 100 linear feet (l.f.) of ribbon type windows on the northwest building elevation were encapsulated with two coats of grey Sikagard 62 epoxy coating and subsequently covered by the newly installed metal window frames (see Figure 4-2).
