MONITORING AND MAINTENANCE IMPLEMENTATION PLAN

University of
Massachusetts

Dubois Library
Amherst, Massachusetts

222955.00
University of
Massachusetts
March 2013

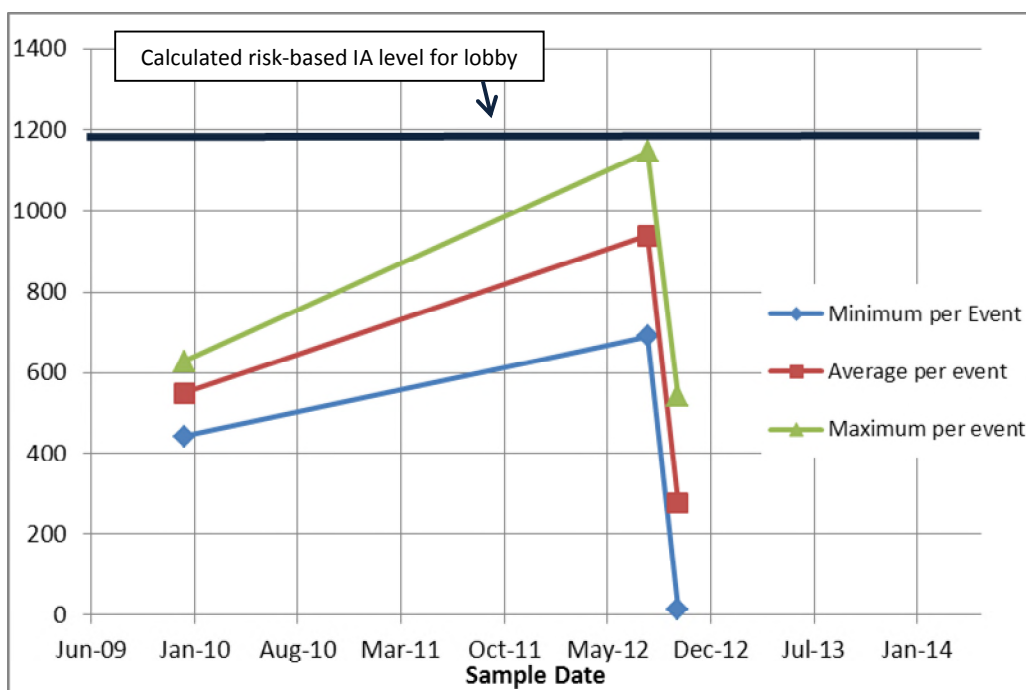
However, the amount of ambient/outdoor make-up air introduced to the building is different throughout the heating/cooling season and may affect indoor air levels. Under normal operating conditions, the dampers for both ventilation zones are less open in the winter and summer months to maintain temperatures within the building and more open in the spring and fall months to allow more outdoor air to aid in cooling the building. As shown on the chart below, the higher levels were observed in the winter and summer months (less make-up air) and the lowest level was observed in the Fall with the dampers more open. This information is being used in the development of the MMIP.

**Range of PCB Concentrations in Indoor Air Samples
over the Three Sampling Events (ng/m³)**
