Re: PCB Interim Measures Completion Report and MMIP
Lederle Graduate Research Center
University of Massachusetts – Amherst

**REVISED
MONITORING AND
MAINTENANCE
IMPLEMENTATION
PLAN**

**Lederle Graduate
Research Center**

Tower A and Low-Rise
Computer Room

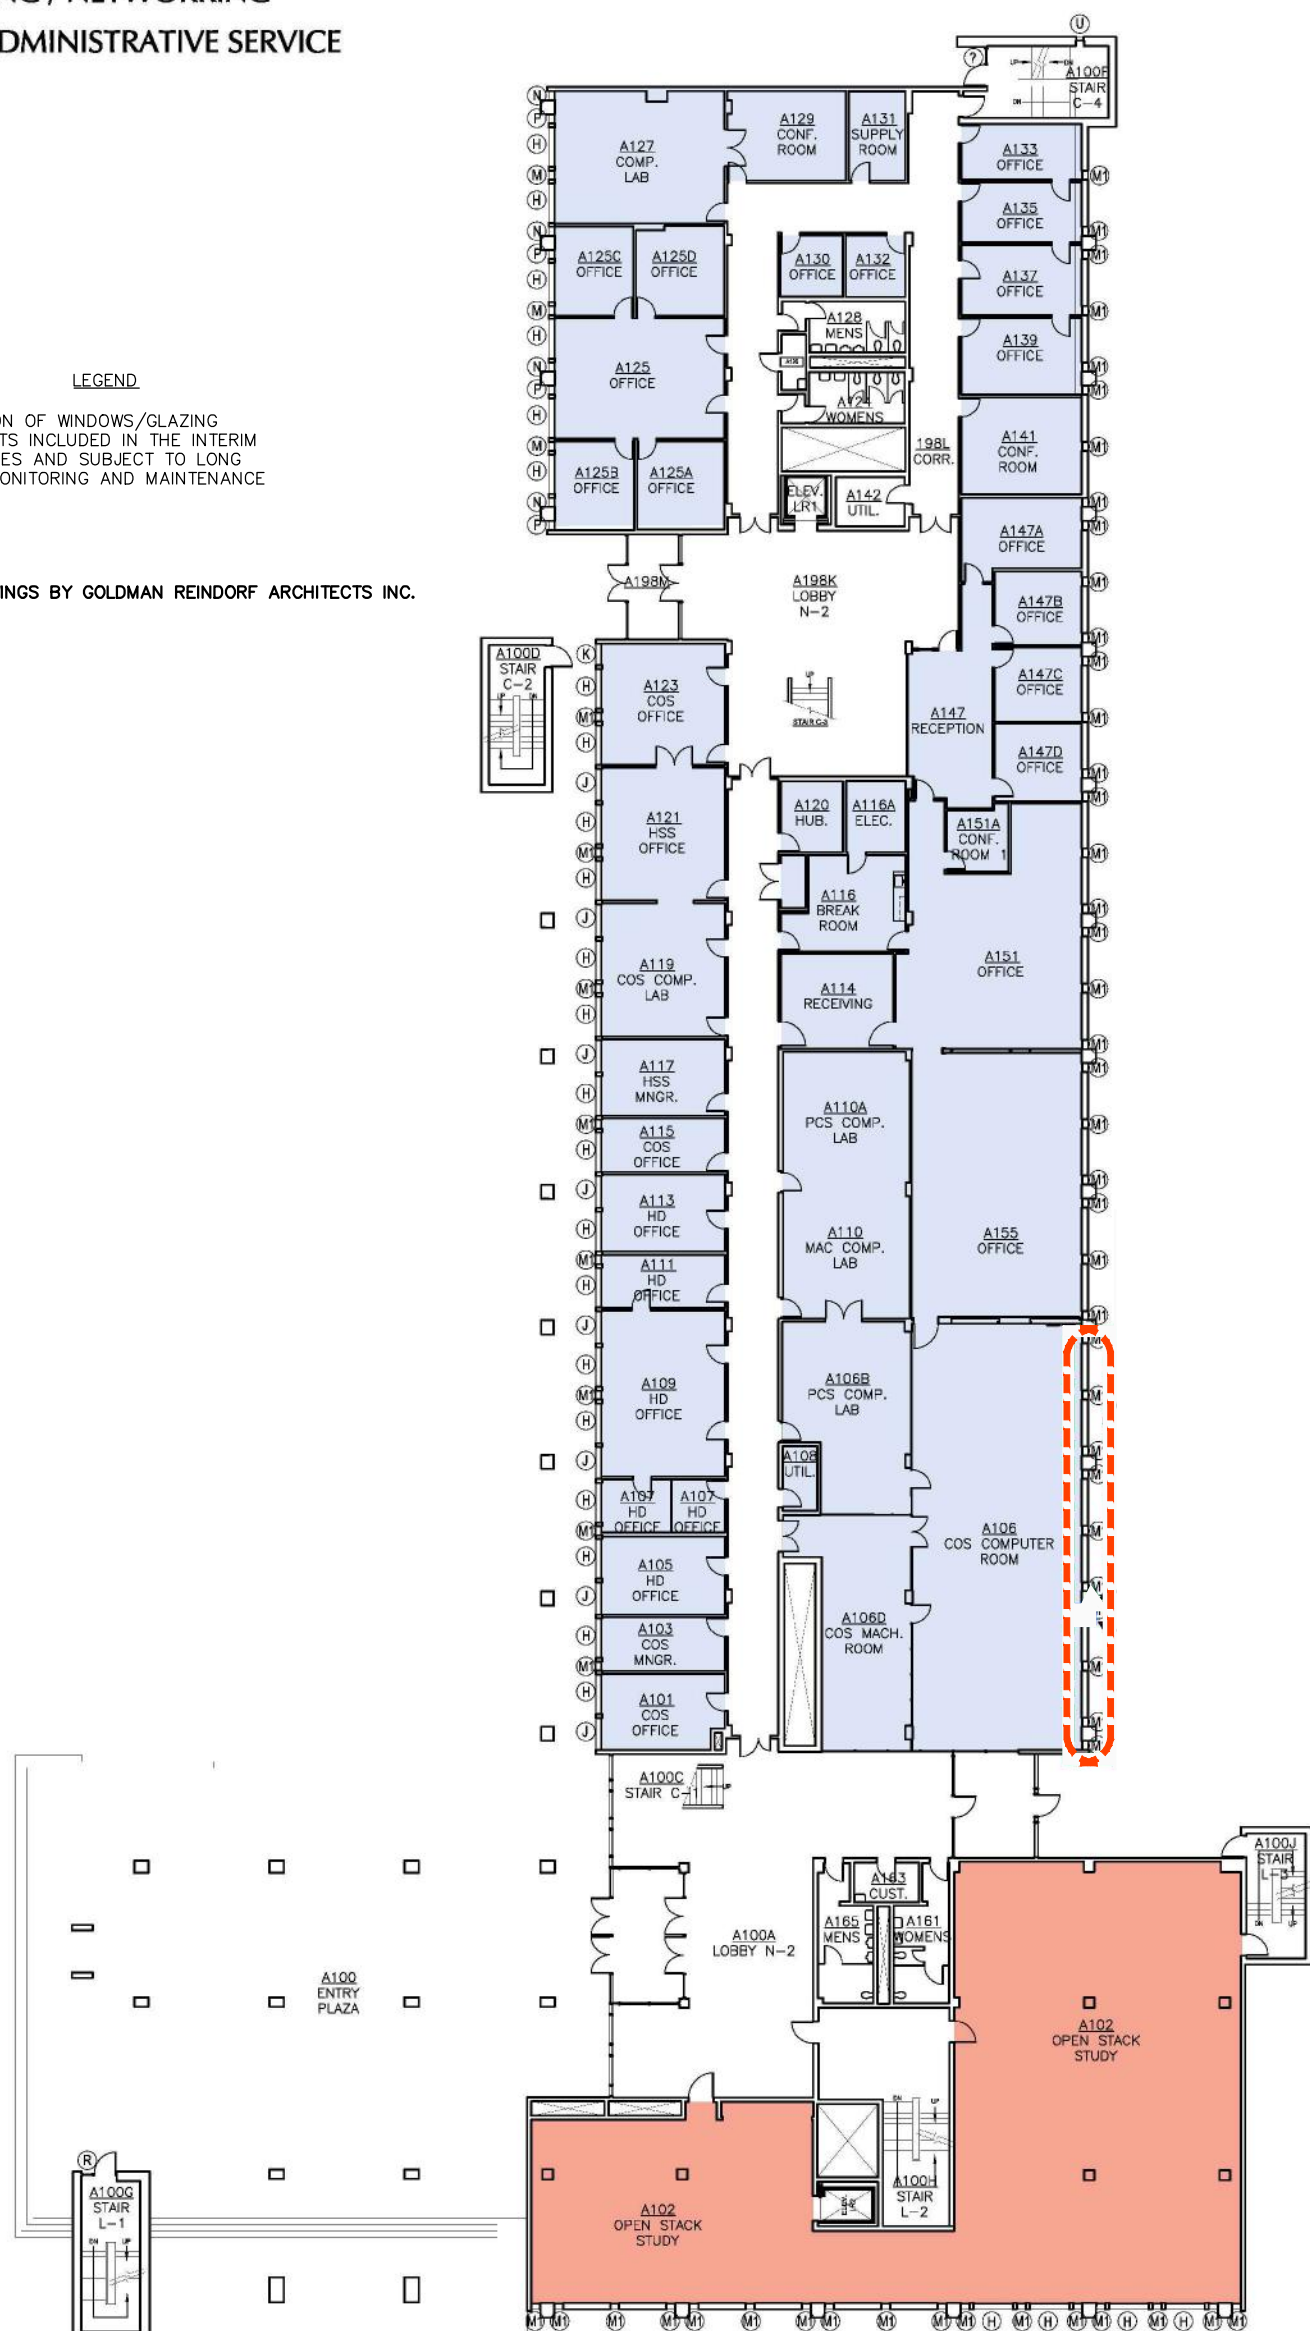
LOCATION OF WINDOWS/GLAZING SEALANTS INCLUDED IN THE INTERIM MEASURES AND SUBJECT TO LONG TERM MONITORING AND MAINTENANCE
